Haines Borough Fish Passage Inventory and Assessment

Haines, Alaska

Prepared by the Takshanuk Watershed Council
November 2011

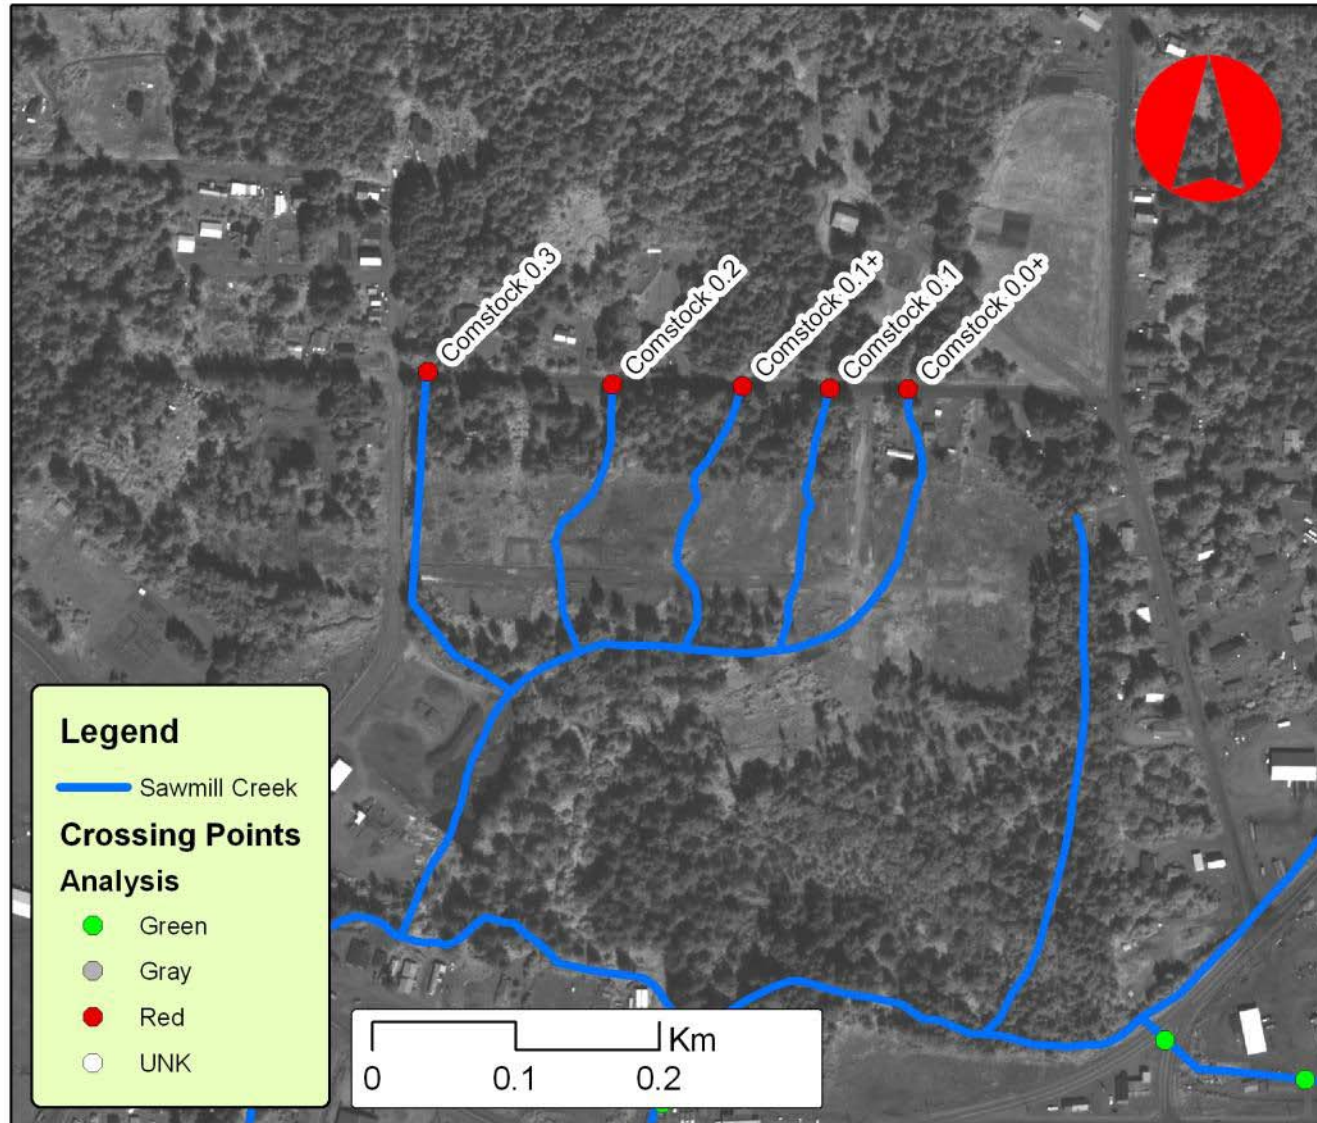
Figure 3. All of the crossings on Comstock Road in the Haines townsite are classified as deficient for fish passage.

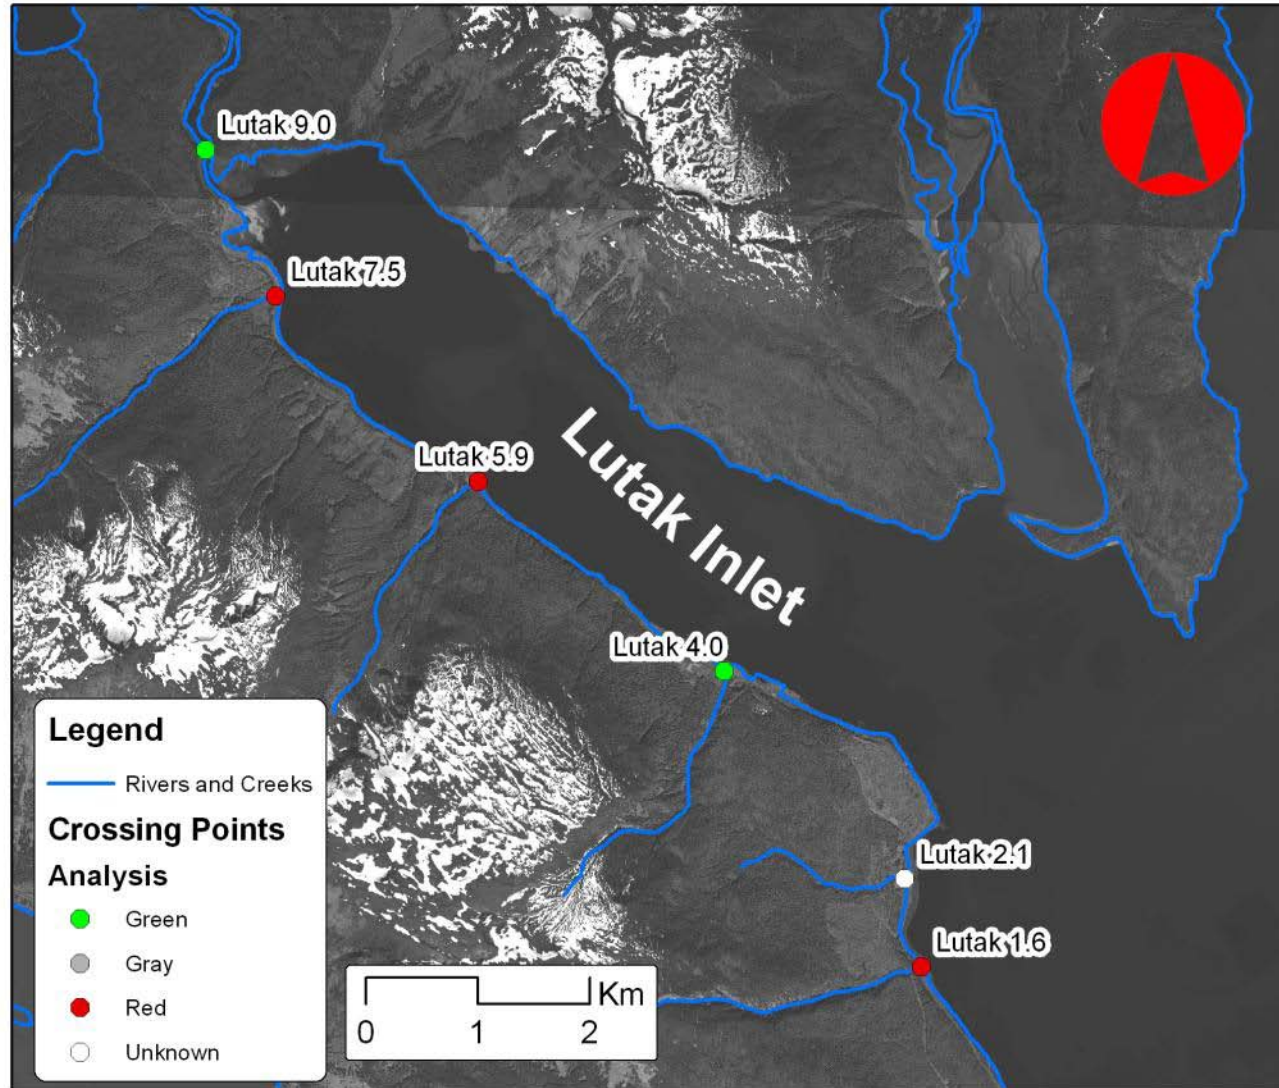
Figure 8. Crossings on the Lutak Road. The Lutak 2.1 crossing was not surveyed.

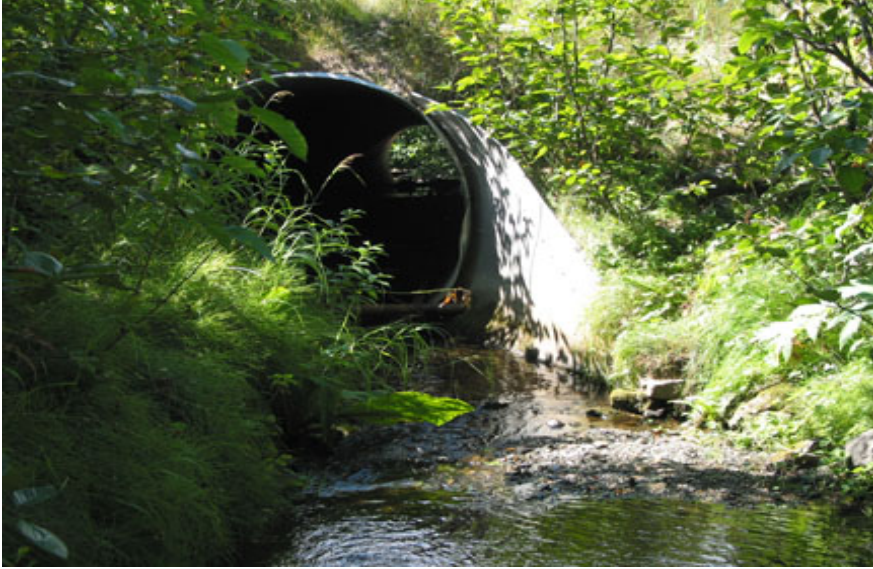
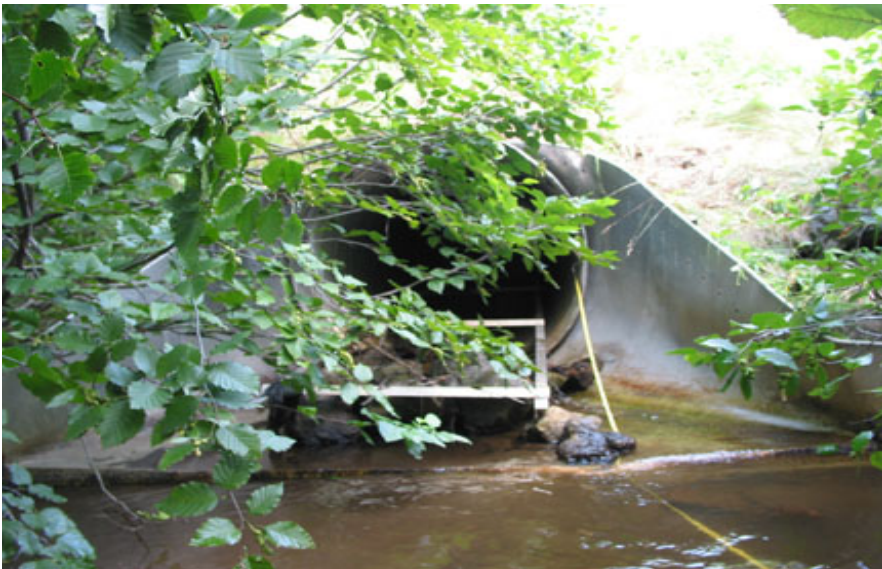
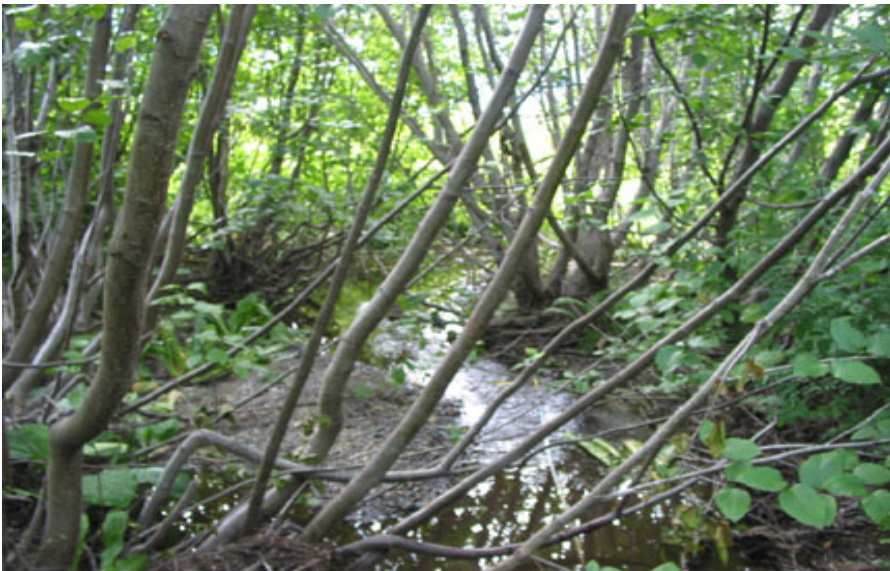
SITE PHOTOS

Most substrate has been removed from baffle device; baffle sections are ~6.6 ft with 13 sections through culvert; nos. 13, 10, 7 still have some substrate ~200mm size; no. 13 is downstream of culvert and might be obstructing passage within the apron end section. Debris has accumulated just outside the outlet and may impede passage.
