Klawock Watershed Road Condition Survey

December 2002

Alaska Department of Fish and Game

Division of Habitat and Restoration

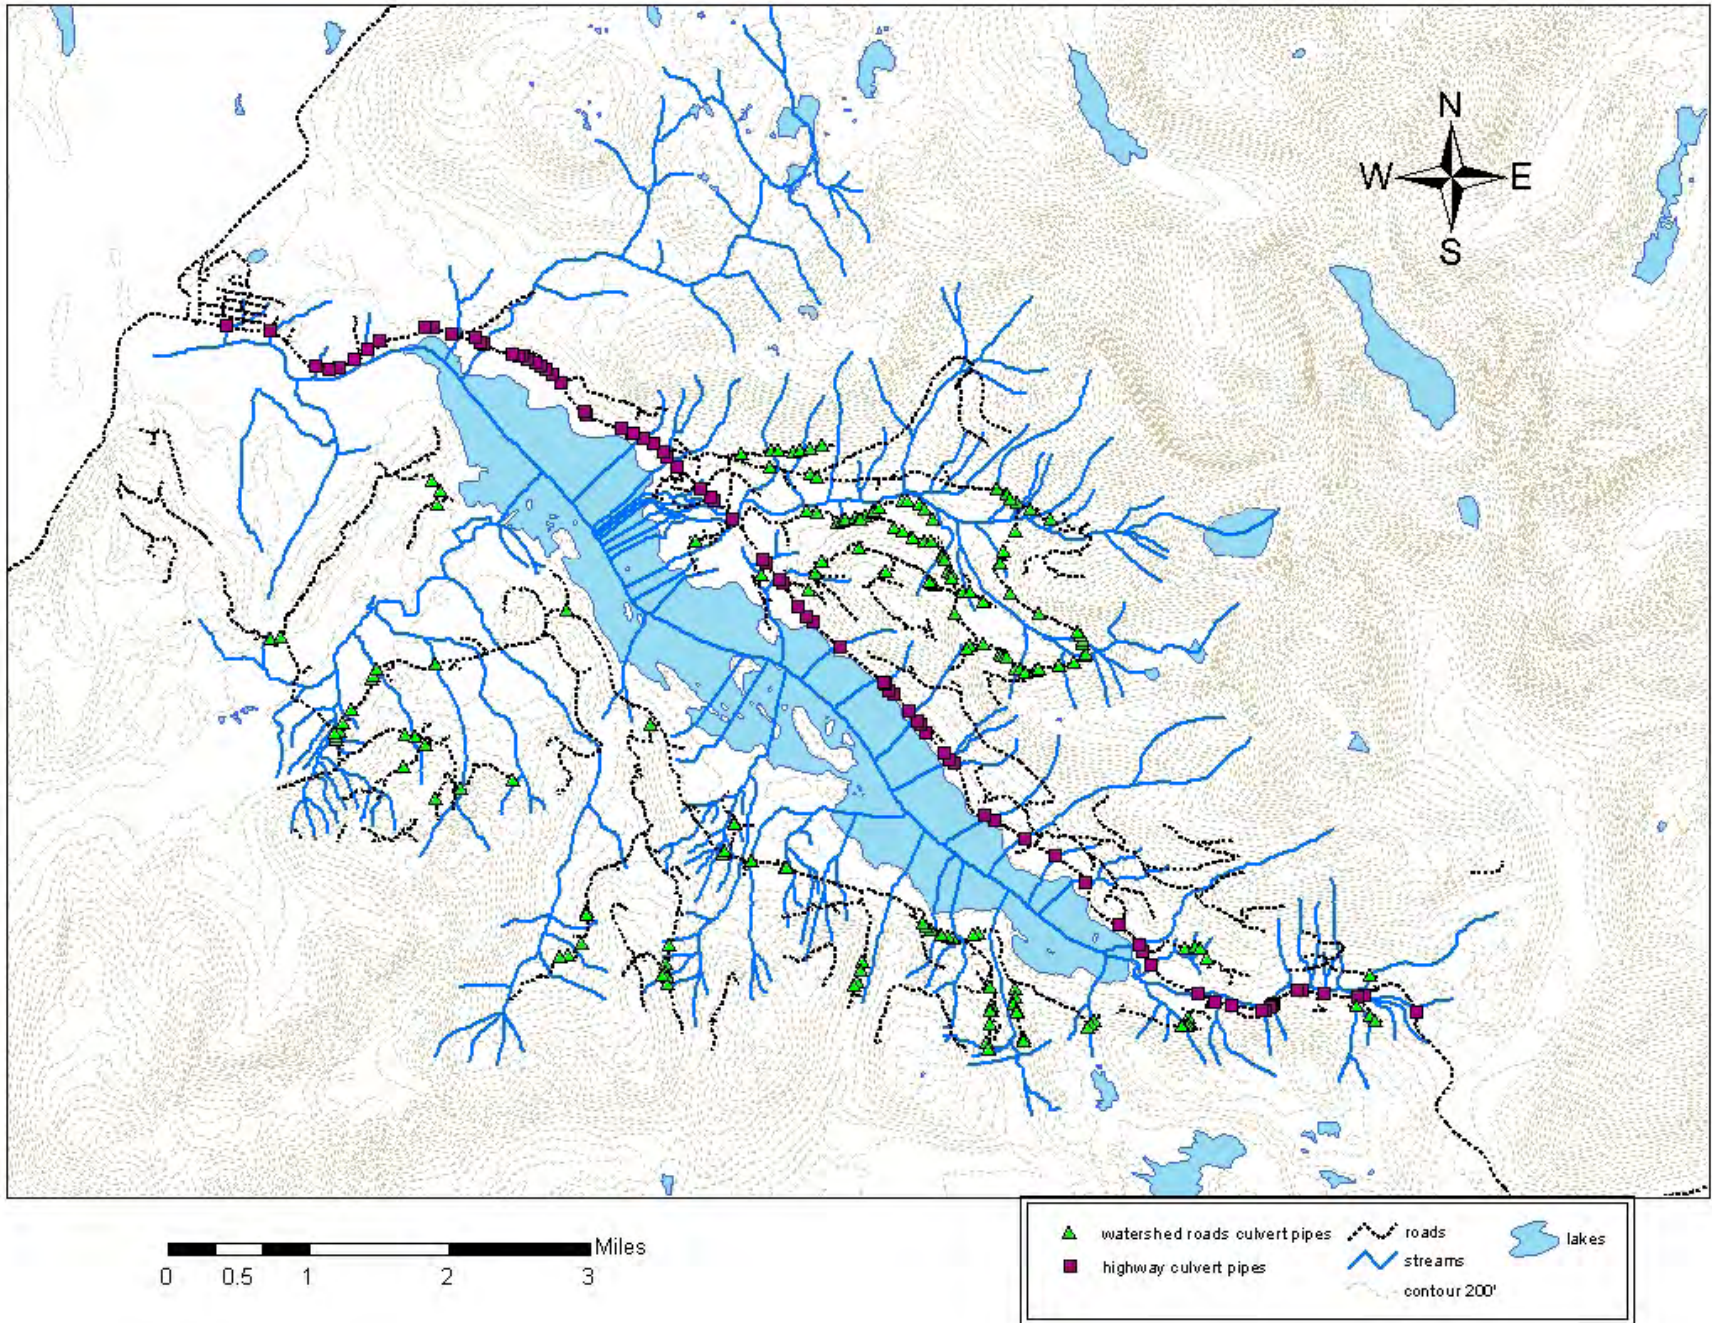
Two types of culvert pipes were used to allow stream passage on the watershed roads: Corrugated Plastic Pipes (CPPs) and Corrugated Metal Pipes (CMPs). The latter represented the majority of stream crossing structures, accounting for over 59% of all structures on the watershed (Figure 4).

Figure 4. Location of all culvert pipes associated with permanent (Klawock-Hollis Highway) and temporary (watershed) roads in the Klawock Watershed, Southeast Alaska.

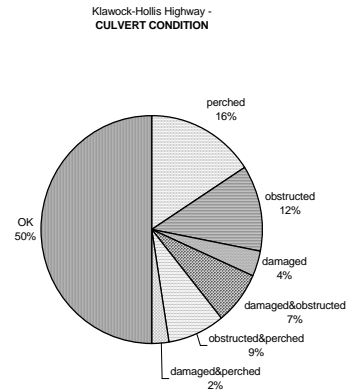
Figure 5. Condition of all culvert pipes associated with the Klawock-Hollis Highway (n=82).

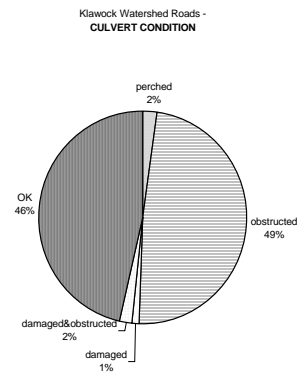
Figure 6. Condition of all culvert pipes associated with Klawock Watershed temporary roads (n=172).

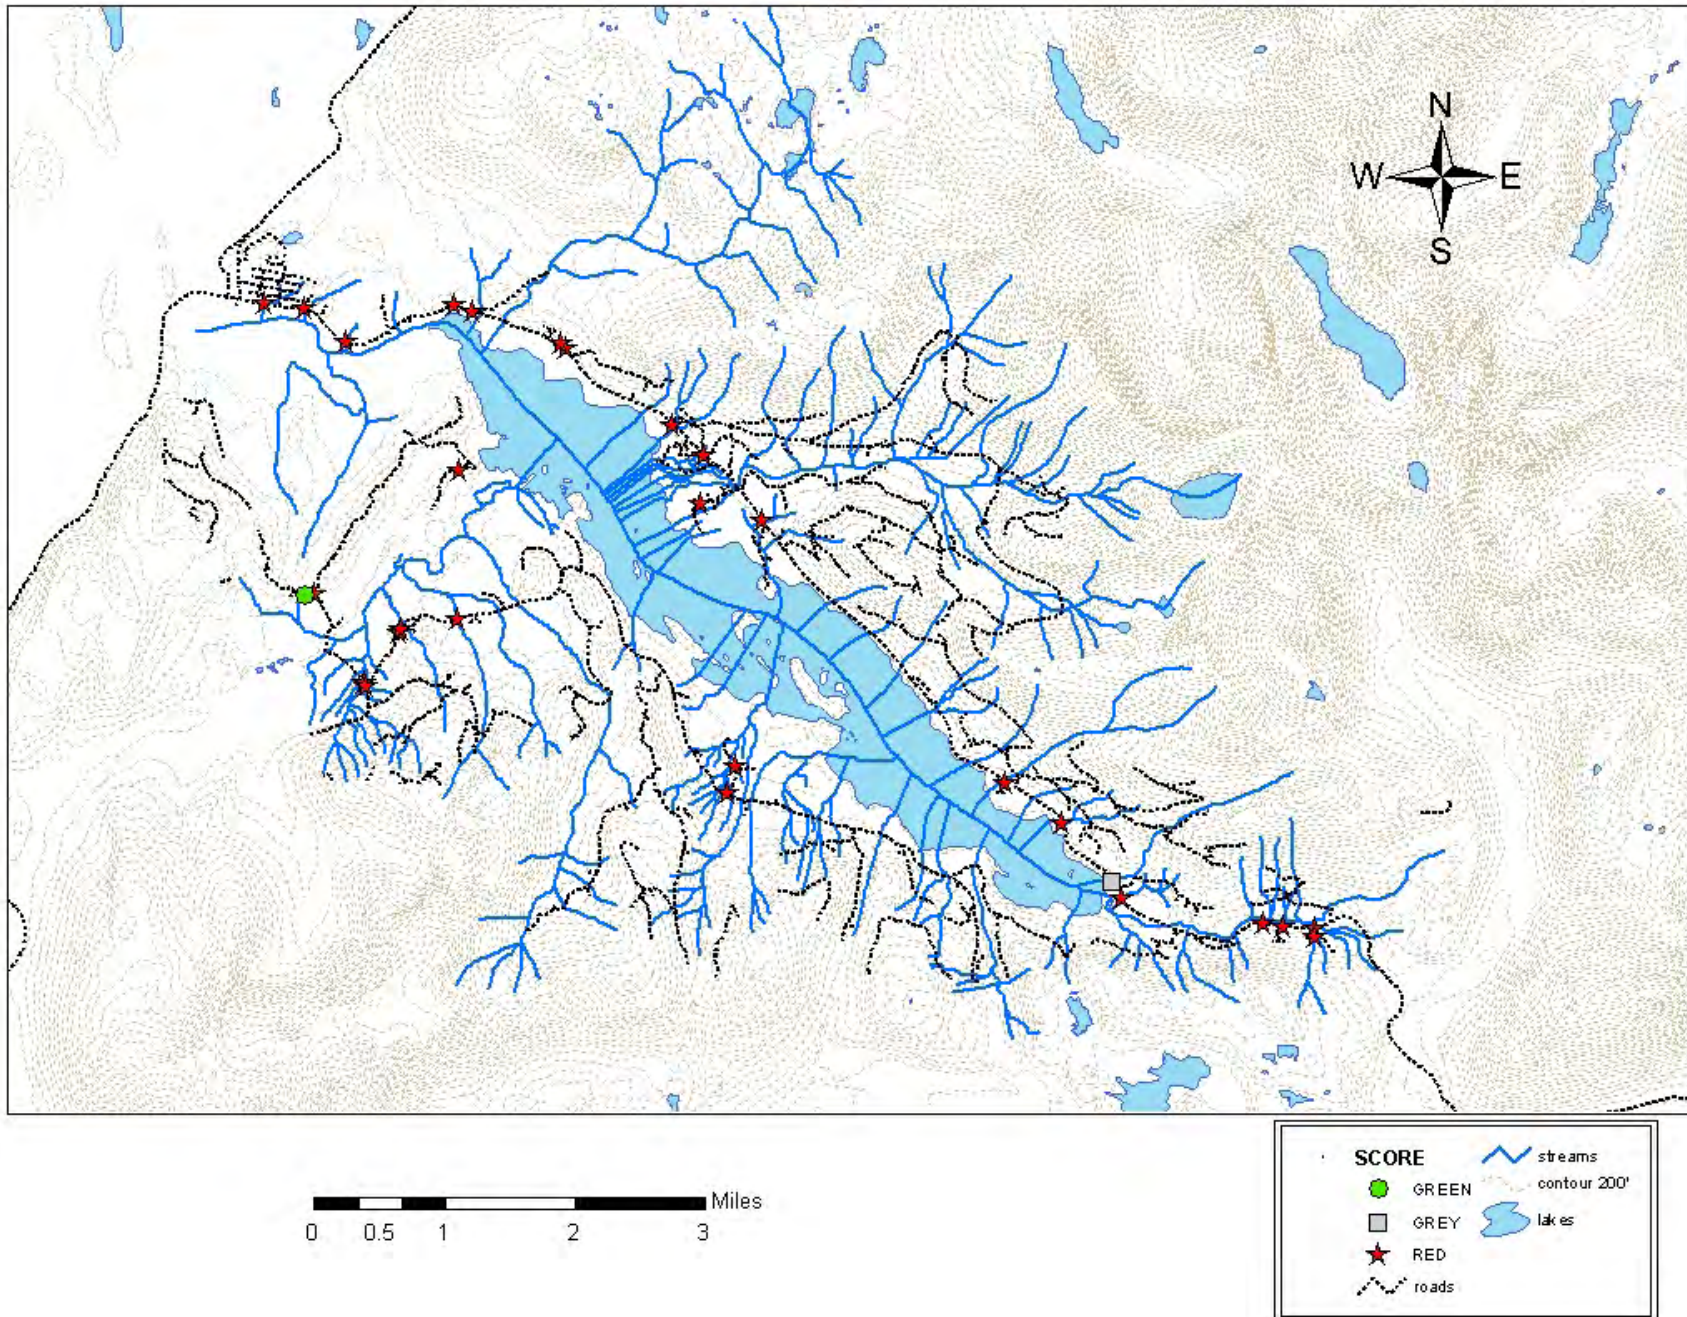
Additional measurements were collected at culvert pipes that occurred within (or potentially within) anadromous habitat, which allowed H&R staff to perform a RED-GREY-GREEN analyses. Thirty-one culvert pipes had enough information to allow this analysis, 29 of these were considered to be RED, indicating that conditions were assumed to be inadequate for fish passage (Figure 7). The full results of this evaluation are summarized in Appendix 8.

Figure 7. Location and SCORE (Red-Grey-Green analyses) of 31 selected culvert pipes occurring within anadromous habitat in the Klawock Watershed, Southeast Alaska.

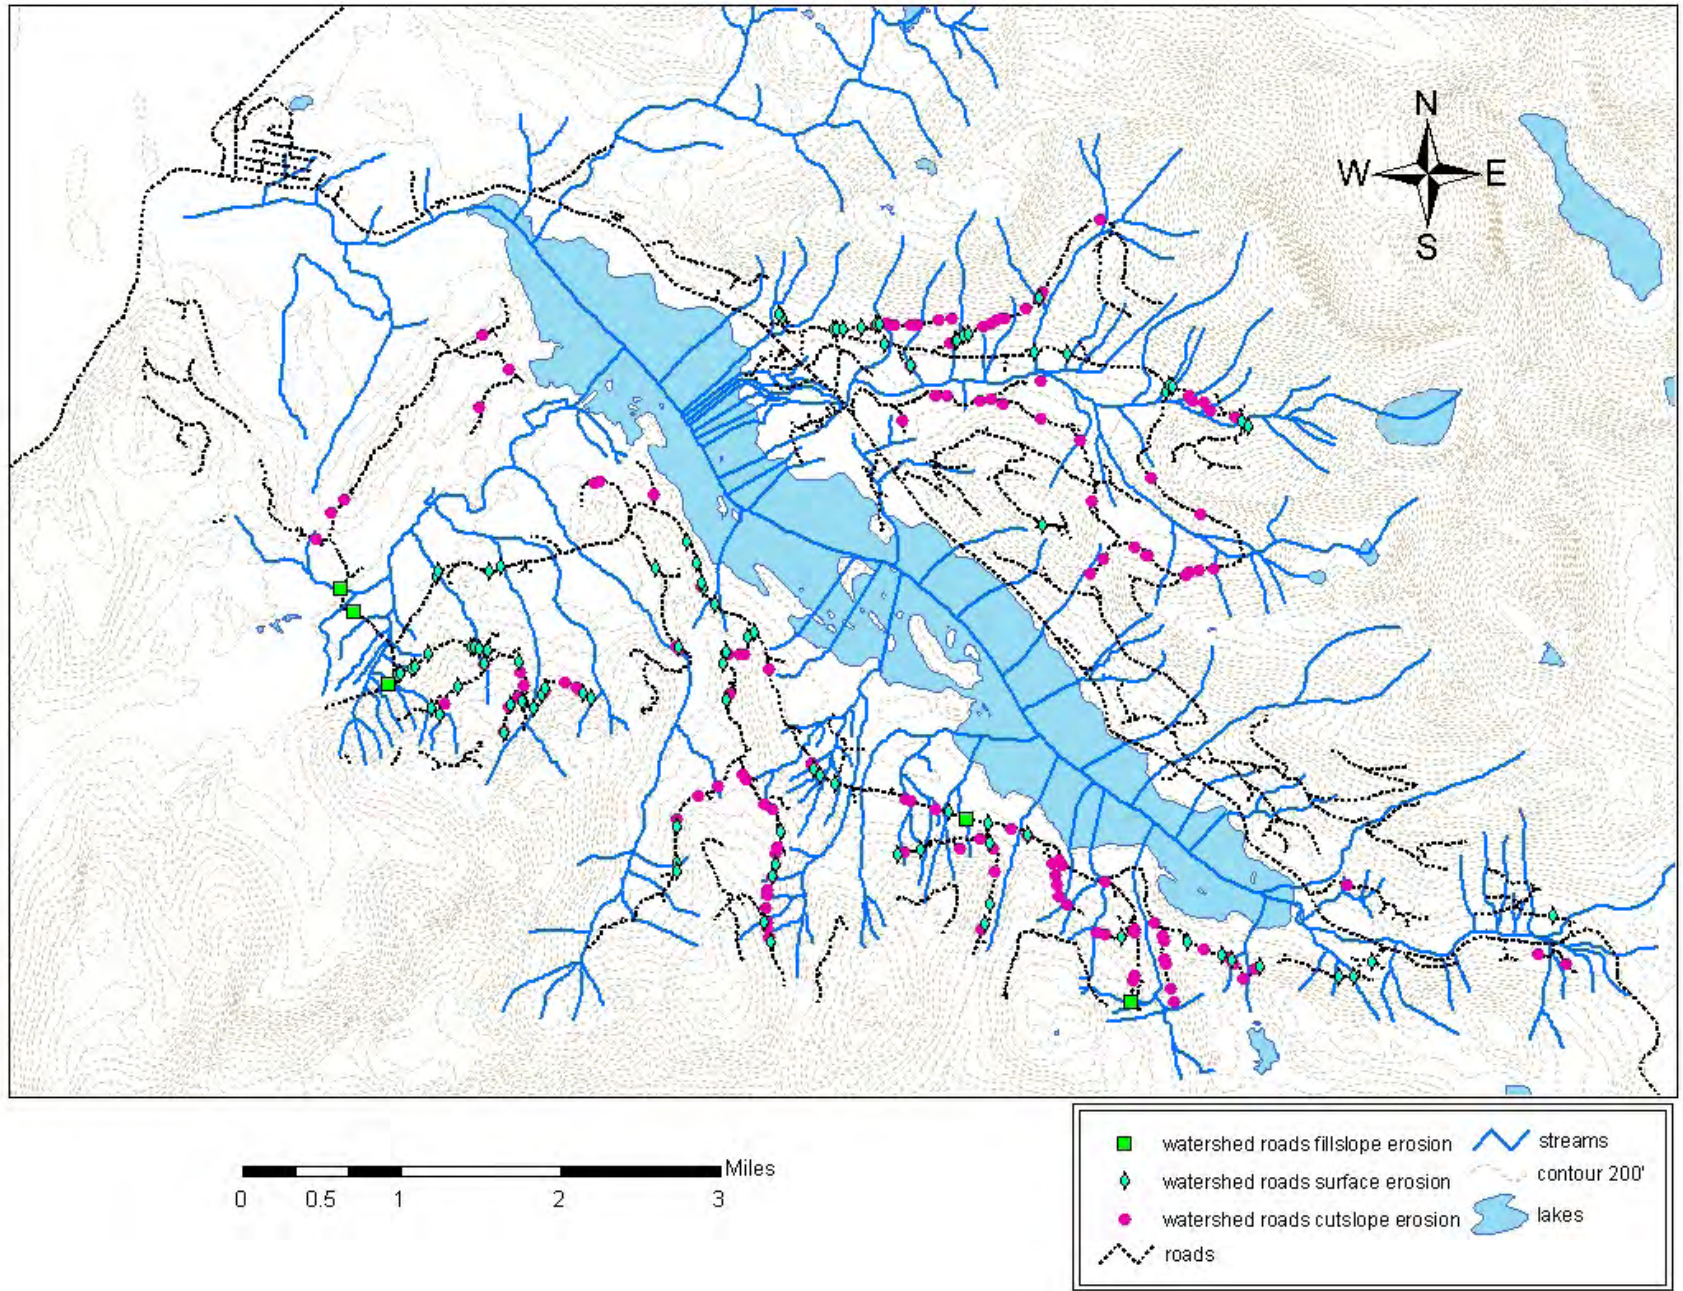
Cut-slope erosion occurred throughout the watershed and was observed at 137 locations (Figure 12). Erosion of this kind paralleled the temporary roads on the watershed and had a mean length of approximately 117 feet (S.D.= 139 ft). The width of cut-slope erosion averaged approximately 18 feet (S.D. = 20 ft). The largest single incidence of cut-slope erosion on the watershed covered an area of approximately 16,500 sq feet (length = 1,100 feet).

Surface erosion occurred on the temporary roads and was observed at 98 locations throughout the watershed (Figure 12). Surface erosion was generally the result of inadequate ditch relief, undersized or obstructed stream crossing structures, or lack of water bars. Erosion on the surface of roads averaged 73 feet long (S.D. = 59 ft) by 14 feet wide (S.D. = 12 ft). The largest single incidence of surface erosion on the watershed covered an area of approximately 1,500 sq. feet.

Several other types of erosion were observed less commonly within the Klawock Watershed and included fill-slope erosion (Figure 12), which was observed at 10 locations; ditch erosion (n = 9); fill falling through road surface (n=6); landslides across road (n=3); removed structure erosion (n =1); and stream abutment erosion (n=1).

Figure 12. Location of major erosional features within the Klawock Watershed, Southeast Alaska.
