Twelvemile Creek Restoration Assessment of 2014 Flooding

USDA Forest Service, Craig Ranger District

TEAMS Enterprise Unit Watershed Restoration Division

February 25, 2015

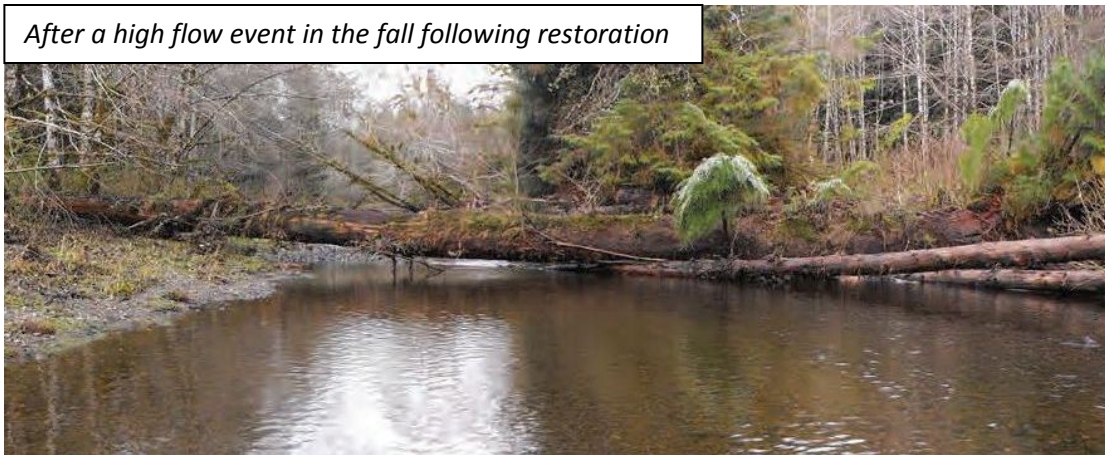
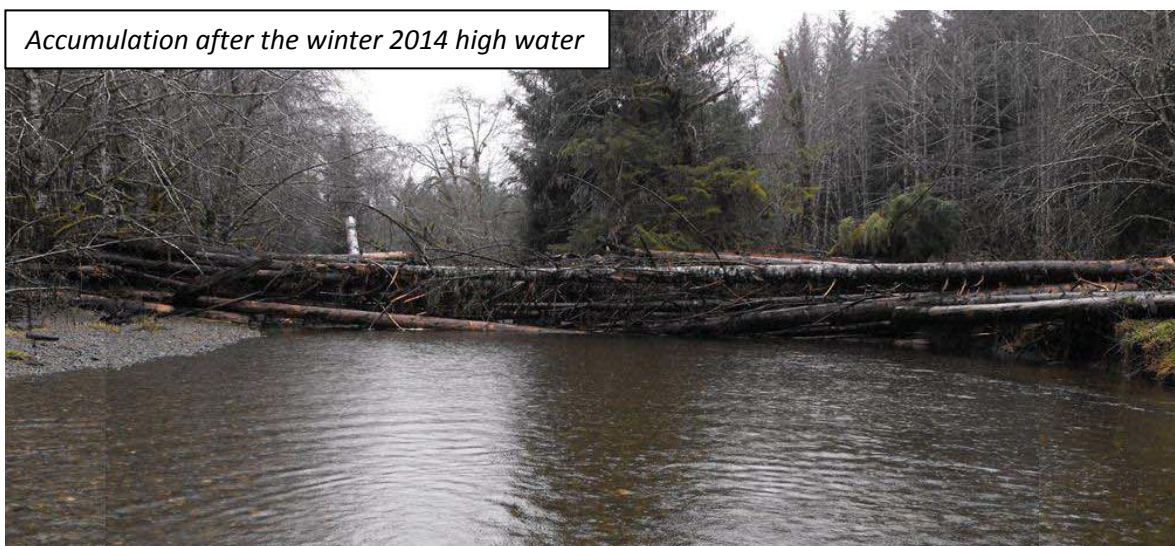
Figure 6. Photos Pre-Post Flood. Looking downstream at the jam downstream of the “hanging pipe” crossing. The large piece of residual wood in the upper photo was originally parallel to the channel on the channel edge prior to restoration. During restoration one end of this piece of wood was moved out into the channel in an effort to deflect flow, induce scour, and create habitat. Early fall flows moved (“spun”) the log to a cross channel location (upper photo) and the January flood resulted in additional wood accumulated on the log. A large, complex, cross channel, log jam has resulted.

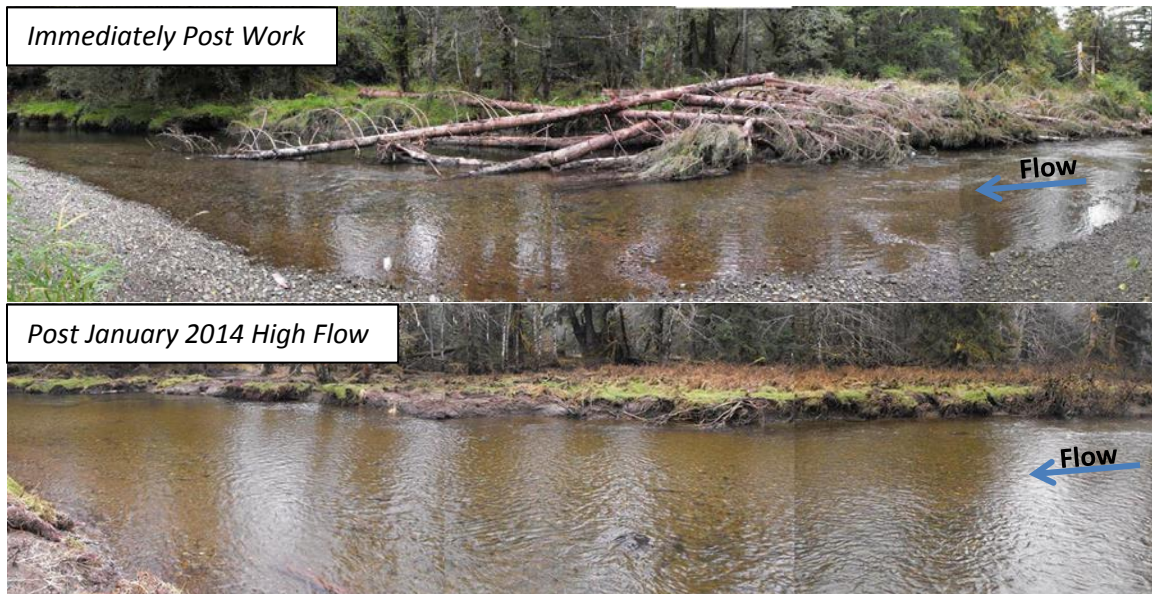
Common of all the FMF structures that fully mobilized was the lack of trenching and burying into the bank. During construction, the decision was made not to trench and bury members at these sites with the thought that structure elevation and ballast alone would mitigate for structure durability. This approach may have worked if the elevations of the structures exceeded the peak flow water surface elevation. Another consistent finding was the lack of standing live trees near the banks at these sites. In other locations, where FMF structures persisted through the floods, there was also a lack of trenching; however, each had standing live trees that were incorporated into the structure functioning as vertical “pilings”. These banks with the live “pilings” also rise more abruptly from the channel providing a higher bank elevation for structure ballast to tie into. Post flood surveys suggest that structure elevation was critical to the stability of the FMF structure and the available bank elevation typically determined the top of structure elevation.

Figure 7. Photos Pre and post flood of an FMF structure where only structure elevation could mitigate for durability, no burial and no live trees to incorporate. Large wood was placed on the floodplain and bank on the outside of the meander bend. Following the January flood the site was completely displaced and the vertical bank exposed.

- If top elevation of the ballast on a structure is the only possible mitigation for structure durability, reevaluate the site. If its decided to proceed, be conservative.

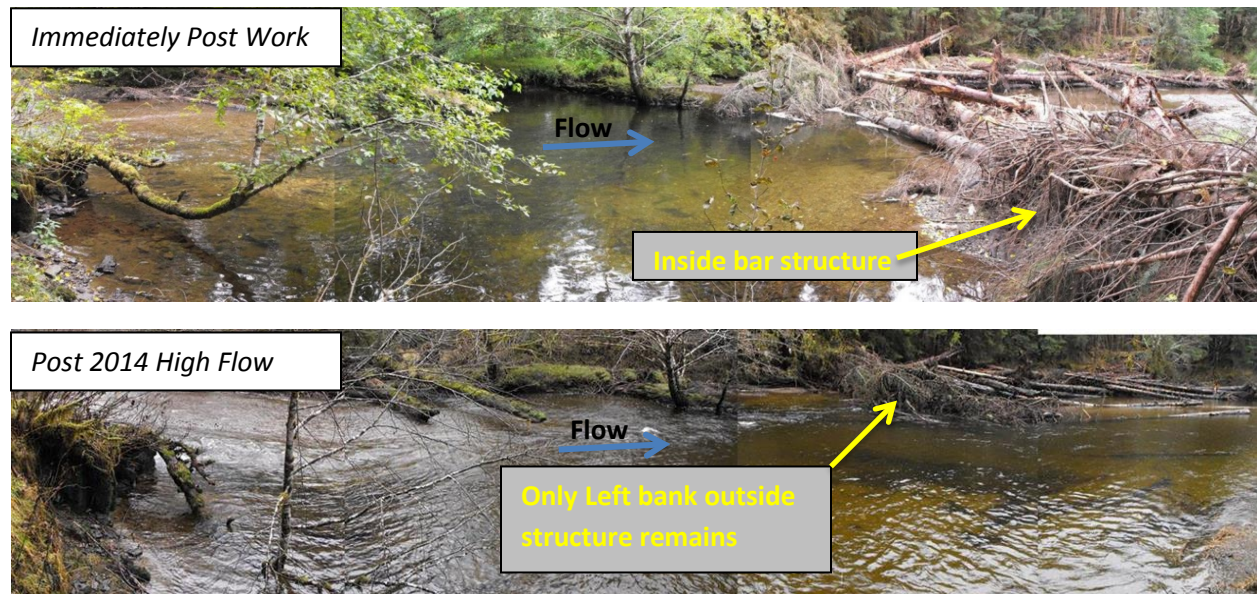
An example is Structure 26 (Figure 8) which was constructed in the lower part of the Phase II project area with a bank structure on the left outside bank and a large opposing structure on the right bank gravel bar. The intention of the large opposing structure was to backwater the channel enough to promote connectivity to existing beaver pond complexes on the left floodplain. During construction it was noted that the wetted width of channel constriction was aggressive (27 feet in width, ~30% less than design) and the flanks reduced the flood-prone width to approximately 80 feet (~20% less than design). The low risk at this site (due to the relatively low slope in the immediate vicinity) was considered in regards to the potential benefits of reconnecting the floodplain and beaver complex at multiple flows. It was decided (on-site) to proceed with the constriction. Due diligence was taken to secure the structure and multiple logs were driven into the gravel bar vertically and semi-vertically by the hydraulic excavator to secure the structure. The pilings were used because there were no live trees on the immediate bank. Some of the piling type members were driven into the gravel bar in excess of 20 feet in depth. The vertical members appeared to be penetrating a clay layer and were easily installed. Aside from the ease of the piling installment, the site appeared to be robust. Unfortunately, the opposing gravel bar complex was displaced during the first large peak flow event, likely due to the aggressiveness of the structure and incompetent pilings (installed in clay). The displaced wood floated downstream and deposited on a large natural (existed prior to restoration) cross-channel log jam. Subsequent visits to this site revealed additional movement and instability of the preexisting jam.

Figure 8. Photos Site 26. This bar structure exceeded the constriction parameters designed for this channel. Flood flows dislodged the vertical holding members of the bar structure and the bar and spanning members were moved downstream.

- Channel constriction significantly affects stream power and can increase scour during flooding. Verify design widths and utilize design during implementation. Keep in mind that when width is decreased, either depth or velocity must increase to accommodate the same flow ($Q=VA$). Evaluate all potential outcomes when choosing to constrict beyond design width.

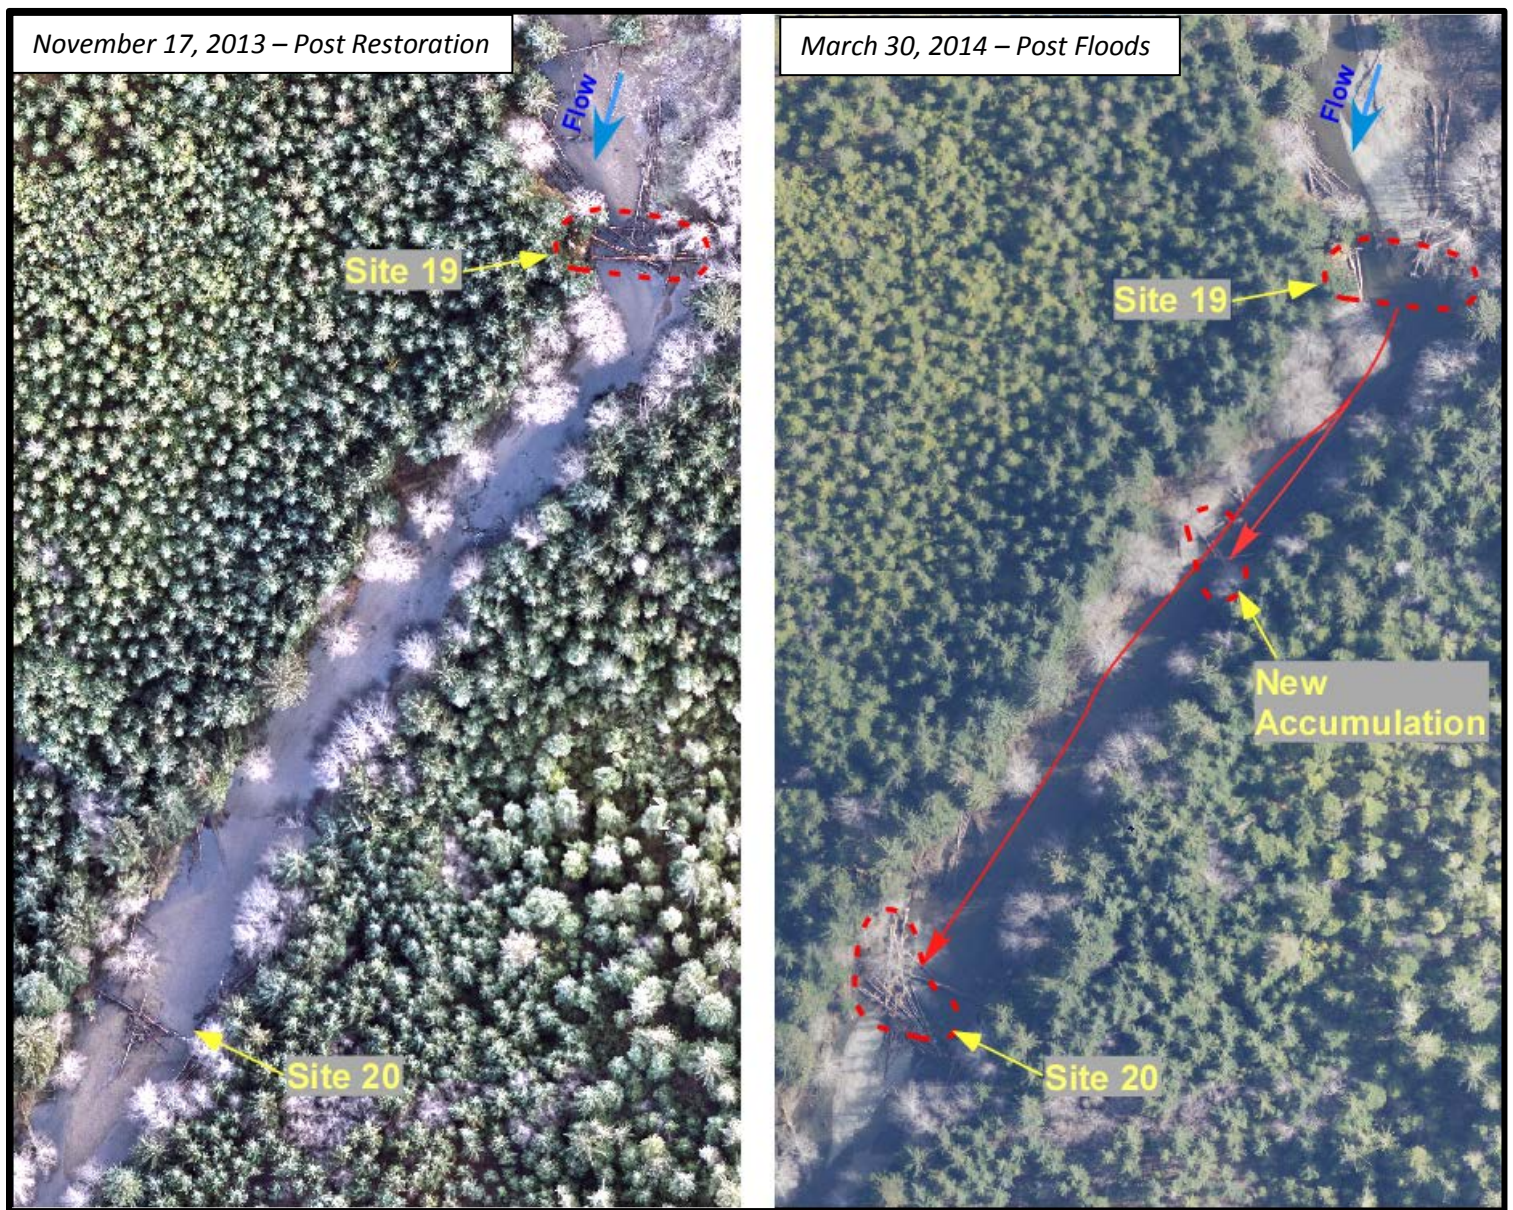
Figure 9. Aerial photos of Site 19-20 within Phase II. Site 19 was implemented with an aggressively reduced channel cross-sectional area (beyond design parameters). The 2014 winter flows moved this wood and re-deposited the wood downstream. Downstream, the mid-channel apex jam performed as expected and captured the passing wood.
