#### Tongass National Forest Road-Stream Crossing Surveys: Methods, Assessment Status, and Data Stewardship

Assessment of Fish Passage at Road Crossings

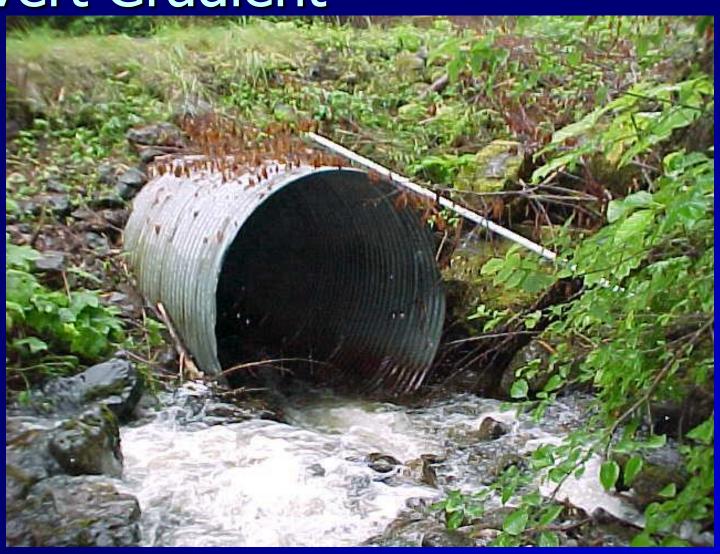
# Culvert Gradient

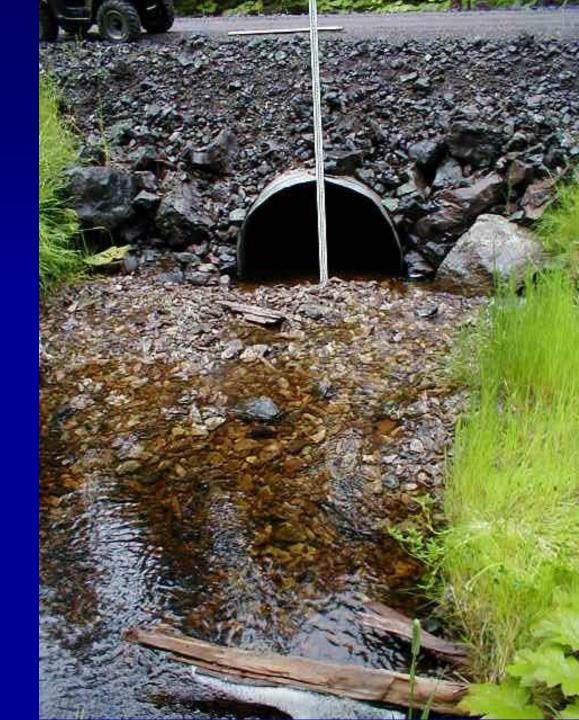
# Stream Channel Constriction

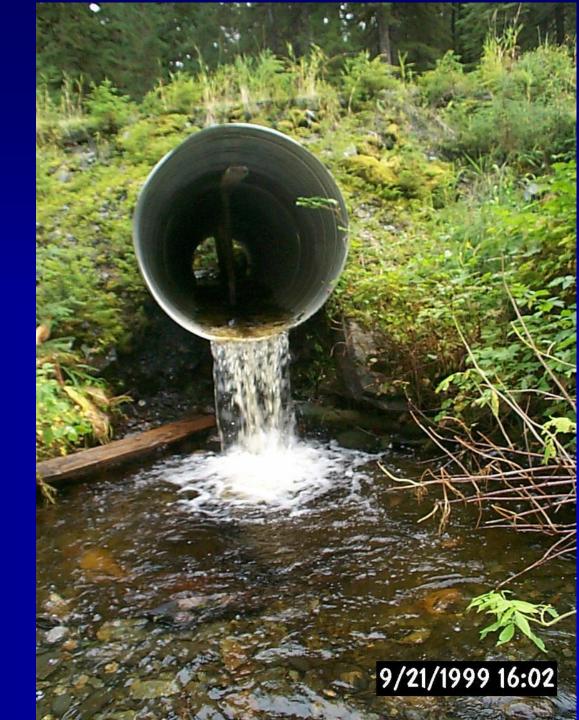
# Perched Outlet

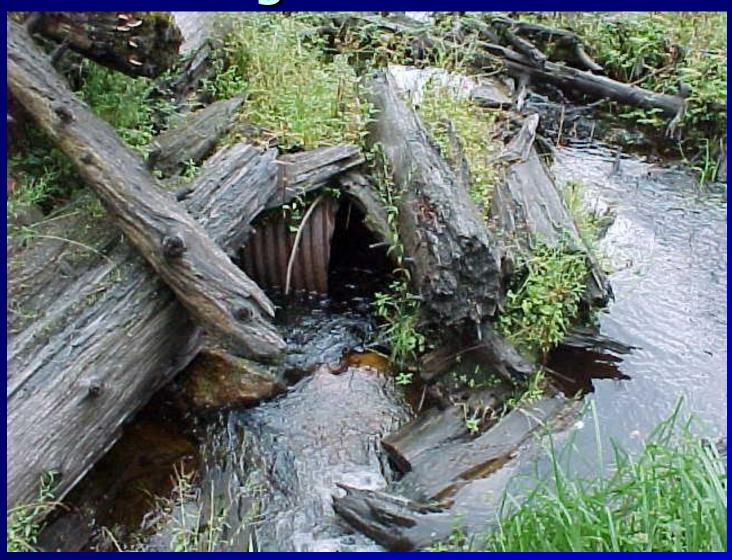
# Debris Blockage
