Klawock Lake Watershed Sockeye Spawning Habitat Assessment

Prince of Wales Island, Alaska

January 2018

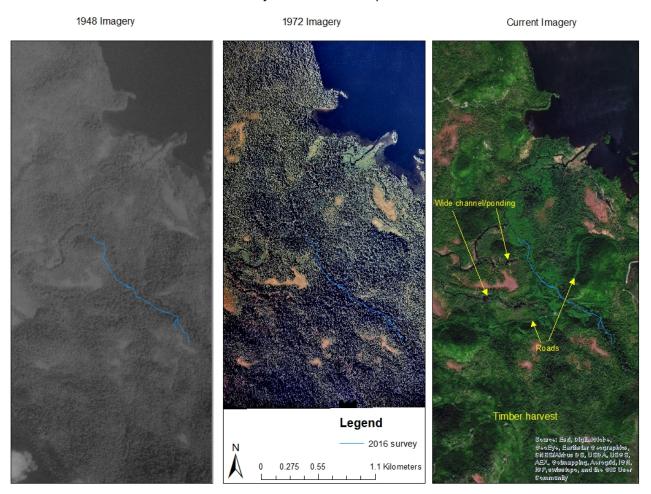
Hatchery Creek Aerial Comparison

The Hatchery Creek watershed aerial imagery shows no difference in stream course or vegetation structure between 1948 and 1972 (Figure 3). Current aerial imagery shows the addition of a logging road and timber harvest around the habitat surveyed area (Figure 3). The stream course does not appear to be altered, however the channel appears wider in locations where tree canopy has been removed; this may be a result of beaver activity, or may have been obscured by vegetation in the past. Further, there are areas where beaver activity have created ponds of water as identified in Figure 3. Overall, this aligns with current observations on the ground, where beaver activity has been extensive in the Hatchery Creek drainage and to an extent may be blocking sockeye salmon access to spawning habitat.

Figure 3. Aerial imagery comparison of the Hatchery Creek sub-basin in the Klawock Lake Watershed on Prince of Wales Island, Alaska. Imagery is from 1948, 1972 and 2015.

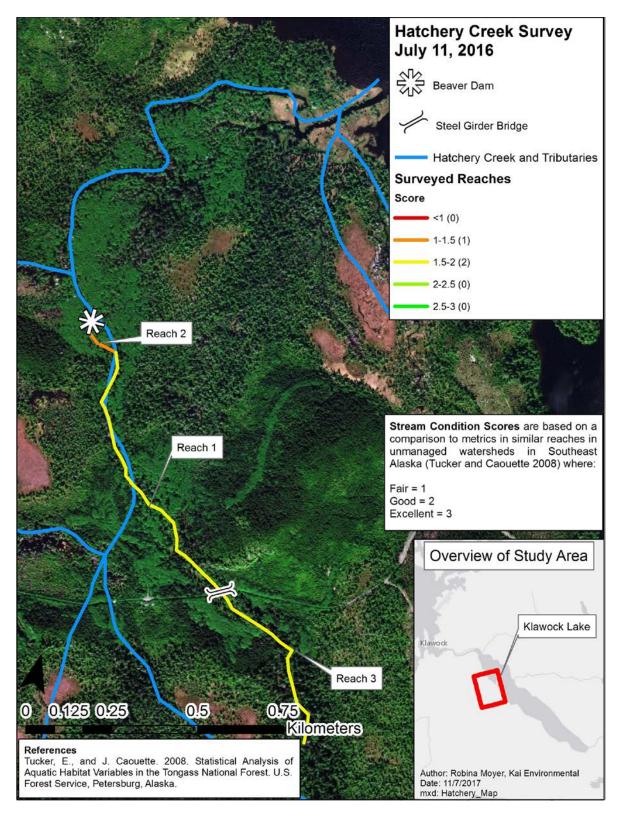
Figure 4: Hatchery Creek Survey Area in Klawock Lake Watershed, Klawock, Alaska. Map shows surveyed reaches and habitat condition scores based on an analysis of the survey data and a comparison to known metrics for Southeast Alaska streams.

Based on the percentile each metric fell into for its given channel type, it was assigned a qualitative value using the information provided in Table 3. The qualitative values for Hatchery Creek are shown in Table 9 with the corresponding numerical score shown in parentheses. A total score for each reach was calculated as the average of the five individual scores, and represented on Figure 4.

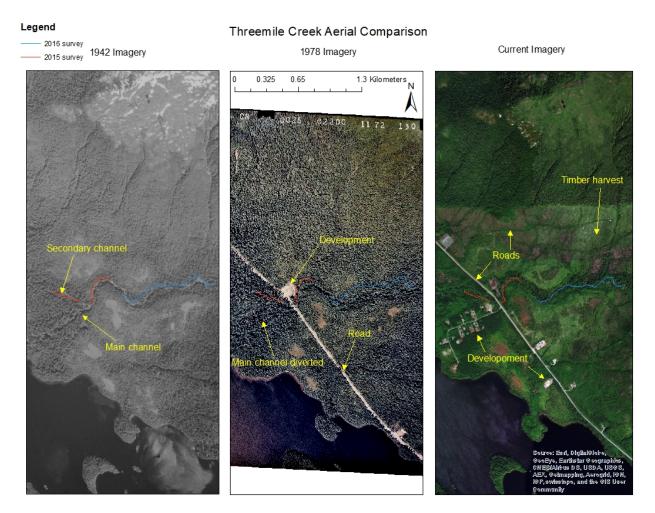
The Threemile creek drainage into Klawock Lake has shown the most dramatic changes when comparing aerial imagery. The 1948 imagery shows high gradient channels carved into the mountain with timber intact, and no roads or development (Figure 6). As noted on Figure 6, the 1948 aerial imagery shows there are two channels into the lake, where the eastern channel appears predominant. In the 1972 imagery the primary change is the addition of the Klawock-Hollis Highway. There is also a rock pit present. In this imagery, the eastern channel into Klawock Lake is less pronounced and is likely becoming dewatered as flows are re-directed from its natural course after the Klawock-Hollis road was built (CCTHITA and USFS, 2002).

In the current imagery, the Threemile Creek sub-basin has timber harvest, roads associated with timber harvest, and a residential subdivision. The subdivision is located directly where the previous eastern channel into the lake was located in the 1948 imagery, and it was noted in CCTHITA and USFS (2002) that the channel has been inactive for years. As a result, significant habitat and subsequent salmon spawning potential has been lost (CCTHITA and USFS, 2002).

Figure 6. Aerial imagery comparison of the Threemile Creek sub-basin in the Klawock Lake Watershed on Prince of Wales Island, Alaska. Imagery is from 1948, 1972 and 2015, and the 2015 and 2016 stream habitat surveyed reaches are included for orientation.

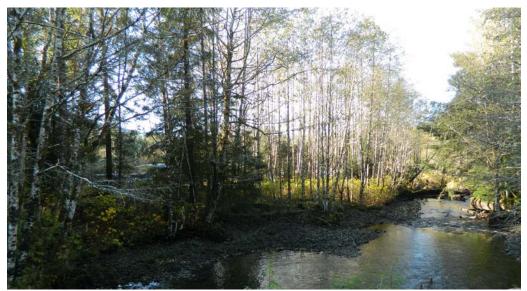
In Reach 1 of the stream habitat survey on Threemile Creek, the field crew noted that a private resident in the Klawock Lake Subdivision constructed a dike on Threemile Creek downstream of the Klawock-Highway culverts, in order to keep the creek from flooding its banks and onto adjacent residential property (Photo 27). This observation was also detailed in CCTHITA and USFS (2002) which noted that the dike was constructed after large rainstorms in mid-October of 1999 when Threemile Creek nearly accessed the historic eastern channel through the middle of the subdivision (Figure 6). The dike is approximately 1.5 meters high, and runs along the left bank (looking downstream) for approximately 137 meters.

Photo 27. Threemile Creek looking downstream from Klawock-Hollis Highway bridge showing the dike installed by a resident of the Klawock Lake Subdivision, Klawock, Alaska.

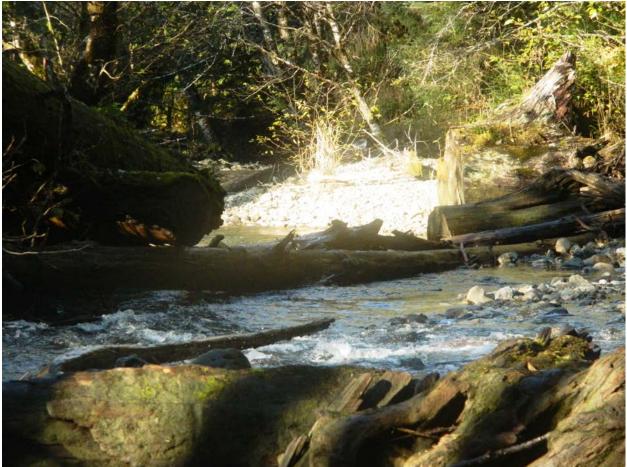
Reach 1, 2 and 3 had a "good" large wood per meter value, while the other Reaches all had a "fair" value, meaning they fell below the 25th percentile. For key wood per meter, Reaches 3, 5 and 6 had an "excellent" value, Reaches 1, 4, 7 and 8 were a "good" value, and Reach 2 was a "fair" value. Field crews also noted that key wood pieces in Reach 1 have been cut out in order to allow water flow through rather than around the large woody debris (Photo 28).

Photo 28: Large woody debris in Threemile Creek that has been cut out in order to allow water to flow, Klawock, Alaska.

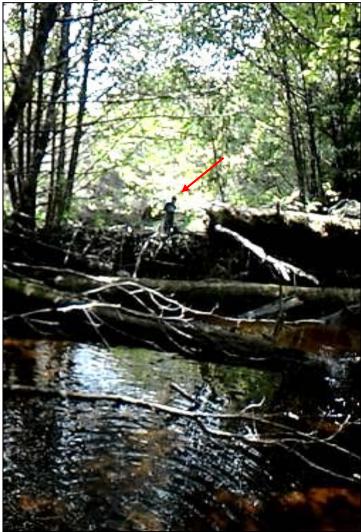
Photo 2: Beaver dam at the downstream extent of Reach 1 (Figure 2) in Hatchery Creek, Klawock Lake Watershed, Klawock,

Alaska. Photo taken from below the dam, looking upstream with a crew member on dam for scale.

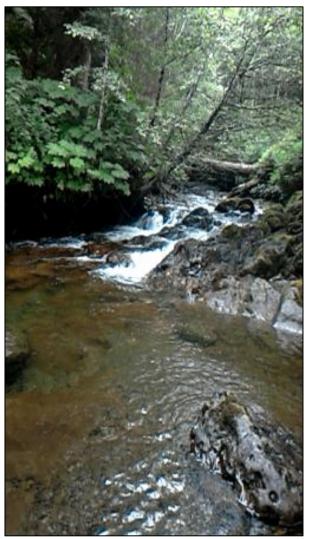
Photo 9: Bedrock chute, a potential barrier to fish passage, at the upper extent of the

surveyed reaches of Threemile Creek in the Klawock Lake Watershed, Klawock, Alaska.

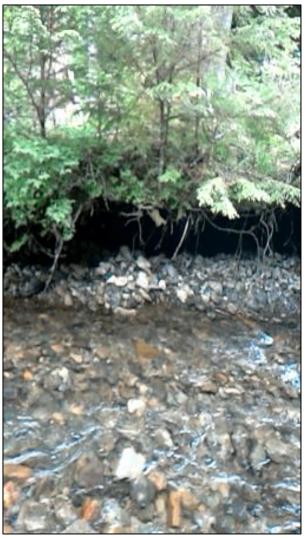
Photo 25: Example of undercut bank seen throughout the reaches surveyed in Threemile Creek in the Klawock Lake Watershed, Klawock, Alaska.

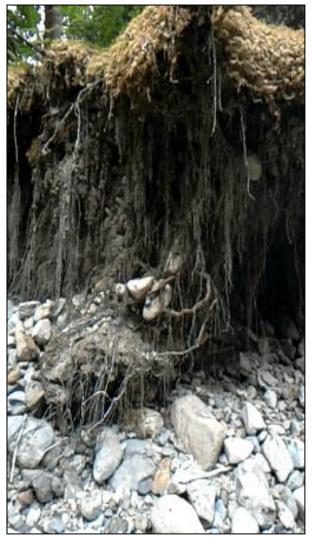
Photo 26: Example of undercut bank and erosion seen throughout the surveyed reaches of Threemile Creek in the Klawock Lake Watershed, Klawock, Alaska.

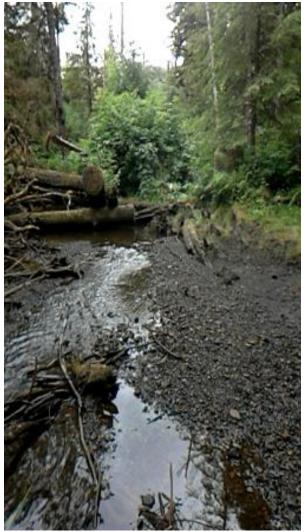
Photo 32. Photo of Inlet Creek, of the Klawock Lake Watershed, Klawock, Alaska. The photo is taken looking upstream from the midpoint of Reach 1, showing large woody debris.
