Coffman Creek Habitat Assessment
Prince of Wales Island, Alaska

January 2019

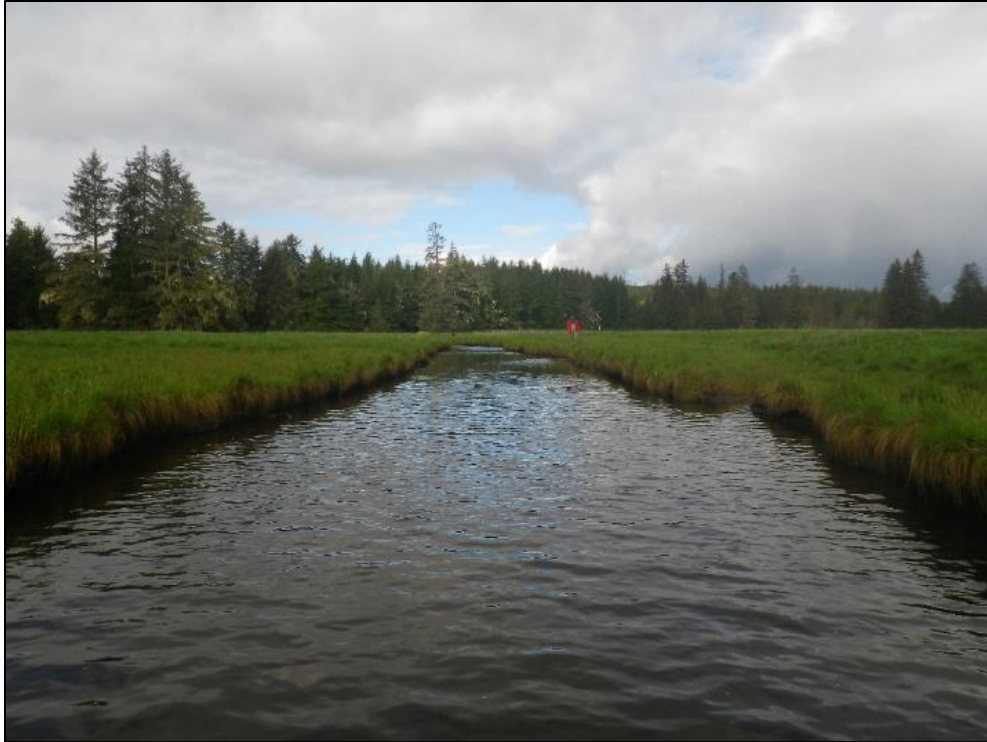
Photo 1: Channel type verification point during stream surveys on Coffman Creek, near Coffman Cove, Alaska. Photo taken looking upstream, representing conditions in the estuarine reaches dominated by grassy riparian vegetation. Taken in Stream 1, Reach 1 (Figure 2).

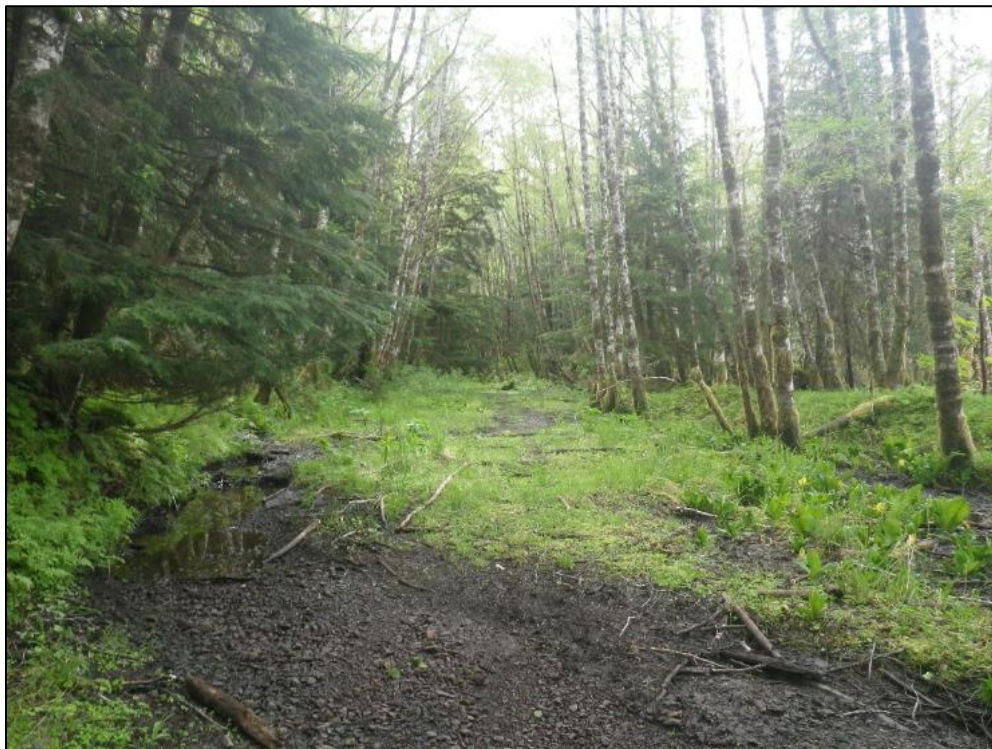
Surveys took place in late spring and water levels were generally high due to snowmelt and recent rainfall. Between the bridge crossing Coffman Creek and the outflow into Coffman Cove, the creek splits from a contained channel into multiple smaller braided channels. These channels all originate from the main stem of Coffman Creek before fanning through the estuary as shown in Figure 2. The estuarine reaches were generally flat with grassy and herbaceous riparian vegetation as exemplified in Photo 1. At the time of the survey, all of the channels in the lower reaches contained water with the exception of Stream 2, Reach 5, shown in Photo 2 (Figure 2).

Photo 2: Dry channel mapped during stream surveys in Coffman Creek, near Coffman Cove, Alaska. Photo taken looking upstream in Stream 2, Reach 5 (Figure 2).

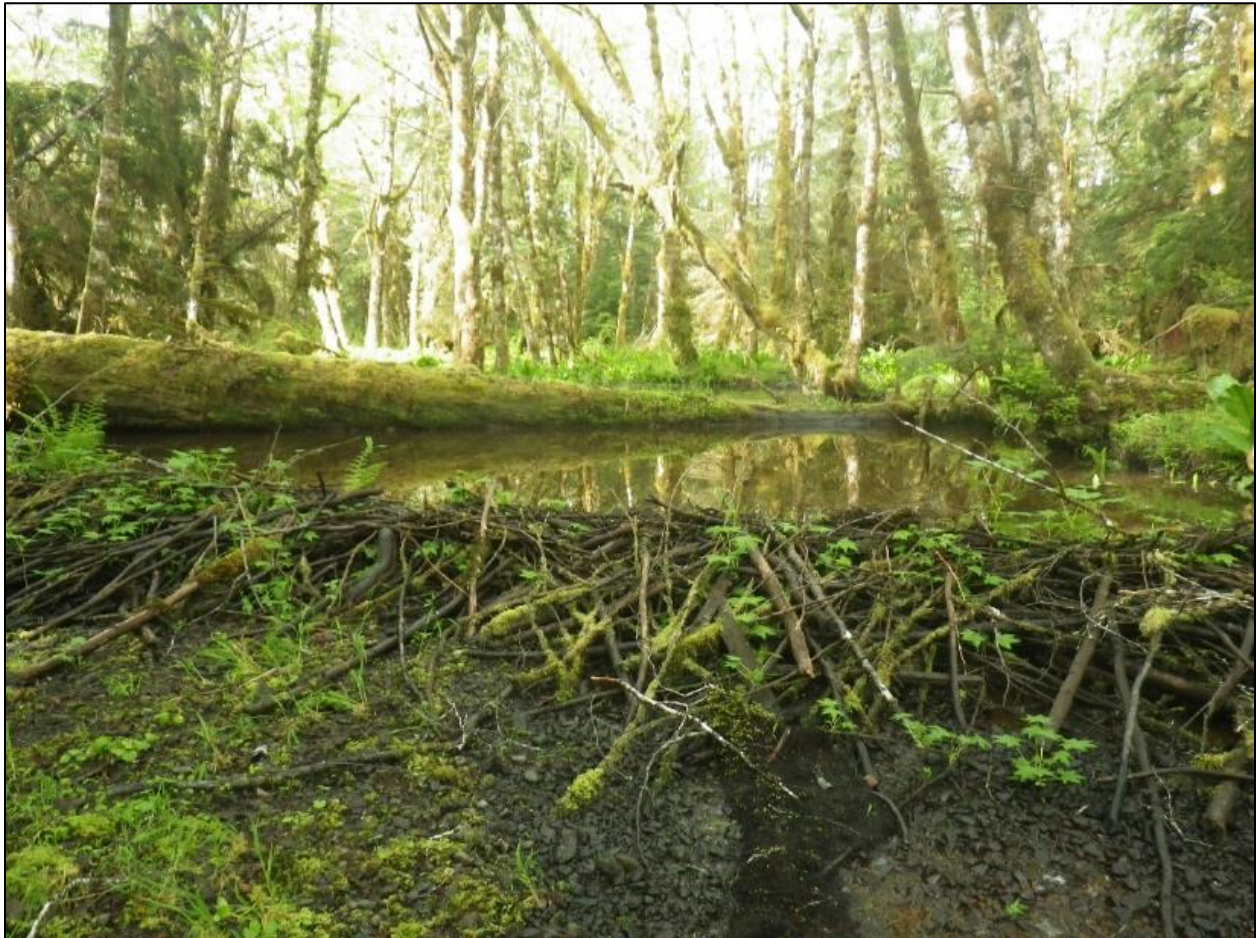
An extensive beaver dam complex was documented in the northern section of the survey area (Photo 3), immediately north of Stream 2. Two surveyed reaches (Main Channel, Tributary 1, Reach 10 and Main Channel, Tributary 2, Reach 11) split off of the main stem of Coffman Creek and flowed into this beaver pond complex. There was a smaller beaver pond complex south of Stream 1 and north of the road, as shown in Figures 1 and 2.

Photo 3: Beaver dam on Coffman Creek, near Coffman Cove, Alaska. The dam was documented along Stream 2, Reach 3 of Coffman Creek (Figure 2) and was part of a series of beaver dams along the creek.

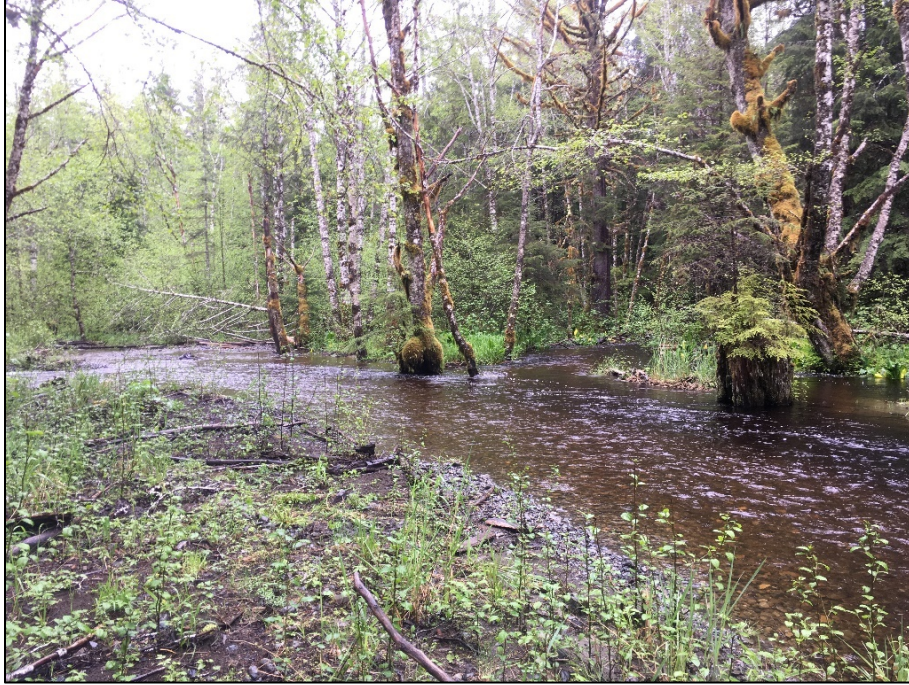
Upstream of the braided estuarine channels and beaver ponds, the creek begins to form a singular main channel just below the bridge crossing. Photo 4 was taken in the main channel at the midpoint of Reach 1 (MCH, Reach 1 on Figure 2). The photo was taken during a high-water event to depict how water begins to divert into separate channels due to the flat nature of the landscape.

Photo 4: Main channel of Coffman Creek, just below the bridge, near Coffman Cove, Alaska. The photo was taken during high water to show how water is diverted to multiple channels. The photo was taken in the Main Channel, Reach 1 (Figure 2).

The area immediately below the Coffman Cove bridge needs further evaluation. This is where the single stream course becomes highly braided as water moves downstream. During flood stage, water moves freely across the landscape into numerous mapped and unmapped channels, and in some places floods the forest floor. While previously thought to be an alluvial fan, the location may be more indicative of a sediment loaded floodplain as discussed in Section 4.2.2. Mr. Tucker recommended evaluating and analyzing upstream sediment sources and metering the supply. Depending on the results, adding wood upstream of the bridge may encourage energy dissipation and storage. Once sediment loading is slowed, the area downstream of the bridge may be evaluated for restoration that encourages water to remain in one or two channels.

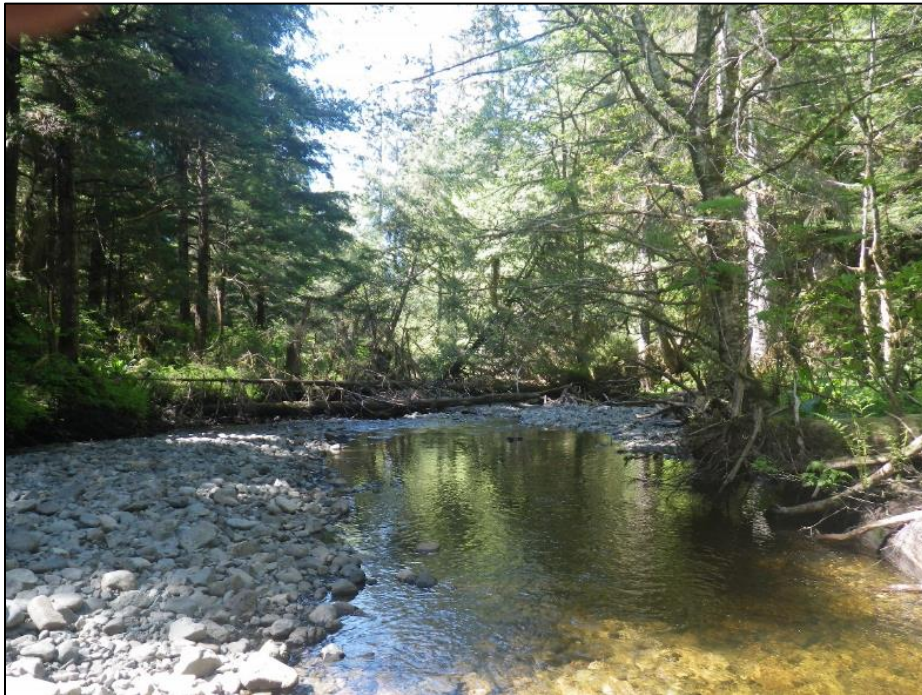
Moderate gradient, singular channels were present above the bridge, as shown in Photo 5.

Photo 5: Channel type verification point during stream surveys on Coffman Creek, near Coffman Cove, Alaska. Photo taken looking downstream, representing conditions in the floodplain and moderate gradient reaches surveyed above Coffman Creek Road. Photo taken in Reach 6 of the main channel 1 (Figure 3).

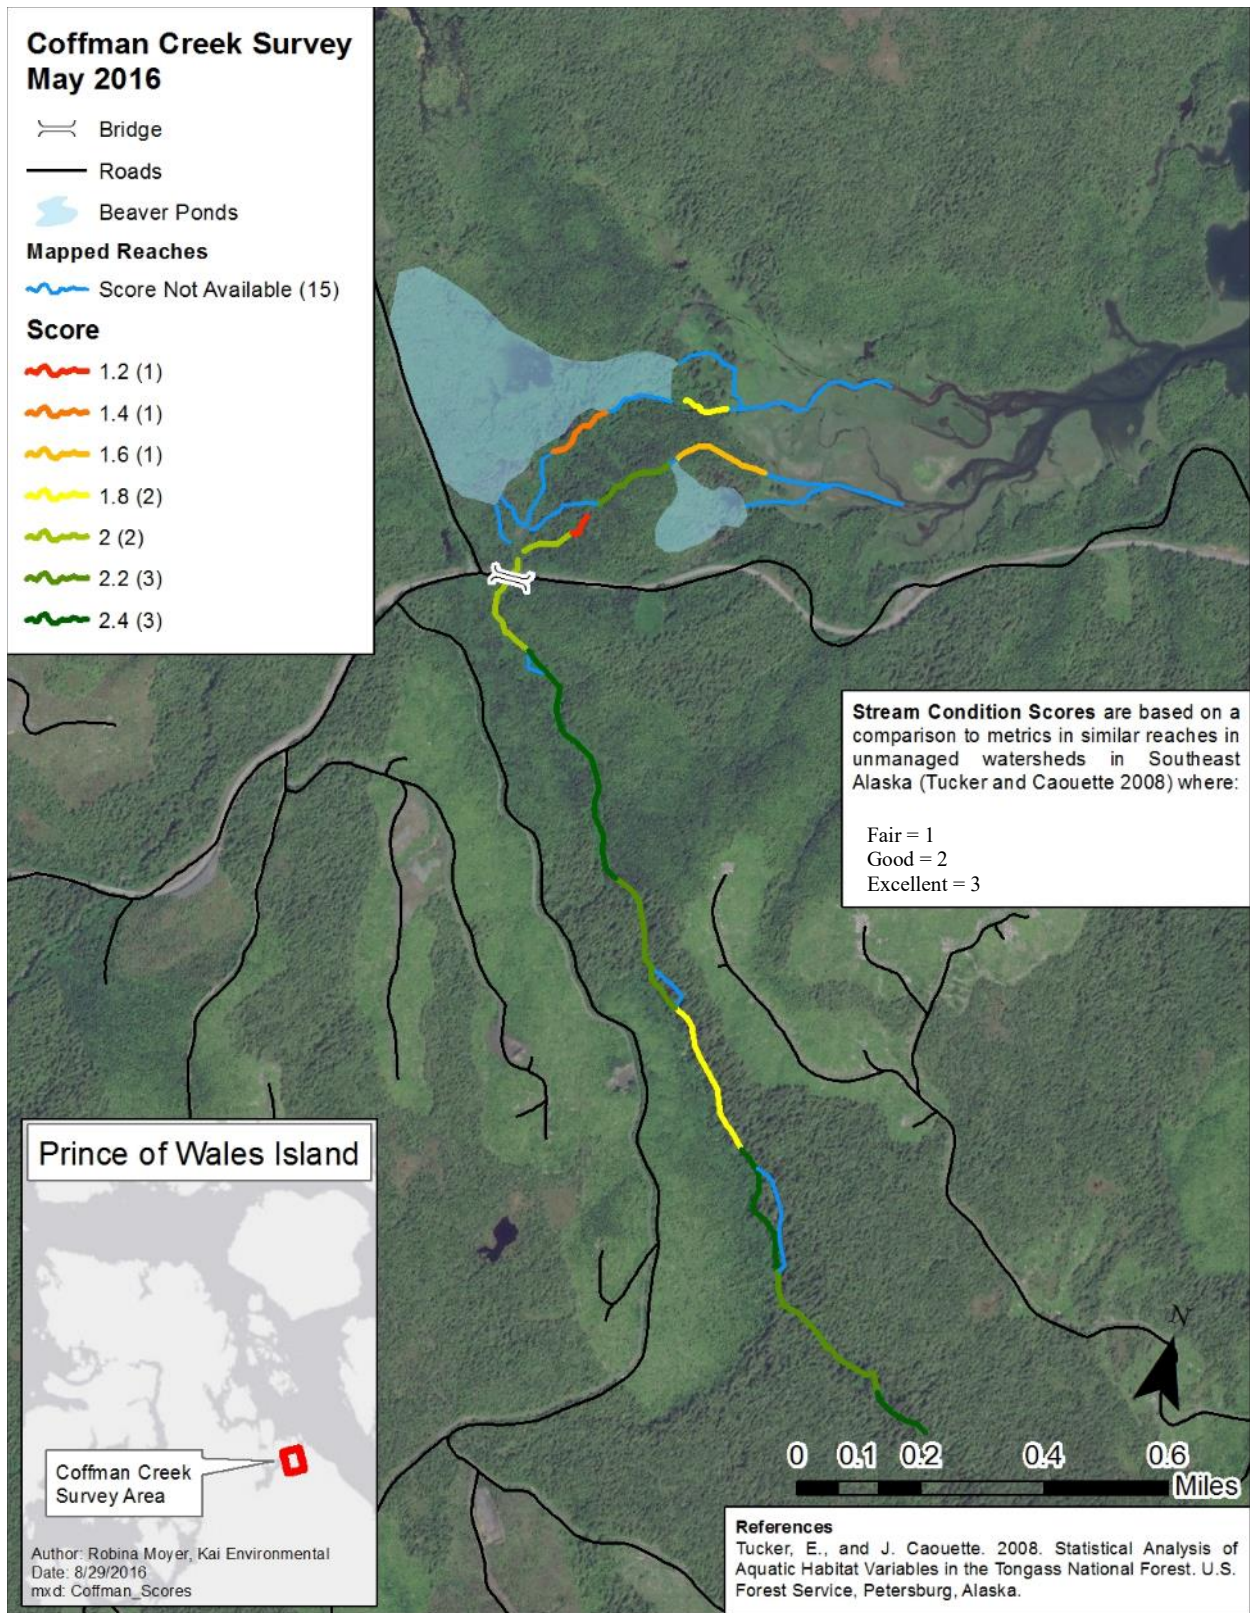
Figure 7: Map of habitat condition for Coffman Creek near Coffman Cove, Alaska. Scores are based on an analysis of stream survey data with 1 being poor condition and 3 being excellent; the number of stream reaches with that score are shown in parenthesis in the map legend.

The remaining six reaches below the bridge had comparative metrics. The final scores varied between 1.2 and 2.2, with only two reaches scoring 2.0 and 2.2. Stream 1, Tributary 2, Reach 8 had the lowest score of 1.2. The reach was 77 meters long with a width to depth ratio of 5.56. There was 0.05 large wood per meter and 0.00 key large wood per meter, indicating the reach lacked large wood almost entirely. The riparian area was classed as having 25-60% cover, dominated by Sitka spruce and Western hemlock. While the current stream condition appears to be lacking in stream structure, large wood recruitment may not be a concern. Reaches above and below Stream 1, Tributary 2, Reach 8 are generally better, while reaches in adjacent braided channels have no comparative metrics. The reach may be a candidate for restoration efforts, such as placing key woody debris into the channel, to improve connectivity within Stream 1.

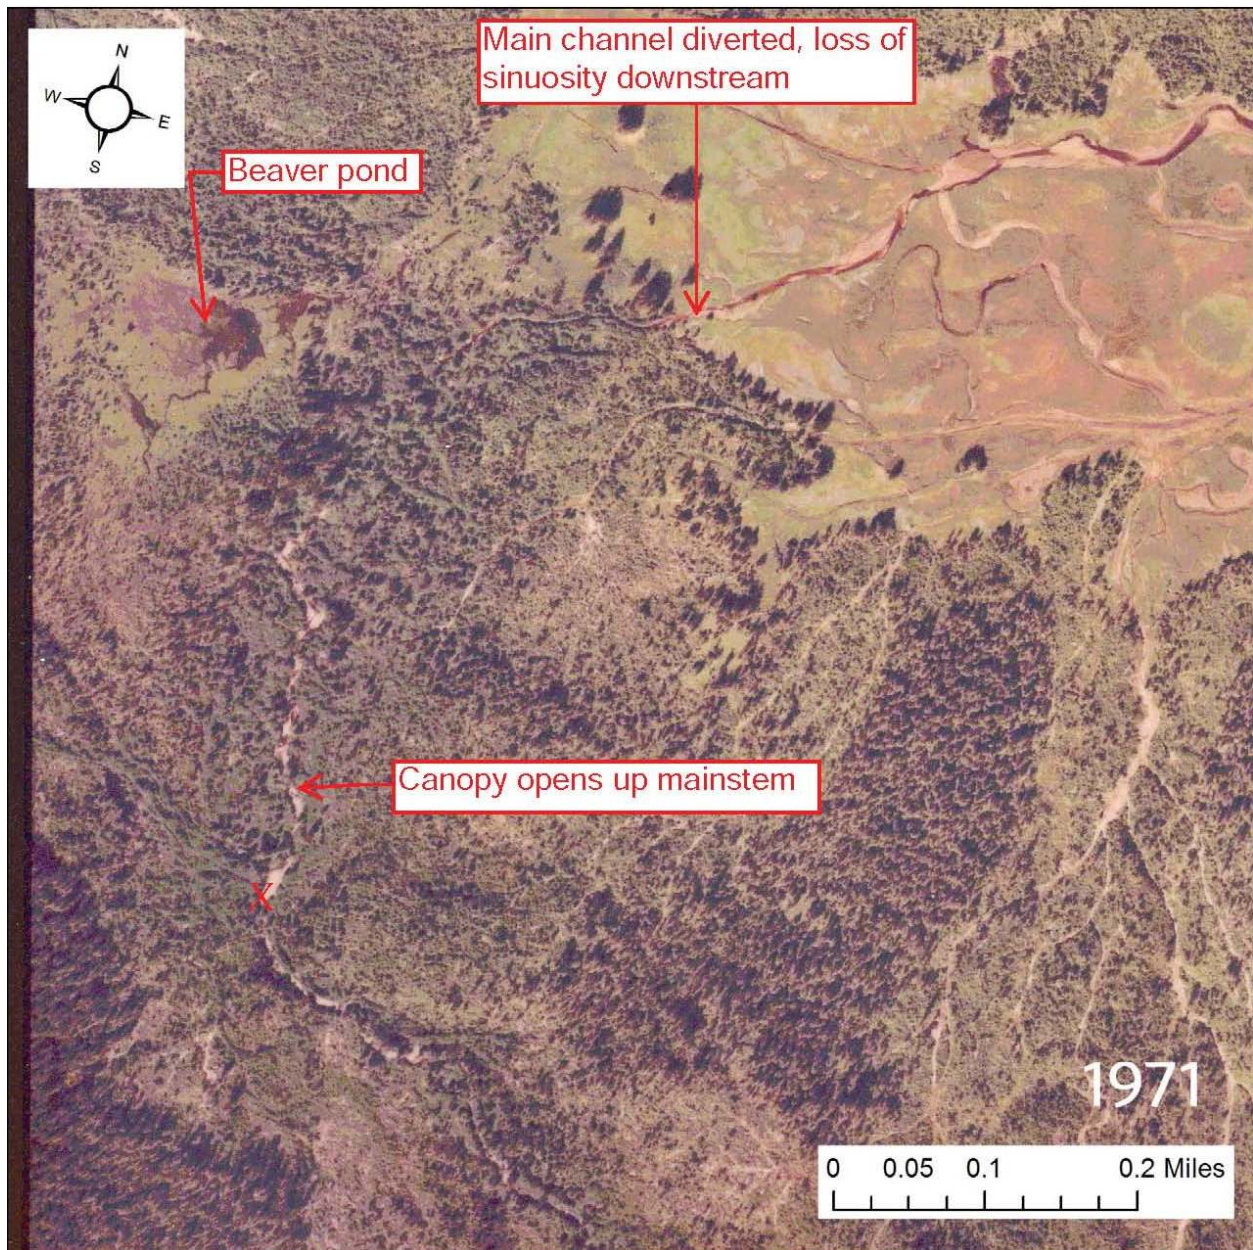
Figure 9: Aerial imagery from 1971 of the Coffman Creek estuary and Coffman Creek, near Coffman Cove, Alaska. The red X on the image refers to where a future road crossing occurs over the mainstem of Coffman Creek. Annotations on the image refer to changes in imagery when compared to other figures in the Coffman Creek Habitat Assessment report (2018).

There was one key difference in the estuary between the 1929 imagery and the 1971 imagery - an apparent diversion of stream flow into a main channel (Figure 9). It is unclear if this diversion was anthropogenic or natural. The imagery indicates that at least some selective harvest around the stream occurred prior to 1971. The change may also be due to an increase in flow regime, which can occur post timber harvest. However, it should also be noted that just inside the treeline from the estuary, is the confluence of two streams that are fed by a larger beaver pond complex, which may have caused or influenced downstream hydrology. While it is noticeable in the imagery, the diverted stream course in the estuary may not be an issue for stream function and/or fish habitat and passage. The new channel appears to be stable through the 1976 and 2006 images, with some of the remnant sinuosity still playing a roll from the salt water influence it receives.

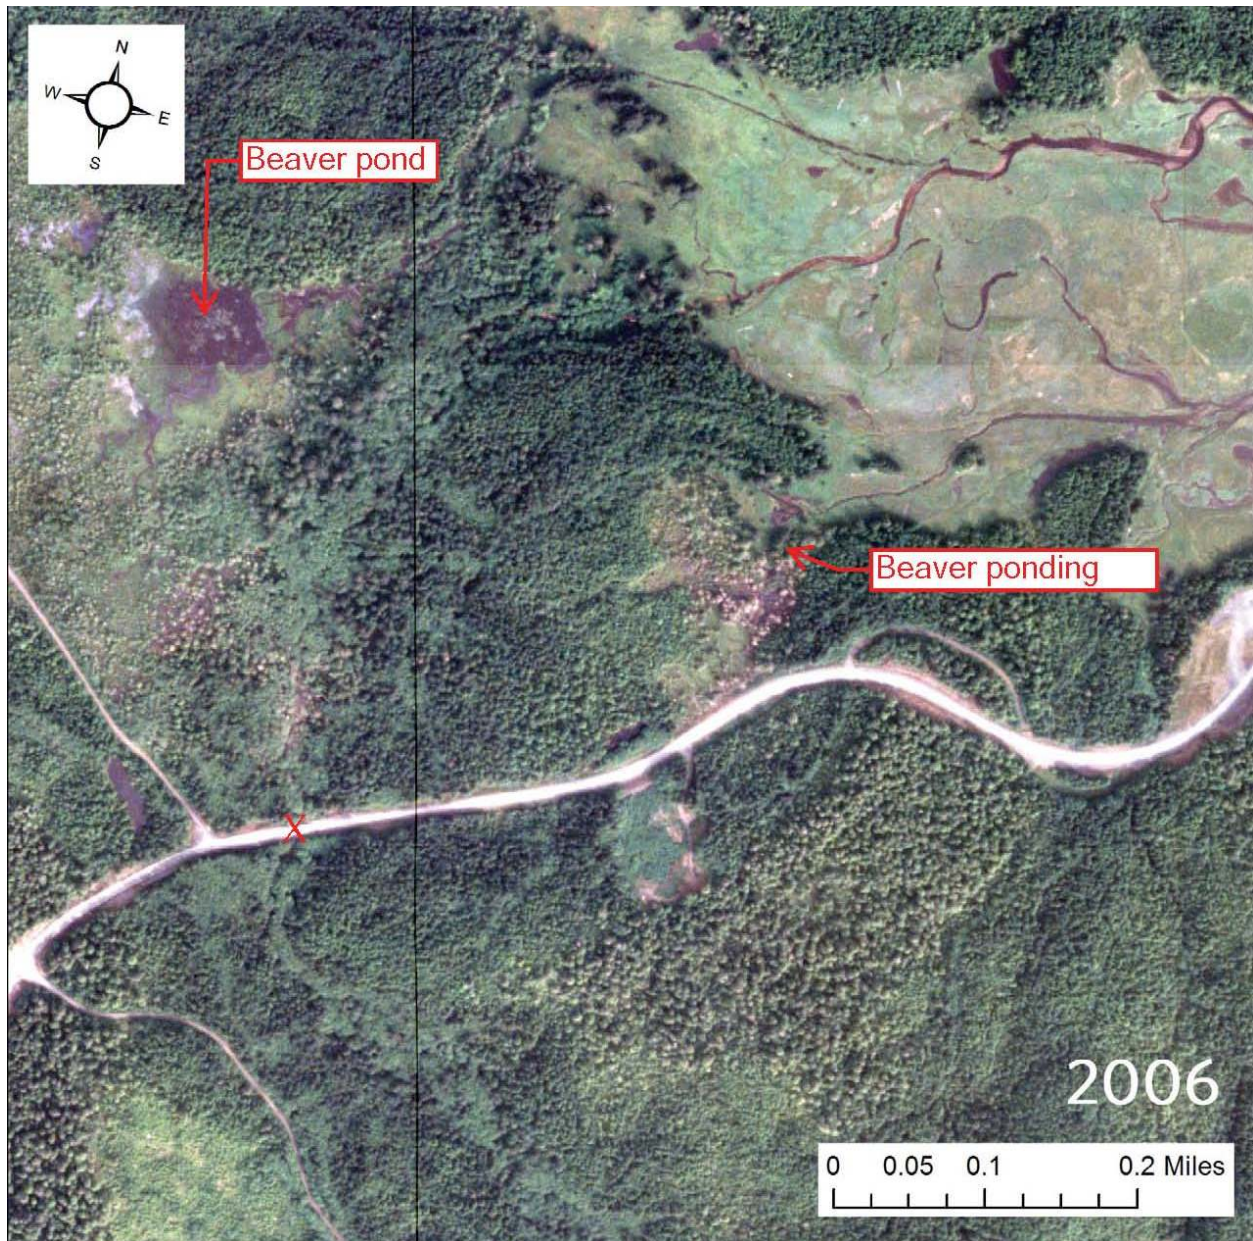
construction and continued impacts from previous timber harvest (USFS 2018). By 2006 (Figure 11), beaver ponds have been established immediately north of the road, seen in the center of the image. The main stream of Coffman Creek remains straight as it enters the estuary in comparison to the 1929 imagery; it is unclear from the images, exactly where and how the diversion occurs. The impacts of 1990 timber harvest can be seen in the southwestern portion of the 2006 imagery. There was additional logging upstream of the imagery area throughout the 1980s and 1990s, in some cases immediately adjacent to the mainstem of Coffman Creek (USFS 2018).

Figure 11: Aerial imagery from 2006 of the Coffman Creek estuary and Coffman Creek, near Coffman Cove, Alaska. The red X on the image is a reference point to earlier imagery before the construction of the road crossing over the mainstem of Coffman Creek. Annotations on the image refer to changes in imagery when compared to other figures in the Coffman Creek Habitat Assessment report (2018).
