North Thorne Project Area Watershed Restoration Plan

**James M. Beard
Fishery Biologist
Thorne Bay Ranger District
August 2011**

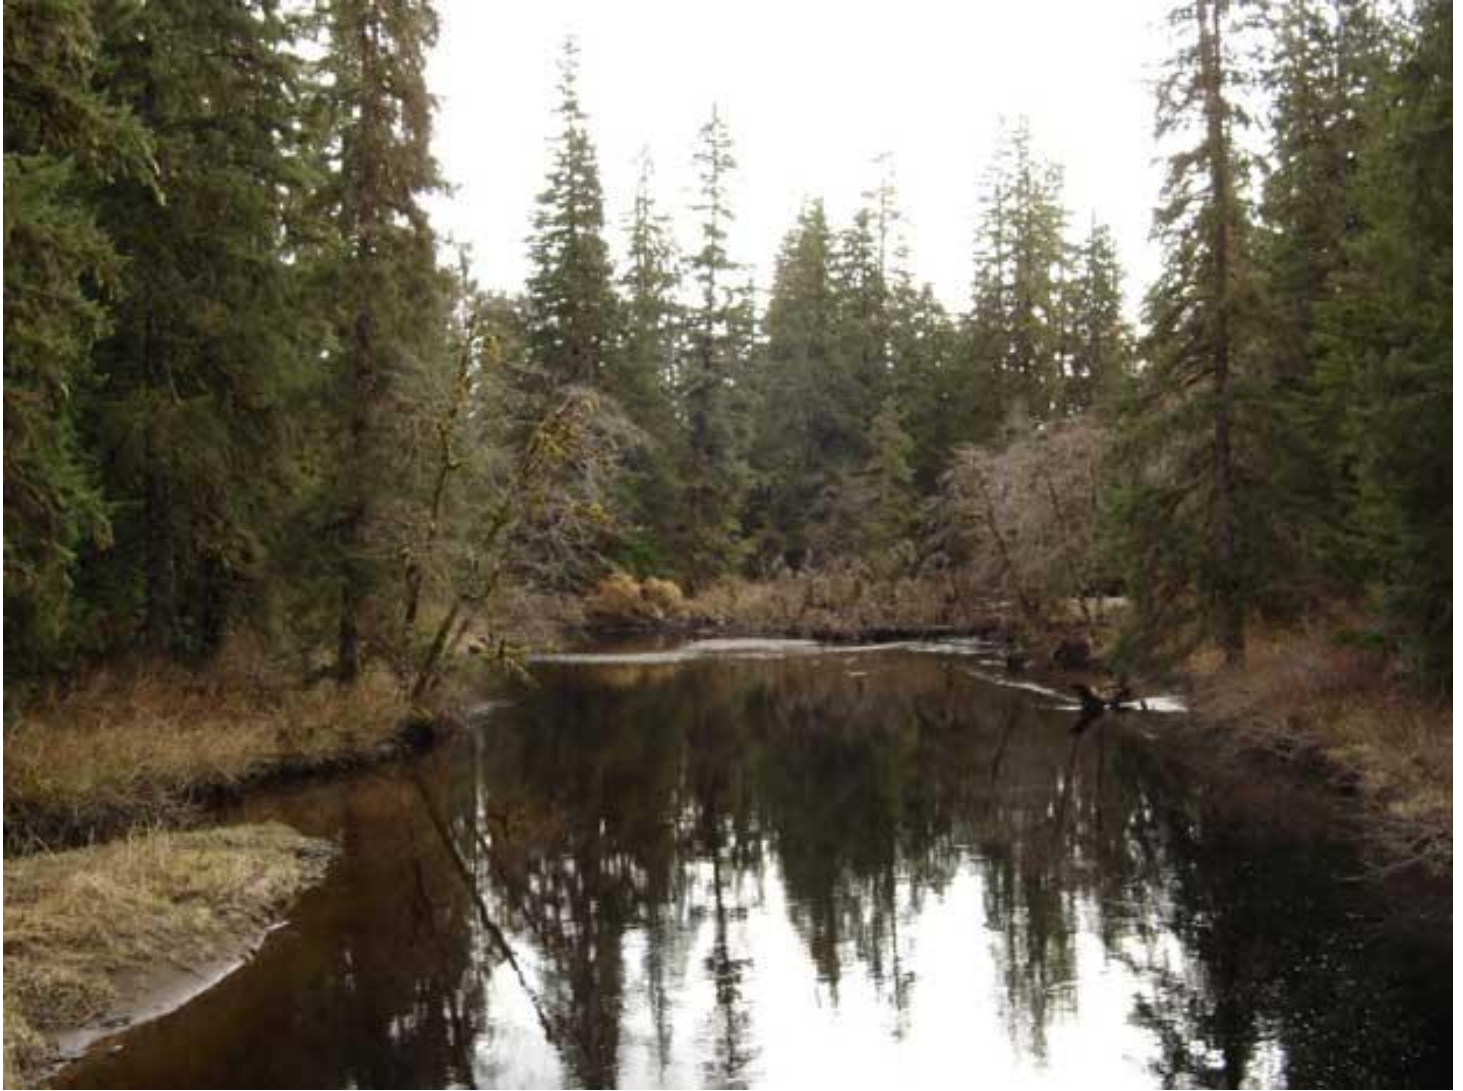
Upstream view from North Fork of the Thorne River Bridge, 3016000 road. The West Fork subwatershed verves off to the left of the picture and the East Fork subwatershed verves off to right of the picture.

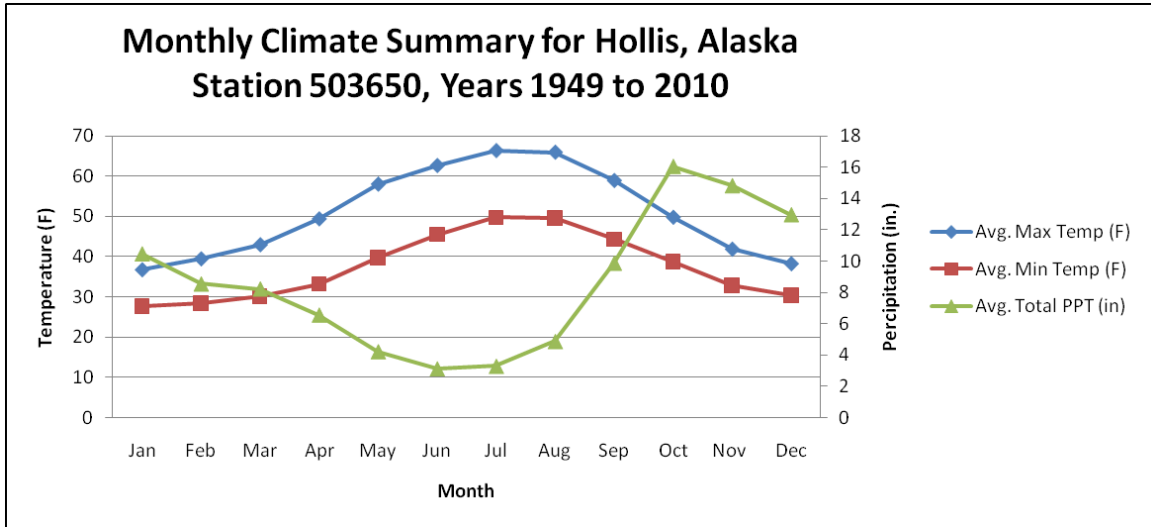
Figure 4. Monthly Climate Summary for Hollis, Alaska, Station 503650, Years 1949 to 2010. Data from WRCC 2011.

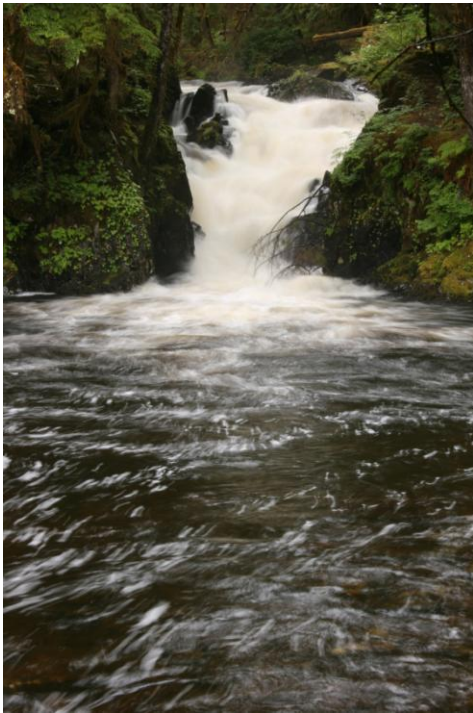
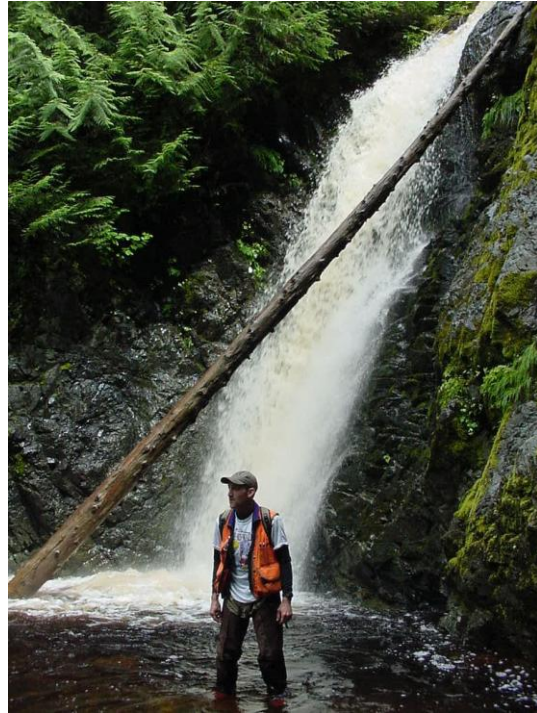
Figure 5. Photo on left is North Thorne Falls, a partial barrier to coho salmon and steelhead. Photo on right is a complete barrier falls to salmon on Falls Creek.

It has been thought that the falls below the Snakey Lakes area is a partial barrier to pink salmon. Beard 2006 observed several adult pink salmon schooling in deeper areas of the North Fork upstream of the North Thorne bridge on the 3016000 road. However, during the previous 5 years no adult pink salmon were observed at this location.

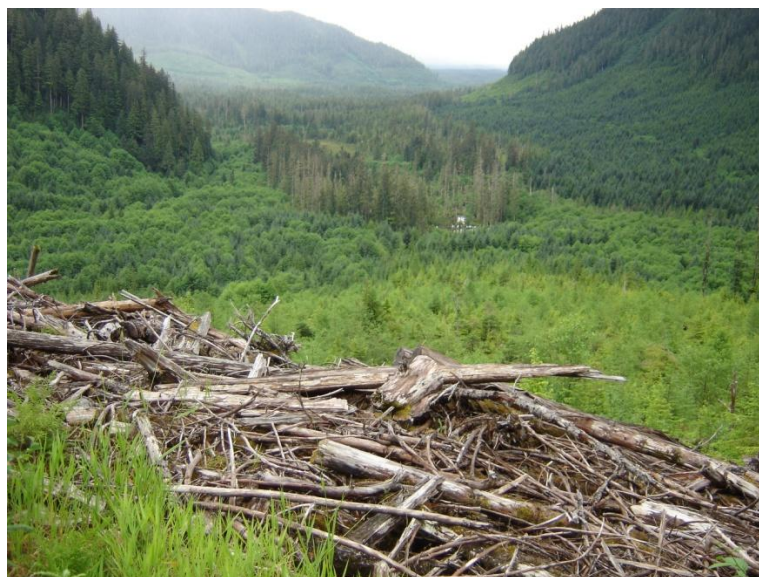
Figure 8. View looking south from the north end of the East Fork of North Thorne subwatershed, showing timber harvest to mid slope.

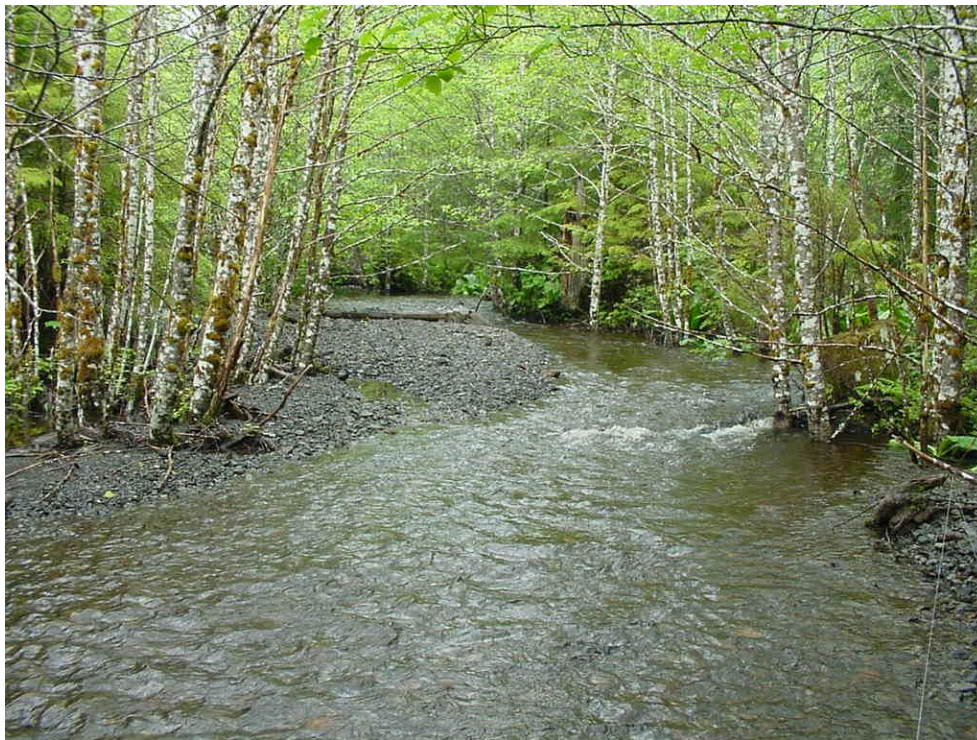
Figure 9. Alder dominated riparian area due to harvest of Old Growth trees up to the streambank in the upper West Fork subwatershed. Note also bedload aggregation due to lack of a stable channel.

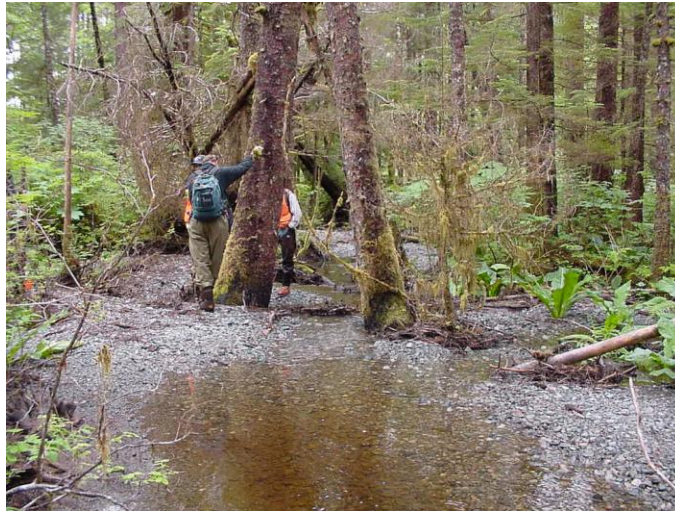
Figure 10. Aggregated bedload surrounding conifers in a side channel in the upper East Fork subwatershed below the 3015640 road crossing

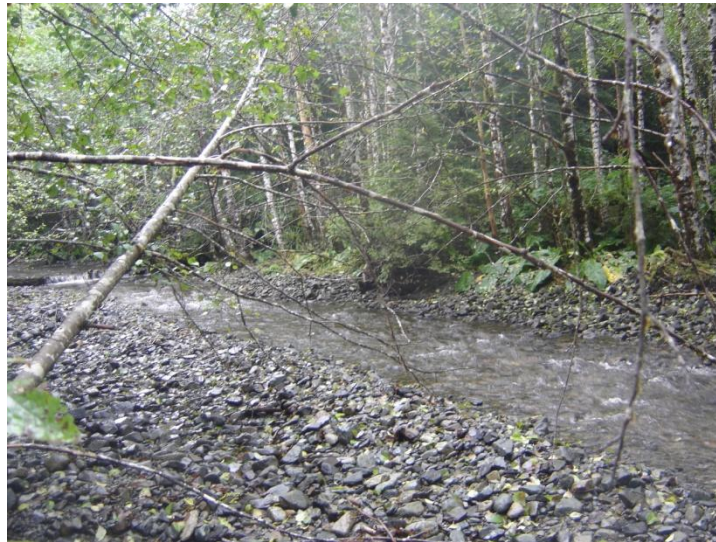
Figure 11. Wide width-to-depth ratio in upper East Fork subwatershed below 3015640 road crossing.

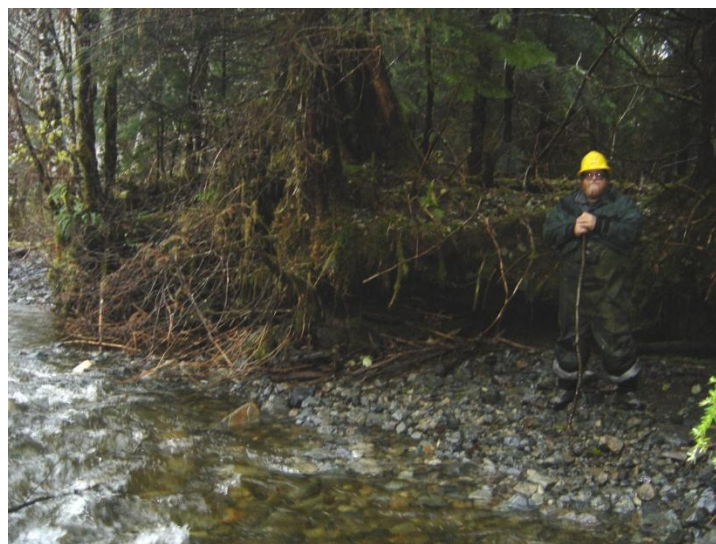
Figure 12. Down-cut channel in upper East Fork subwatershed above 3015640 road crossing.

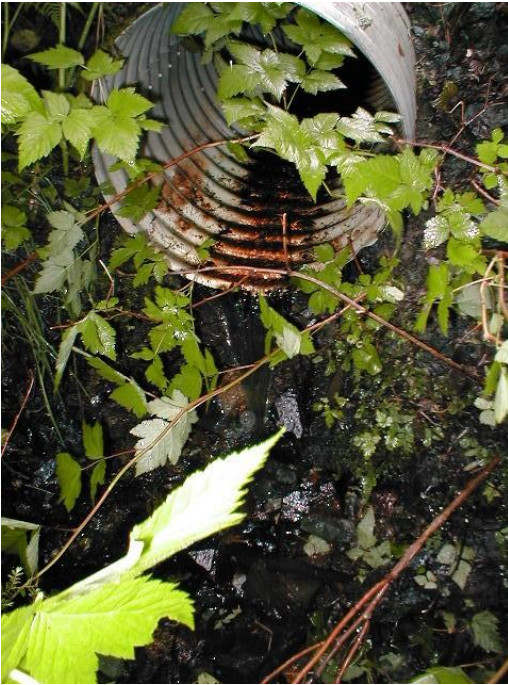
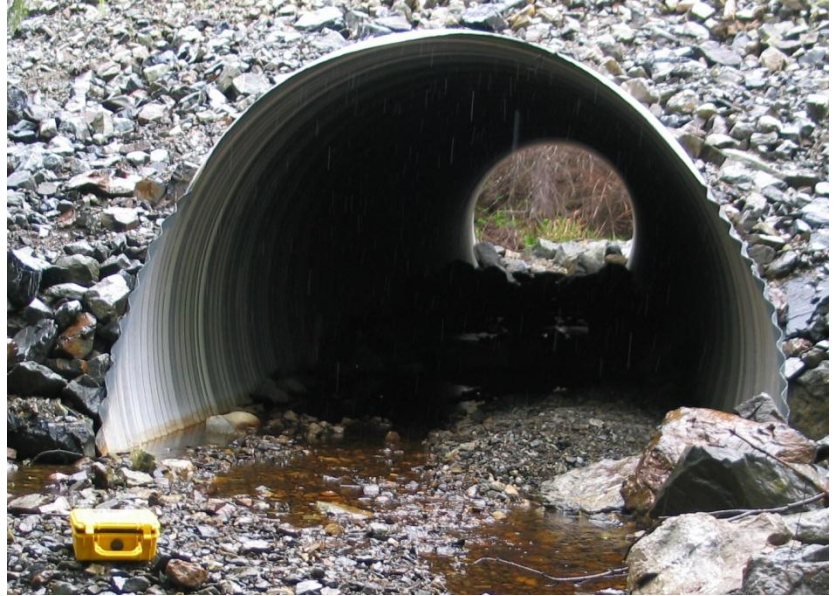
Figure 13. A remediated red pipe at 3015000 MP 0.344. Before photo (left) shows a 36 inch pipe that is perched and is installed at a steep gradient. After photo (right) shows a 96 inch pipe that has had bedload placed inside the pipe simulating a stream bottom.

Road No.	MP	Previous Culvert Size (in)	New Culvert Size or Total Removal due to road storage	Amt of Habitat upstream (ft)	Species Present
3015000	0.344	36	96x96 in.	4158	CT
3015000	2.641	36	79x117 in. arch	2986	SS, CT, DV

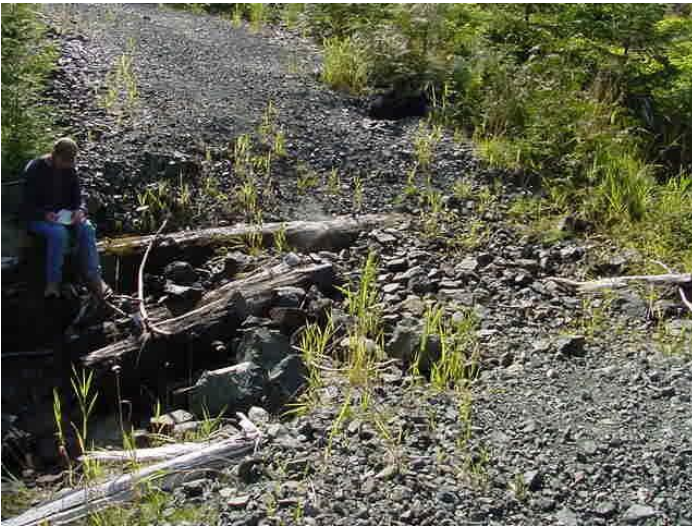
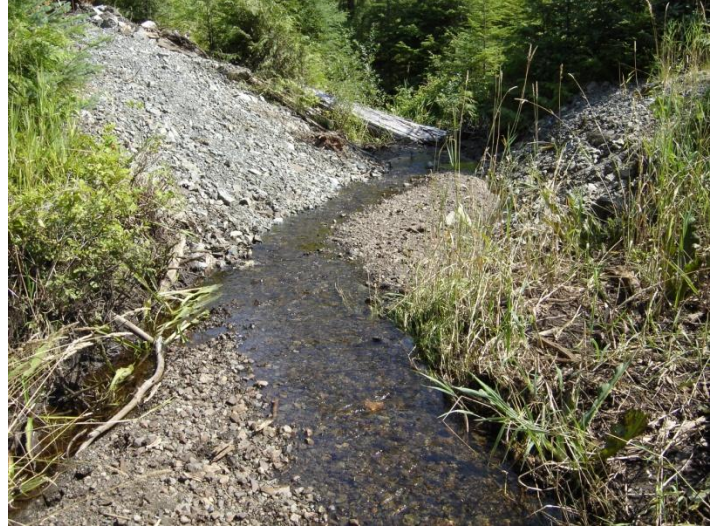
Figure 14. A red pipe removed at 3015105_0.96L MP 0.038. Before photo (left) shows 36 in pipe that is crushed and buried in the road prism. After photo (right) shows downstream view of removed crossing due to proper road storage.
