Vanderbilt Creek Watershed Recovery and Management Plan

Vanderbilt Creek Watershed in Juneau, Alaska

Author: Amy Sumner
Prepared for: Juneau Watershed Partnership
June 2007

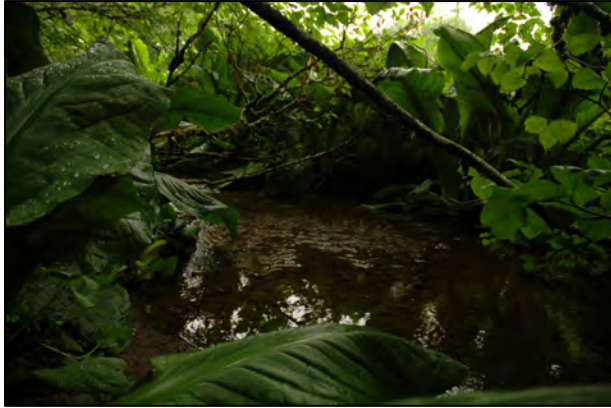
Figure 1. Vanderbilt Creek at the entrance to the Lemon Creek Trail off of Glacier Highway.
Photo by: Eric J. Chandler

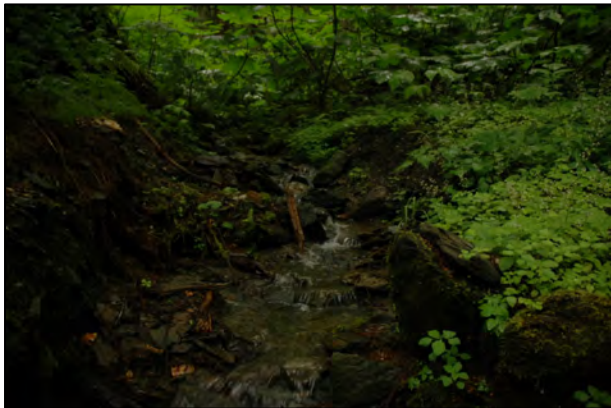
Figure 2. A tributary flowing from Blackerby Ridge, located along the Lemon Creek Trail.
Photos by: Eric J Chandler

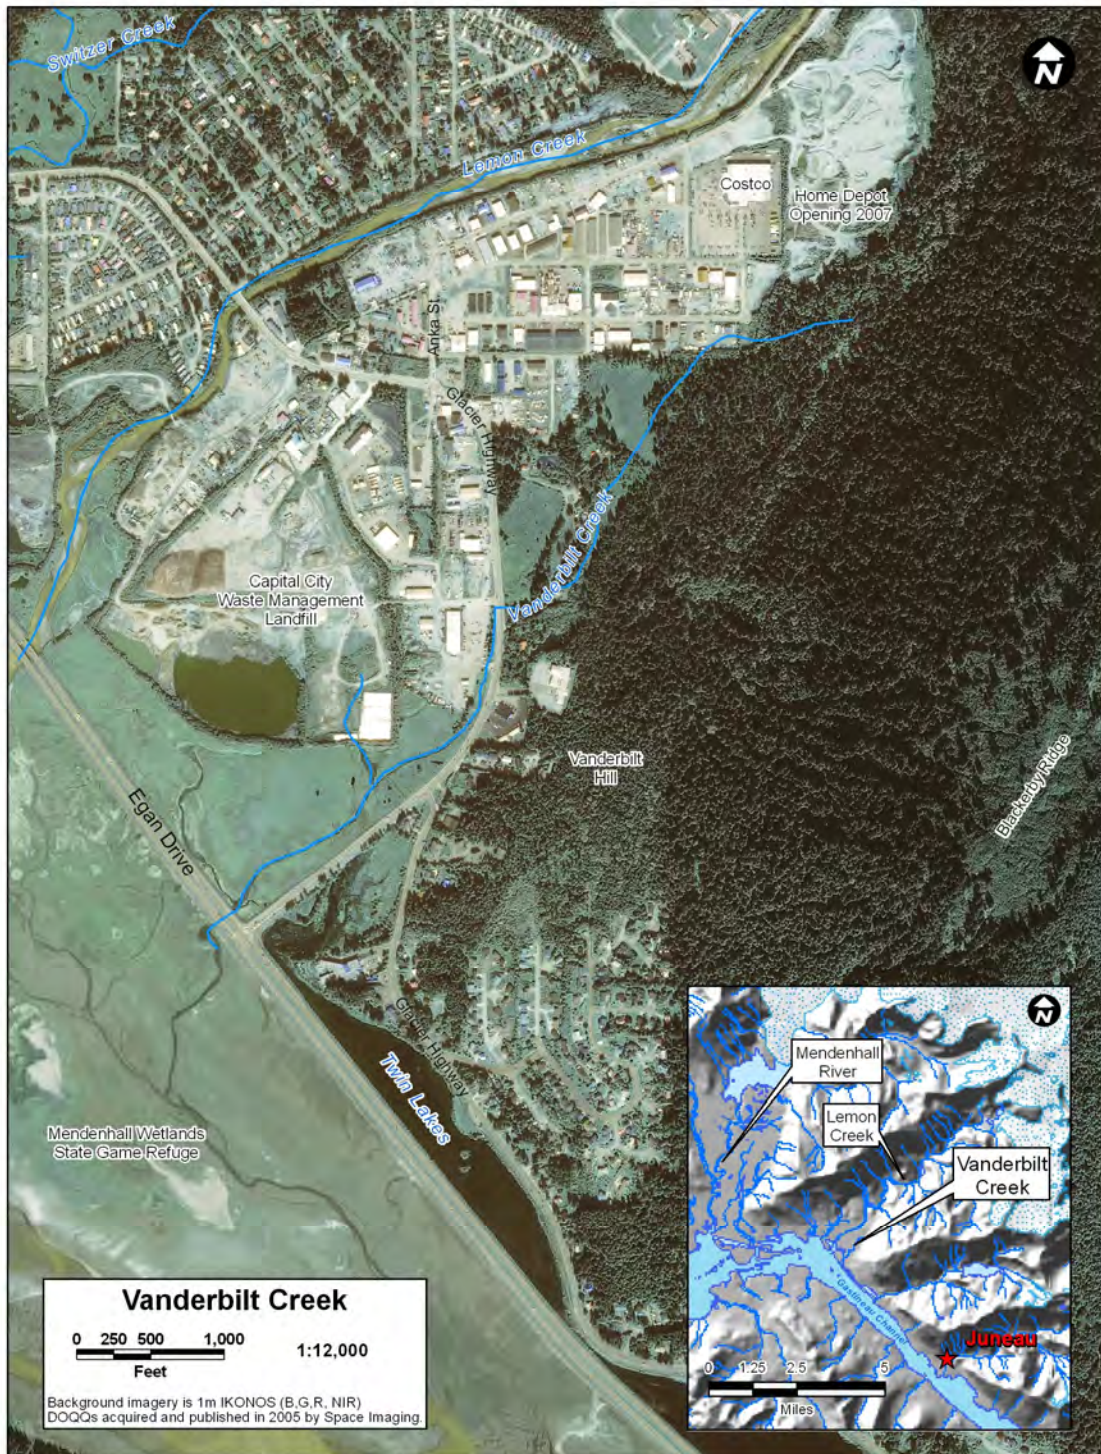
Figure 3. Map of Vanderbilt Creek. Stream layer is from the Alaska Department of Fish and Games' Anadromous Waters Catalog. Cartography by Deb Spicer, Juneau Watershed Partnership, May 2007.

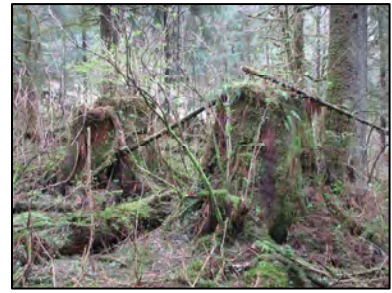
Figure 4. Decaying tree stumps from logging along Lemon Creek Trail.

Development of the Lemon Creek Valley began in the early 1900s. Between 1900 and 1950, the primary land uses of the area included logging, homesteading, and fishing. Evidence of logging in the Vanderbilt Creek Watershed still exists along the Lemon Creek Trail (Figure 4), which was used as a logging road in the 1940s and 50s (Pat Quigley, personal communication, May 13, 2007). Wood core samples taken from a spruce tree and analyzed by Discovery Southeast and Dzantik'I Heeni Middle School students in 2003 suggest that logging may have occurred along Vanderbilt Creek as early as 1902.

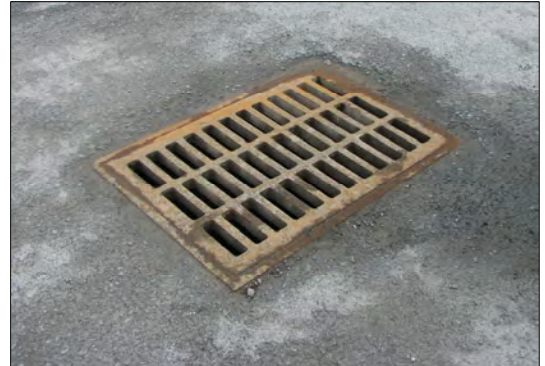
Figure 5. A storm drain on Short Street that transports sediment directly into Vanderbilt Creek.

There are several conveyances of concern: a drainage pipe conveying stormwater from the located along Glacier Highway accumulating sludge, a grate located on Short Street, and the conveyance diverting runoff from the HD site. Improvements on some of these conveyances are listed as separate actions.

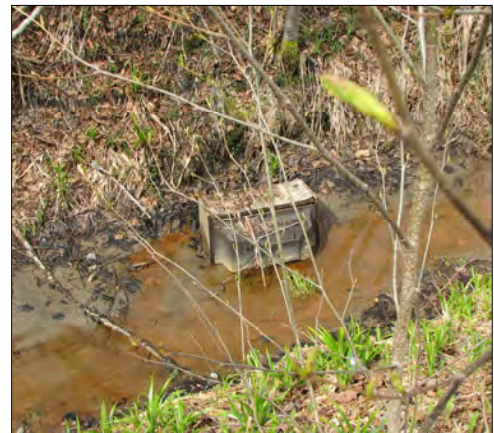
Figure 6. A TV in a ditch that drains from Charles Way to Vanderbilt Creek.

Garbage and other debris can reduce aesthetics, introduce contaminants, impede fish passage and degrade habitat. Sources of debris in Vanderbilt Creek include littering, sediment/debris wedges from naturally occurring landslides, and potentially windblown, loose debris from the nearby landfill or other areas.

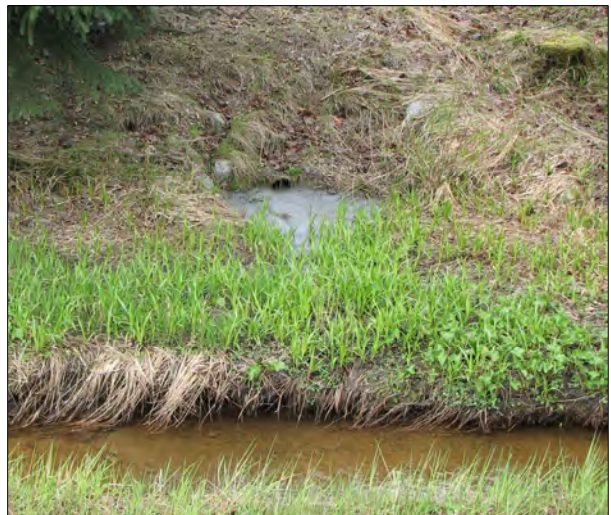
Figure 7. A small drain with a pool of sludge accumulating near Vanderbilt Creek.

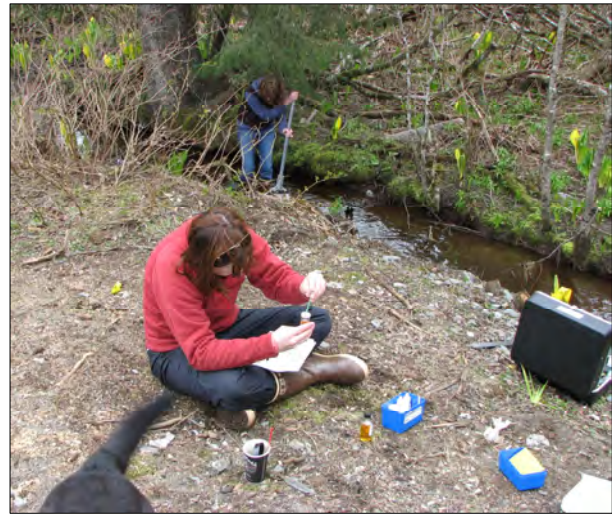
Figure 8. JWP volunteers conducting a rapid bioassessment on Vanderbilt Creek.

The Juneau Watershed Partnership (JWP) volunteers conducted a rapid bio-assessment of Vanderbilt Creek in May 2007 (Figure 8). Using the volunteer-level methods developed by ENRI, data was collected along a 25-meter portion of the ENRI sampling site on Vanderbilt Creek. The JWP data was collected in association with this project to establish a point in which to begin current discussions of the stream's health. Data from JWP's rapid bioassessment suggest that Vanderbilt Creek's water quality continues to be impaired (see Appendix C).

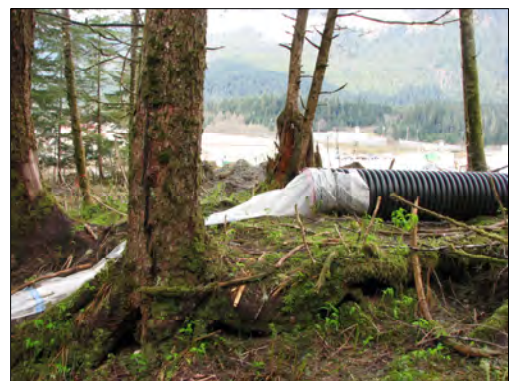
Figure 9. The temporary water diversion conduit that transports stormwater from the hill behind Home Depot into Vanderbilt Creek. June 2007

Action 1.3.2: Work with Home Depot to improve quality of stormwater diverted into Vanderbilt Creek.

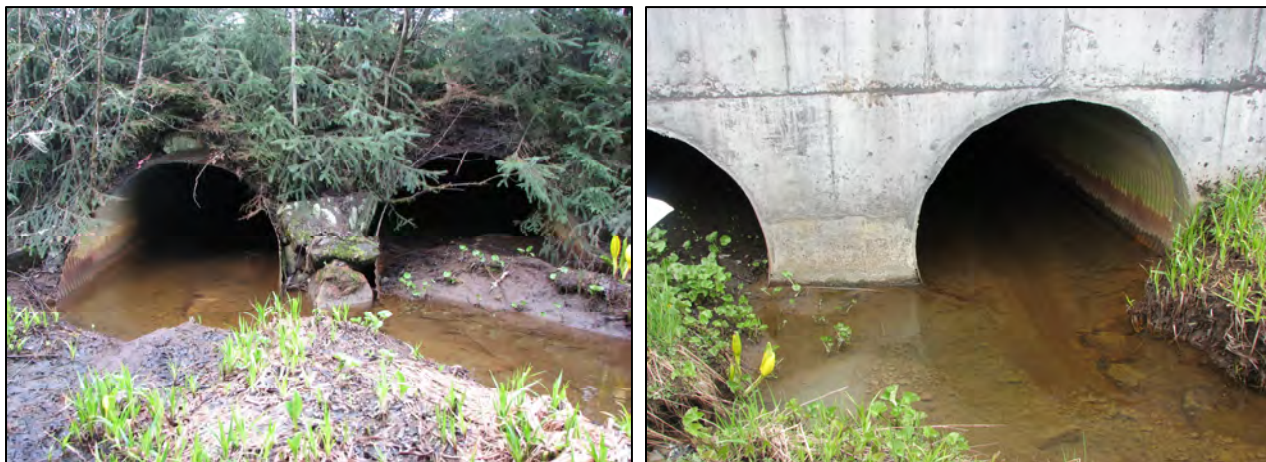
Figure 10. The inlet (left) and outlet (right) of the Glacier Highway culverts. As shown, one of the culverts has failed due to sediment build up.

The pair of culverts that direct the mainstem of Vanderbilt Creek under Glacier Highway have several problems that make them a priority for replacement. Both culverts are closed-bottom which could affect the presence of natural substrate and hydrologic conditions, and there is visible rotting of the culvert material in one of the culverts.

In addition, the culverts are not placed in a manner that creates an appropriate fish crossing. One of the culverts has failed, and does not seem to be directing stream flow (Brian Frenette, personal communication, May 13, 2007). This particular culvert appears to be blocked by a sediment bank that formed at the inlet of the culvert. According to Brian Frenette, at high flow this culvert may provide a velocity barrier to fish, and he recommends that these culverts should be replaced with a bridge.

Before a decision is made to replace the culverts with a bridge, the crossing can be assessed using the USFS “FishXing” software, and the crossing conditions can be assessed to determine what type of structure would be the best replacement.

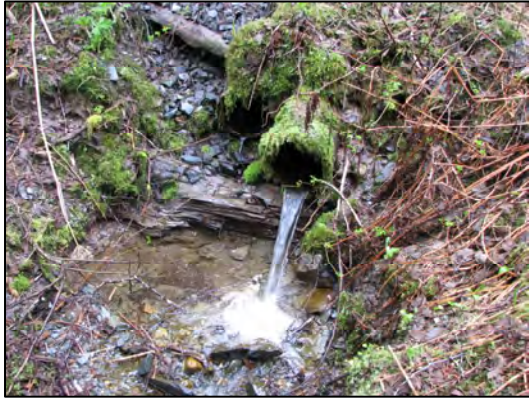
Figure 11. One of several undersized, perched culverts on Vanderbilt Creek along the Lemon Creek Trail

The Vanderbilt Creek tributaries along the Lemon Creek Trail bisect active alluvial fans, which appear to provide excellent coho habitat (Brian Frenette, personal communication, May 13, 2007). However, many of the culverts directing tributaries under the Lemon Creek Trail are too small in diameter and have perched outlets. In addition, the Lemon Creek Trail, which is actually a 15-ft wide drivable gravel route, is acting like a dike and constricting water flow. Both the culverts and the road are subsequently disconnecting much of the habitat at the toe of the alluvial fan.

Though fish have not been seen using many of these tributaries (Pat Quigley, personal communication, May 13, 2007), Frenette suspects that coho have historically used the waters and will do so again once the habitat is reconnected. Replacing these culverts with bridges would allow each tributary to flow naturally across the landscape, reconnecting the habitat. Frenette says proper stream crossings would also prevent road washout along the Lemon Creek Trail. Again, these culverts can be assessed using the US Forest Service' (USFS) "FishXing" software and alternatives for replacement structures can be considered.

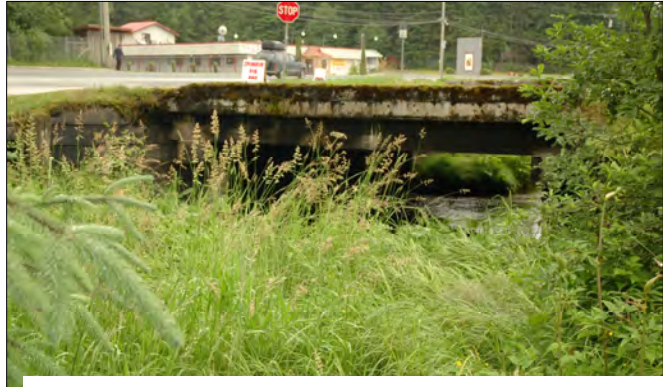
Figure 12. One of the creosote bridges crossing Vanderbilt Creek. Photo by: Eric J. Chandler

Two creosote bridges cross Vanderbilt Creek on Glacier Highway, providing access to Grant's Plaza/Western Auto and Jerry's Meats. There is also an additional creosote abutment that is currently not being used as a bridge.
