# Hetta and Eek Lake Habitat Mapping

## ... The Project ...

In 2012, partners in this project set out to map baseline salmon distribution and habitat conditions in Hetta and Eek Lake watersheds in Southeast, Alaska.

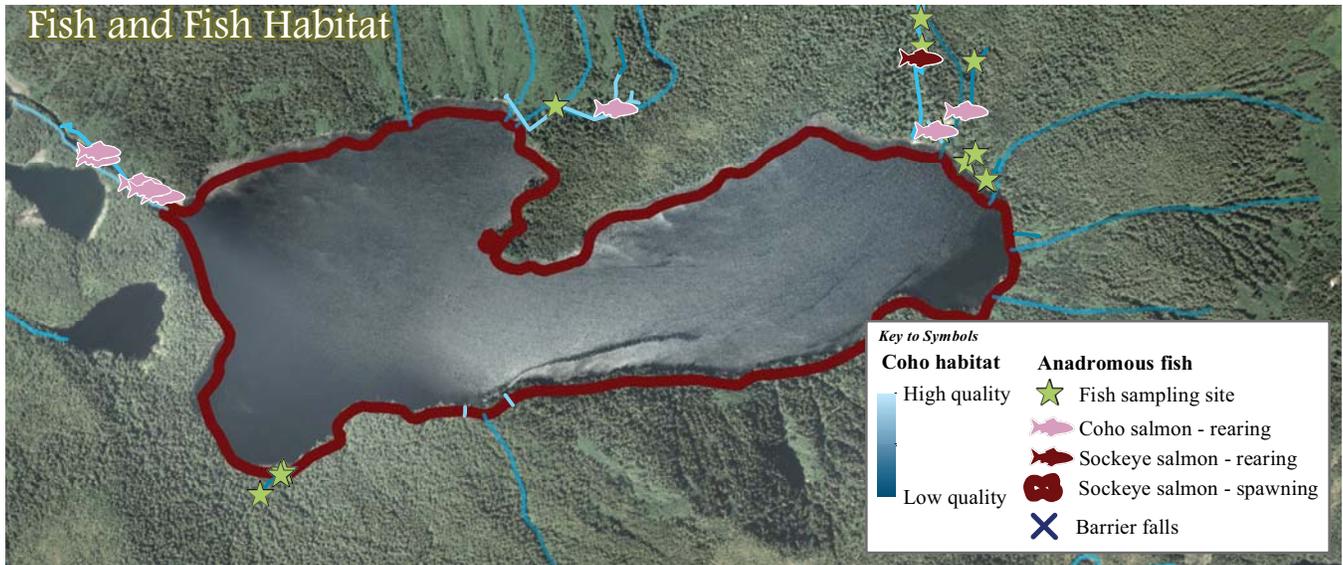
## Fish and Fish Habitat

In order to document fish presence in the Hetta watershed, minnow trapping was used in 10 locations. Eight new locations were documented in the AWC for rearing coho salmon and one for rearing sockeye salmon. In addition, adult sockeye salmon were visually observed using Hetta Lake for spawning. Other species found include Dolly Varden Char, rainbow trout, and cutthroat trout.

The Hetta watershed features many tributaries feeding into Hetta Lake. Based on geomorphology alone, the lower portions of most of these tributaries have high potential as coho spawning and rearing areas, pink and chum spawning areas, and steelhead spawning and rearing habitats. Many of the tributaries quickly become higher gradient streams, where they have high potential for Dolly Varden spawning and rearing, but less so for other fish species.

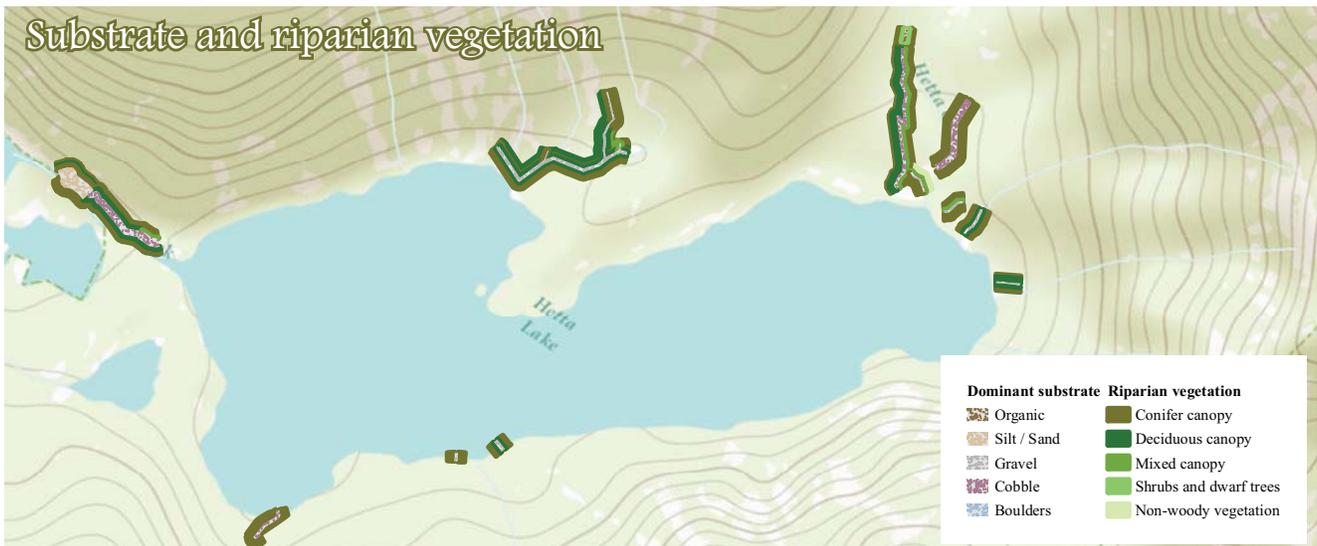
Fish habitat quality of all reaches in the Hetta watershed as compared to other SEAK unlogged streams:

% Poor	% Fair	% Good
Pool density	42%	16%	42%
Wood density	68%	5%	27%
Key wood density	32%	32%	36%

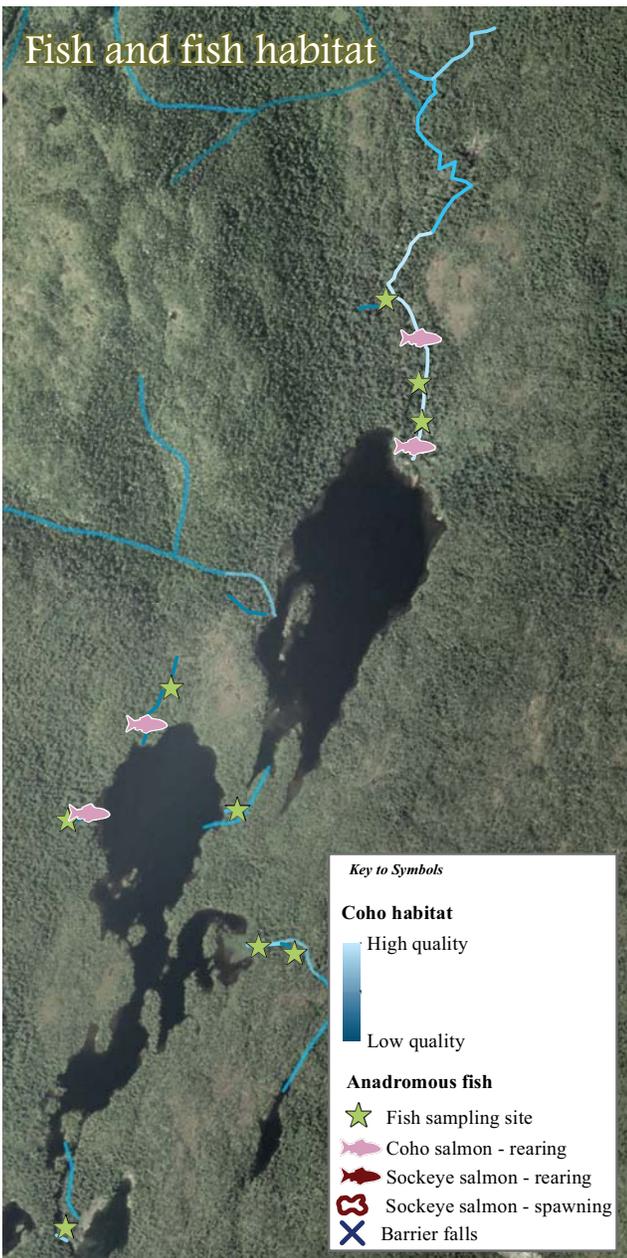
In order to document fish presence in the Eek watershed, minnow trapping was used in 8 locations. Four new locations were documented in the AWC for rearing coho salmon. Other species found include Dolly Varden Char, rainbow trout, and cutthroat trout.

The Eek watershed features several small tributaries feeding into lower Eek Lake, and a longer tributary feeding into upper Eek Lake. Based on geomorphology alone, the lower portions of most of these tributaries and a large stretch of the long tributary have high potential as coho spawning and rearing areas, pink and chum spawning areas, and steelhead spawning and rearing habitats.

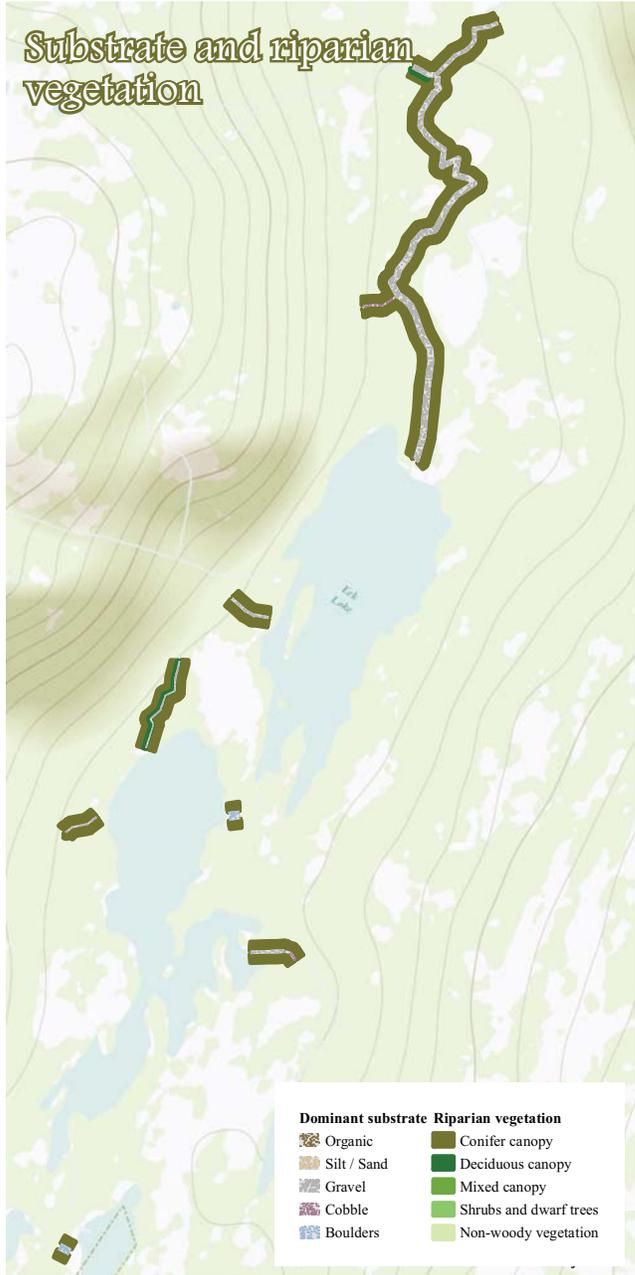
Four new locations were documented in the AWC for rearing coho salmon
