Klawock Lake Watershed Sockeye Spawning Habitat Assessment

Klawock Lake Stakeholder Meeting
November 14-15, 2017

Sockeye Salmon Habitat

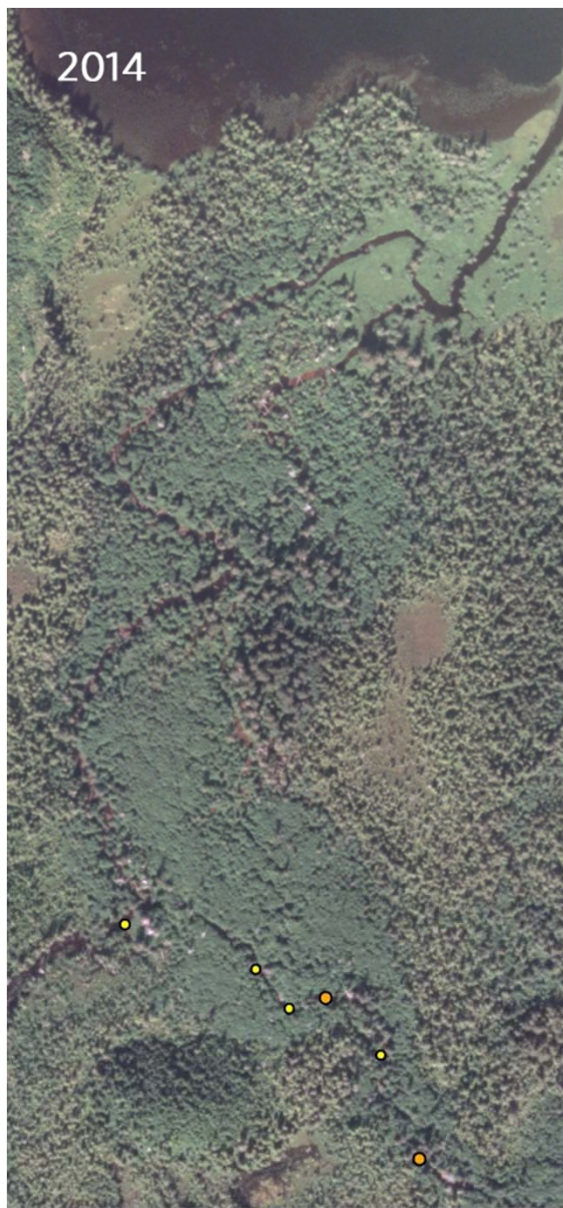
Location of Salmon Redds
Hatchery Creek - Klawock Lake

Hatchery Creek					
Survey Date	Live Sockeye	Spawning Sockeye	Sockeye Carcass	Redds	Spawning Area (m ²)
9/10/2014	16	11	0	6	7.5
9/15/2015	35	29	3	8	124
8/24/2016	High and dark water prevented observations				
9/14/2016	High and dark water prevented observations				
9/20/2016	15	1	14	5	112
9/30/2016	No fish in creek

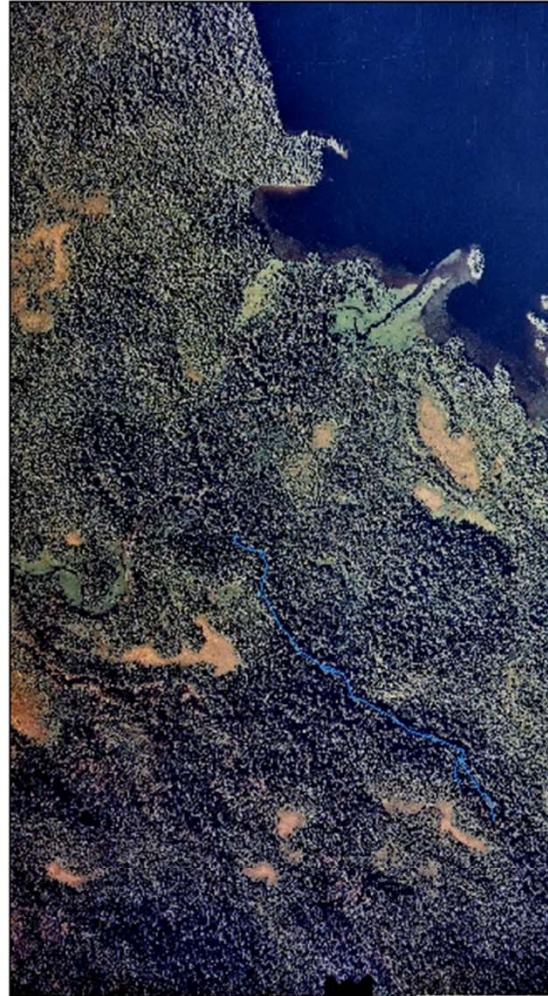
Hatchery Creek Aerial Comparison

1948 Imagery

1972 Imagery

Current Imagery

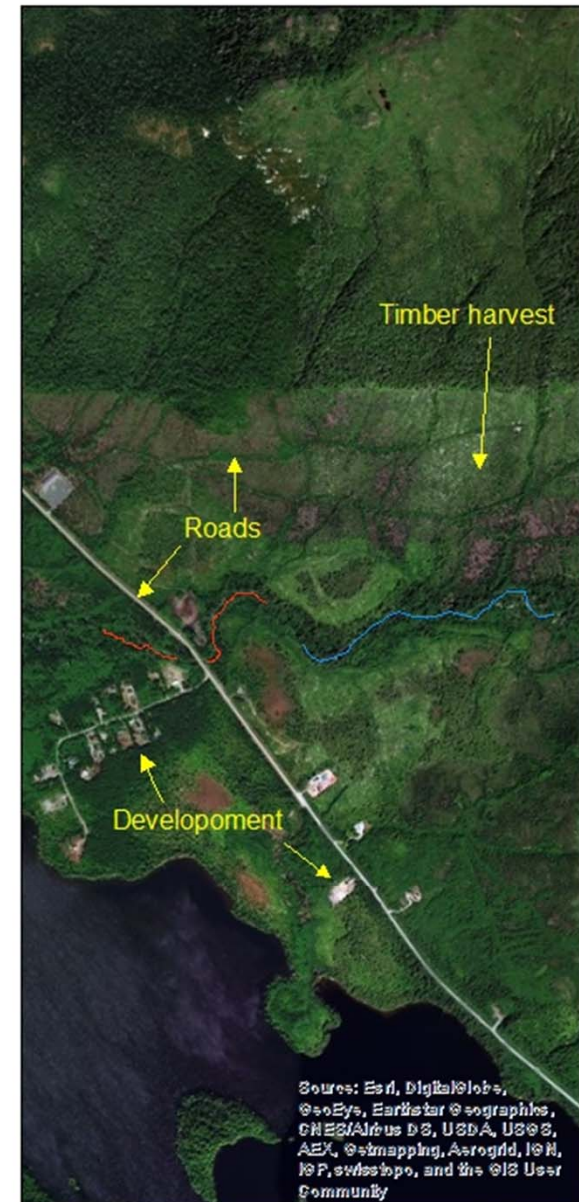
Threemile Creek Aerial Comparison

1978 Imagery

Current Imagery

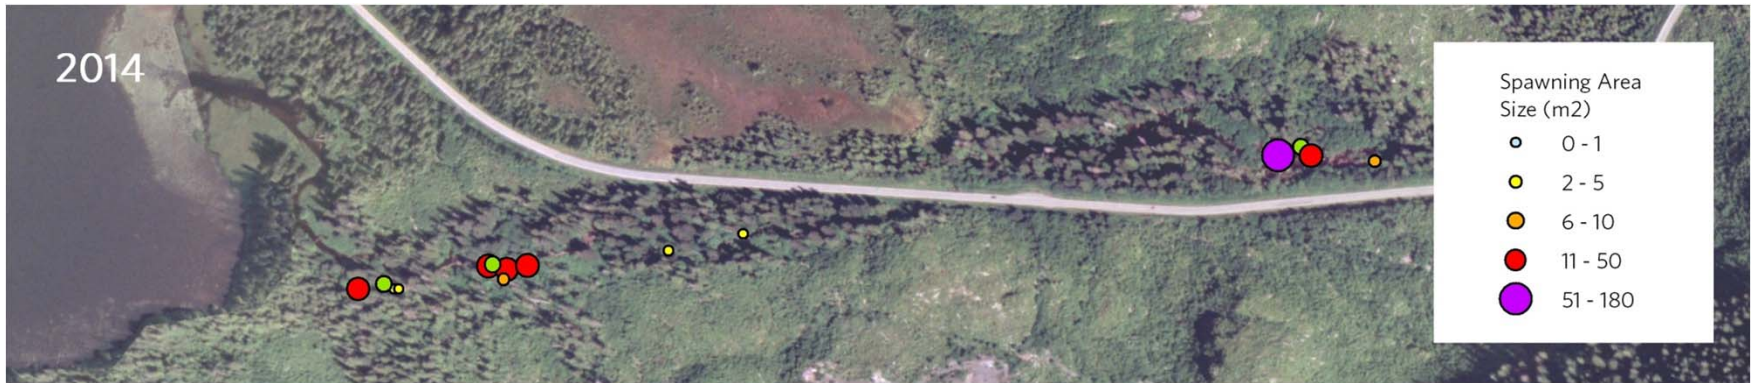
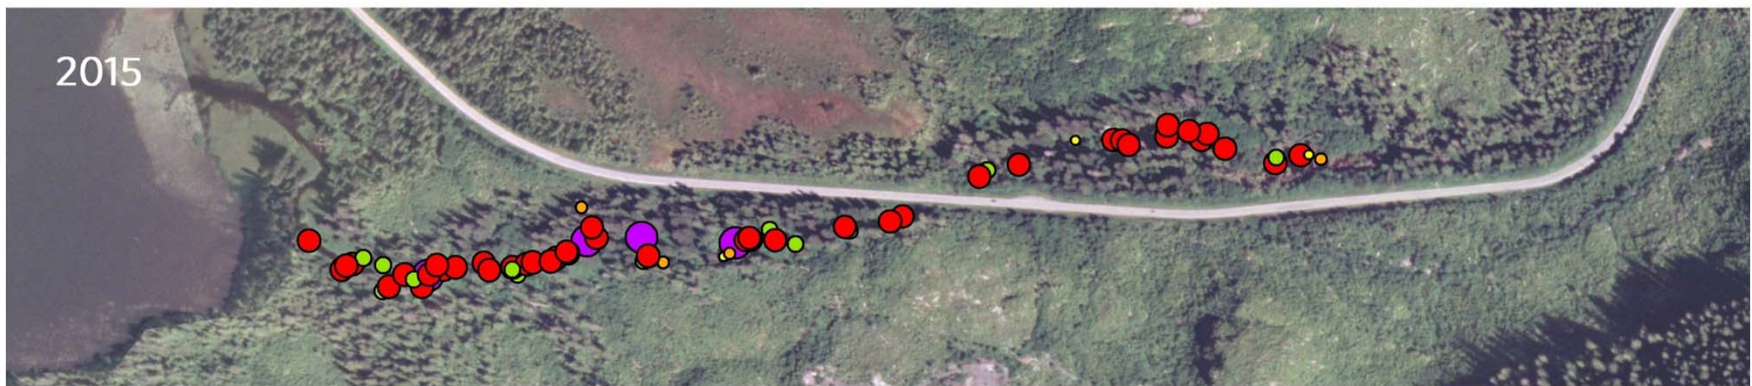
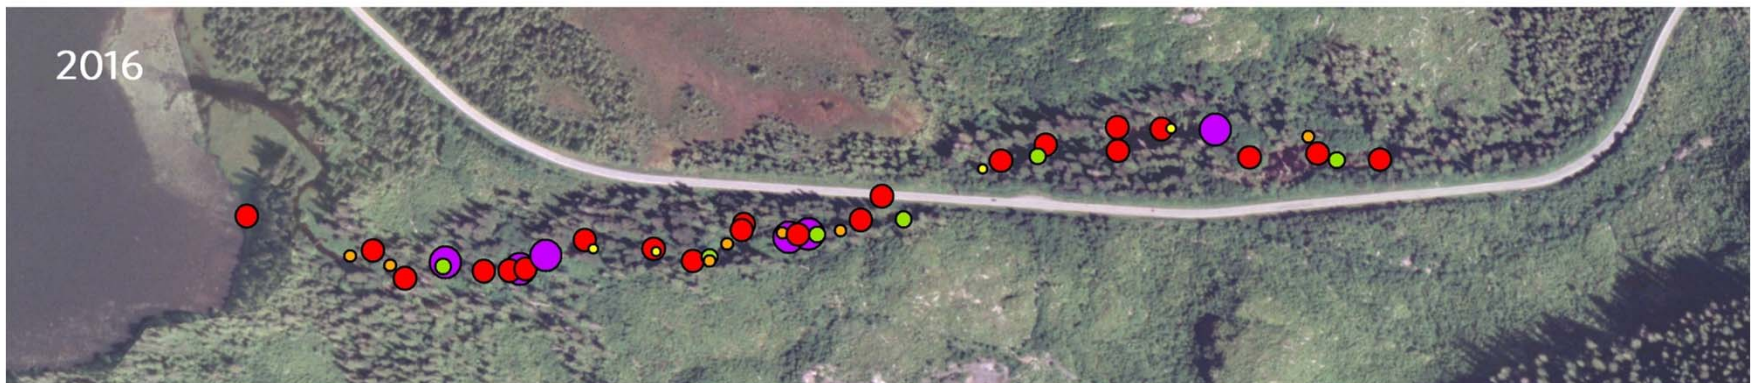
Location of Salmon Redds
Inlet Creek - Klawock Lake

Inlet Creek					
Survey Date	Live Sockeye	Spawning Sockeye	Sockeye Carcass	Redds	Spawning Area (m ²)
9/5/2014	84	30	1	11	27
9/17/2014	64	42	11	25	96
9/23/2014	9	9	0	3	64
9/30/2014	39	13	4	6	16
8/27/2015	77	49	0	16	192
9/1/2015	337	128	0	40	657
9/7/2015	388	268	19	80	536
9/21/2015	202	116	26	52	373
10/1/2015	21	15	2	3	24
8/31/2016	New beaver dam blocking fish (18 live at mouth)				
9/12/2016	575	531	20	135	1529
9/19/2016	264	239	67	76	400
10/3/2016	10	0	3		0
10/11/2016	No fish in creek
