Watershed Assessment Approaches and Restoration Priorities

--Tongass National Forest--

Watershed Condition Framework

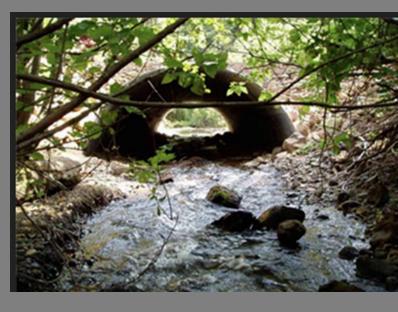
amount of habitat upstream of culverts that restrict fish passage

Restoration actions to improve watershed condition would include replacing and removing culverts to restore fish access to upstream habitat.

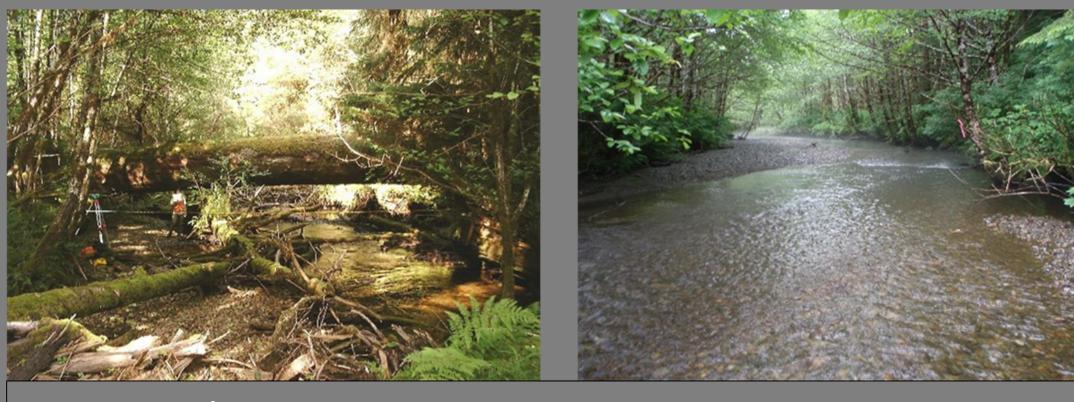
Watershed Scale Assessment

- Streams and Floodplains
- Riparian Forest

Properly Functioning

Not Properly Functioning
