Haines Borough Fish Passage Inventory and Assessment

Haines, Alaska

Prepared by the Takshanuk Watershed Council
November 2011

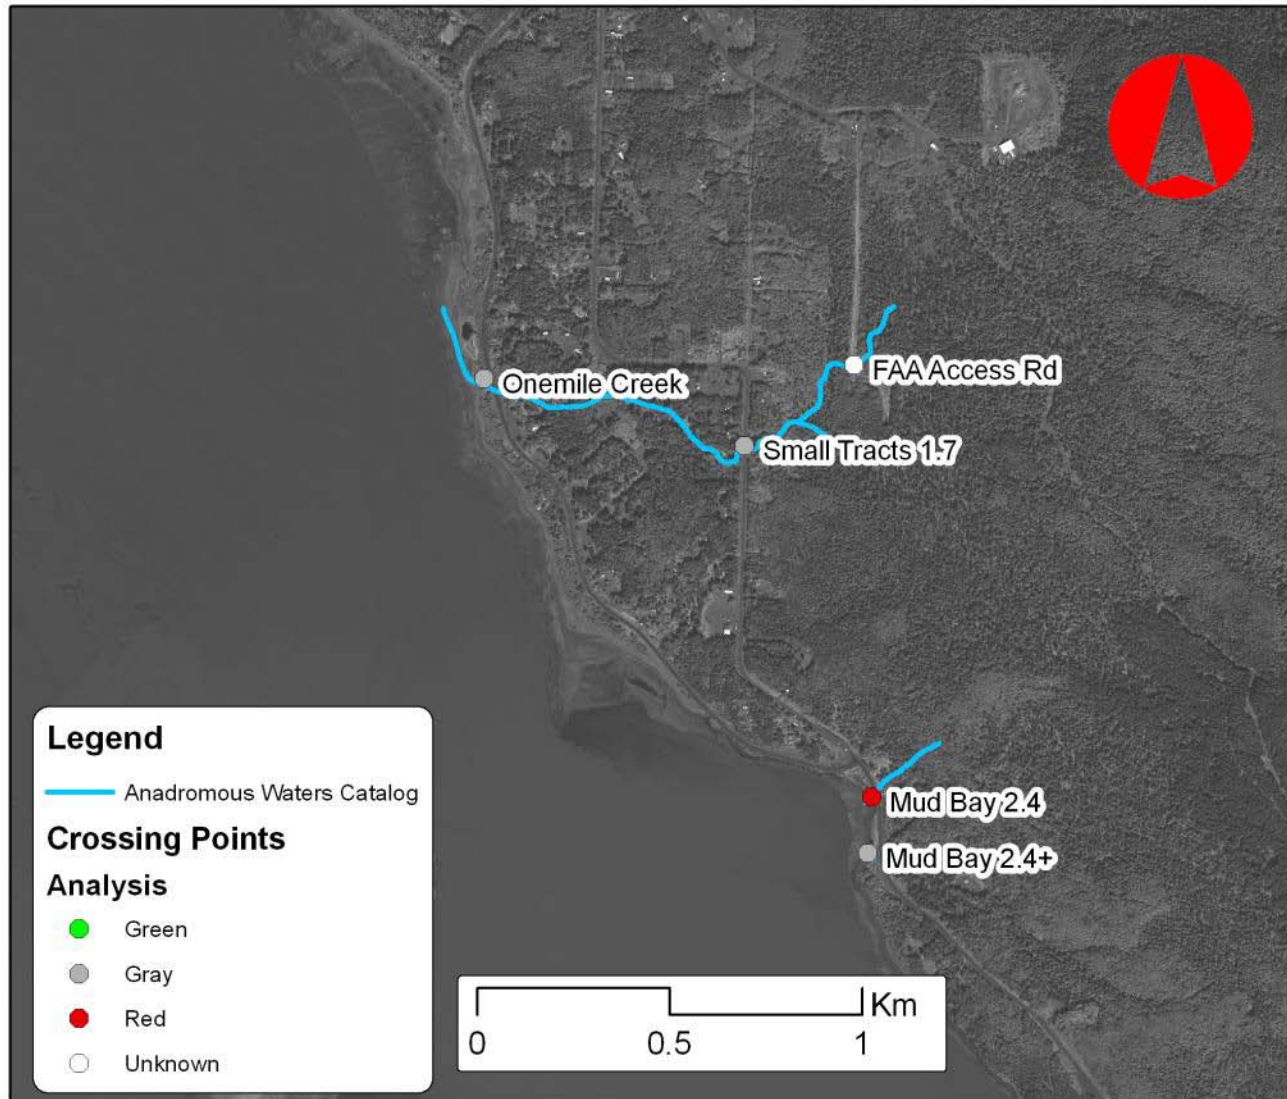
Out the Lutak Road, four crossings were surveyed with three Red and one Green (Table 3). The crossing at 4 mile Lutak Rd was not surveyed because it was replaced in 2009 (Figure 8). Towards Mud Bay, of the eleven culverts surveyed, eight are Red and three are Gray (Figures 9 & 10). In addition, two culverts were identified but not surveyed in this area.

Figure 10. Crossings in southern Mudbay area.
