Klawock Watershed Road Condition Survey

December 2002

Alaska Department of Fish and Game

Division of Habitat and Restoration

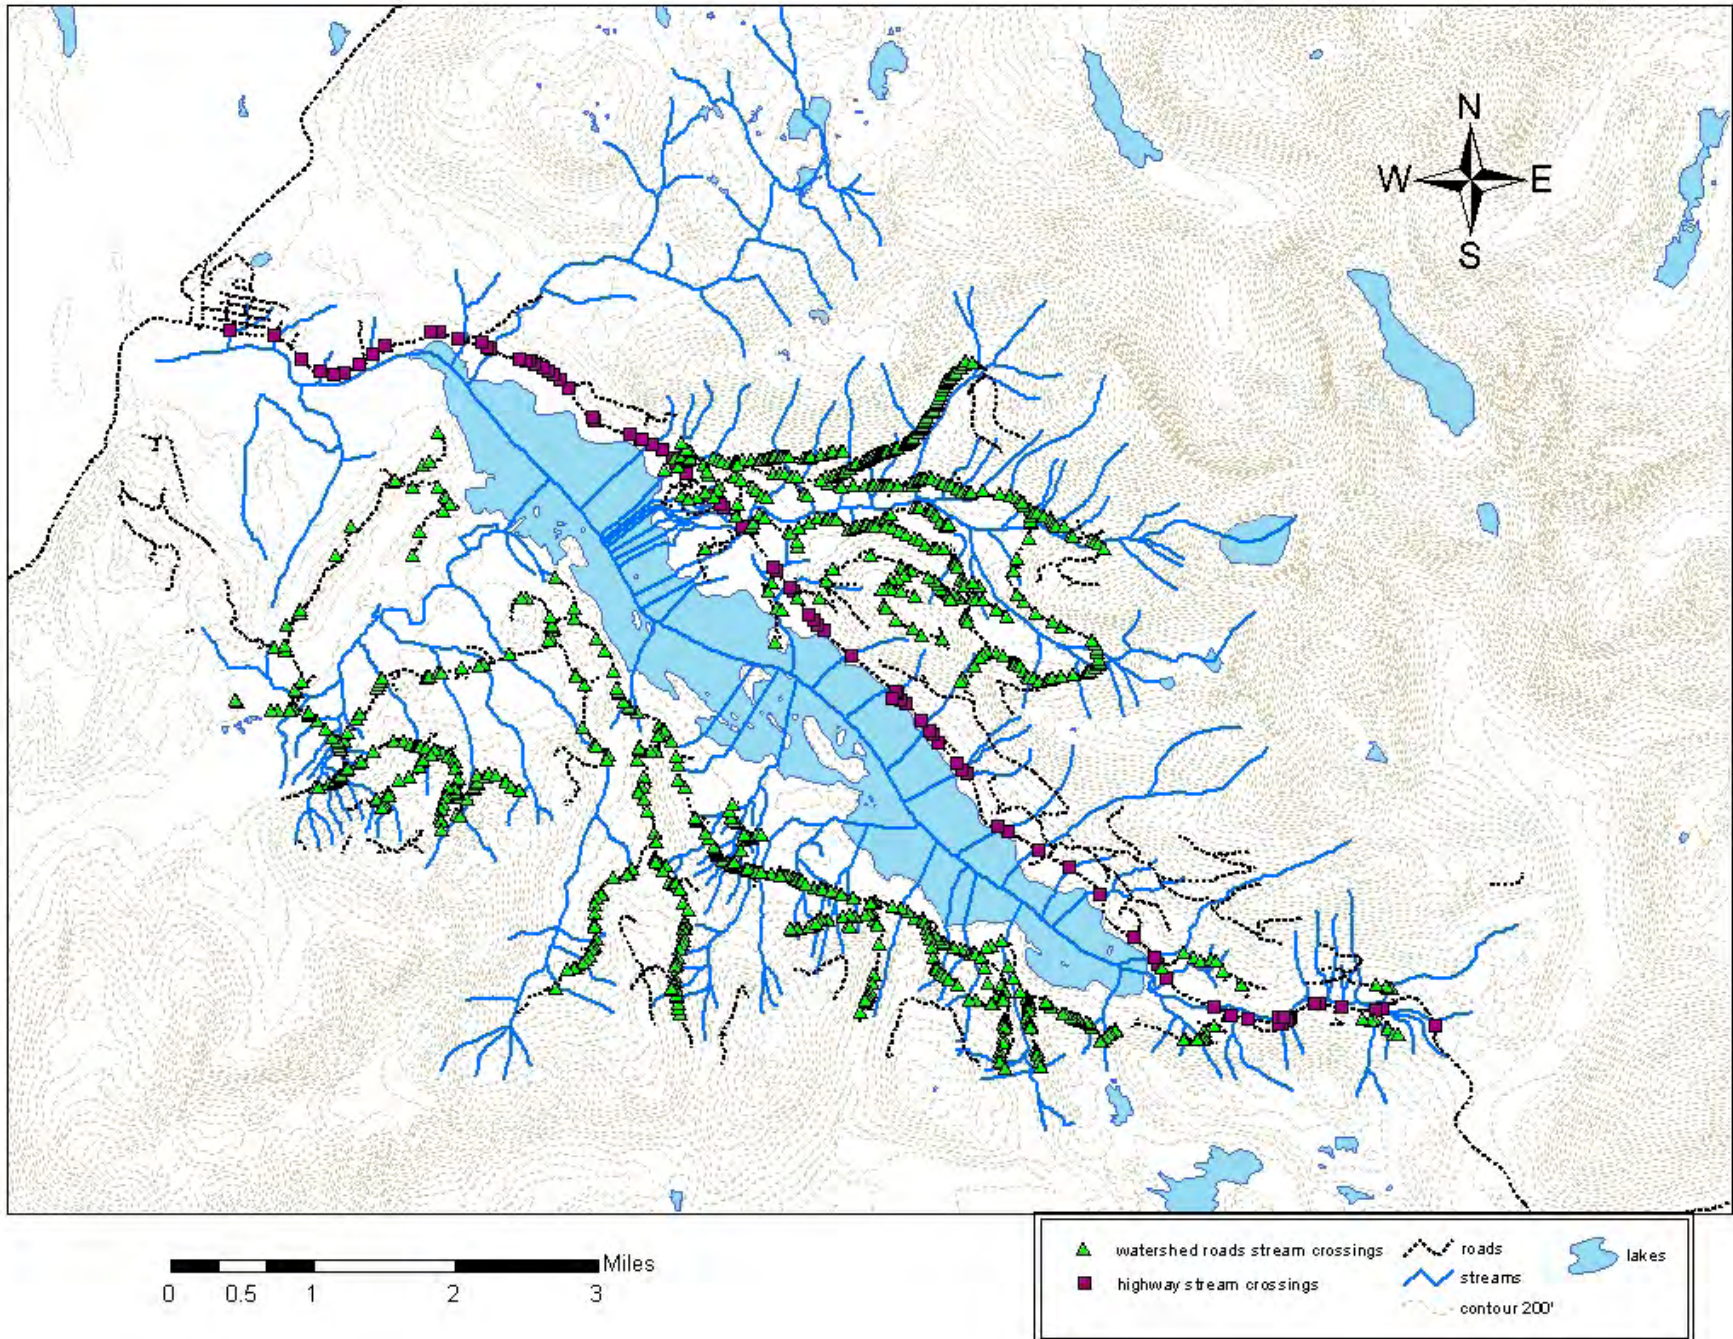
Over 400 stream crossings were documented on the watershed (Figure 3). These included streams associated with a variety of structures, specifically addressed in the following sections.

Figure 3. Location of all stream crossings associated with permanent and temporary roads in the Klawock Watershed, Southeast Alaska.

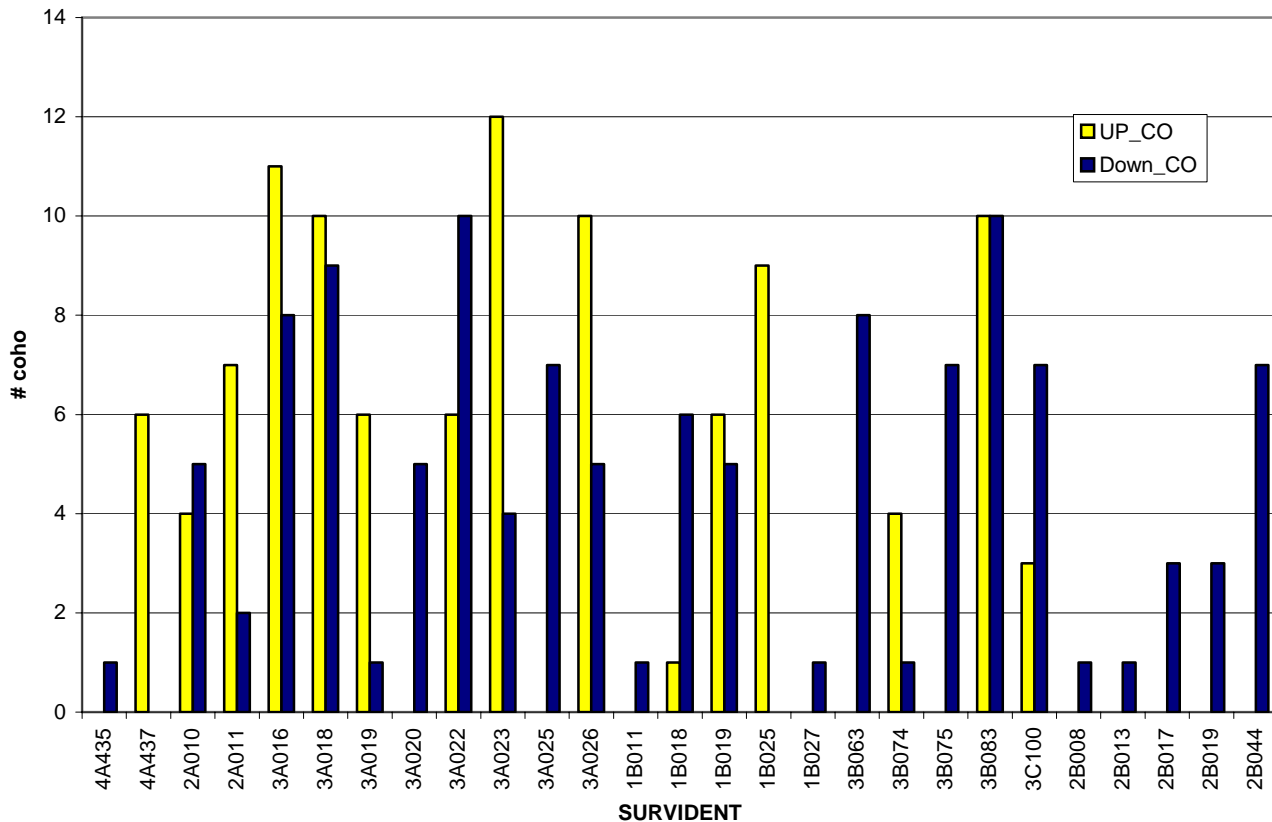
H&R staff baited and set 206 minnow traps to determine fish presence and distribution patterns at 73 locations across the watershed. Full results are summarized in Appendix 6. Coho salmon, *Oncorhynchus kisutch*, were the only anadromous species captured in H&R trapping efforts on the watershed and were captured at 27 locations; at 12 of these locations, coho were captured downstream of the stream crossing feature only (Figure 8).

Figure 8. Coho trapping results upstream (UP_CO) and downstream (Down_CO) of stream crossing structures on Klawock Watershed.

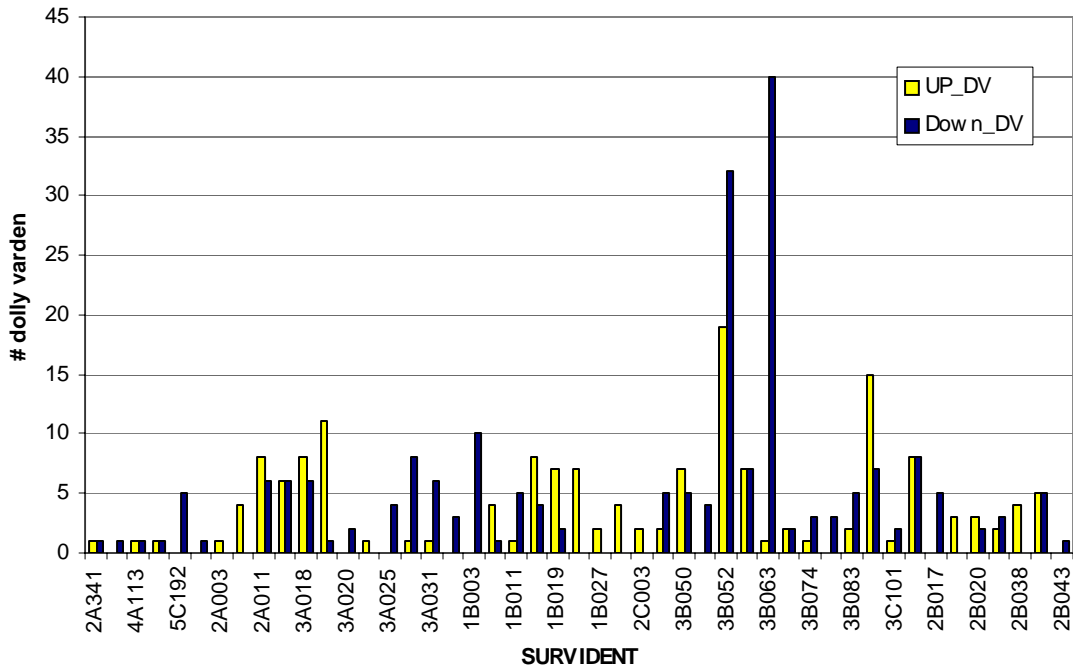
Dolly Varden, *Salvelinus malma*, were captured at 47 locations throughout the watershed; at 11 of these locations, dolly varden were captured only downstream of the crossing feature (Figure 9). Cutthroat trout, *Oncorhynchus clarki* were captured at a total of 39 locations throughout the watershed, 12 of which included locations where cutthroat were only captured downstream of the crossing structures (Figure 10).

Figure 9. Dolly Varden trapping results upstream (UP_DV) and downstream (Down_DV) of stream crossing structures on the Klawock Watershed.

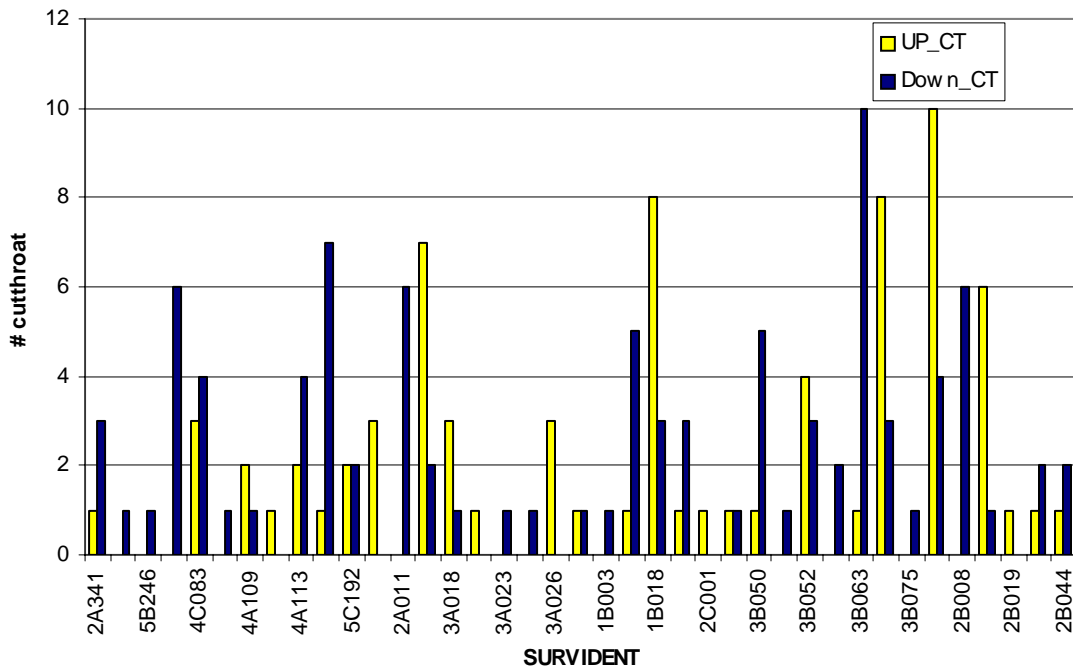
Figure 10. Cutthroat trapping results upstream (UP_CT) and downstream (Down_CT) of stream crossing structures on the Klawock Watershed.

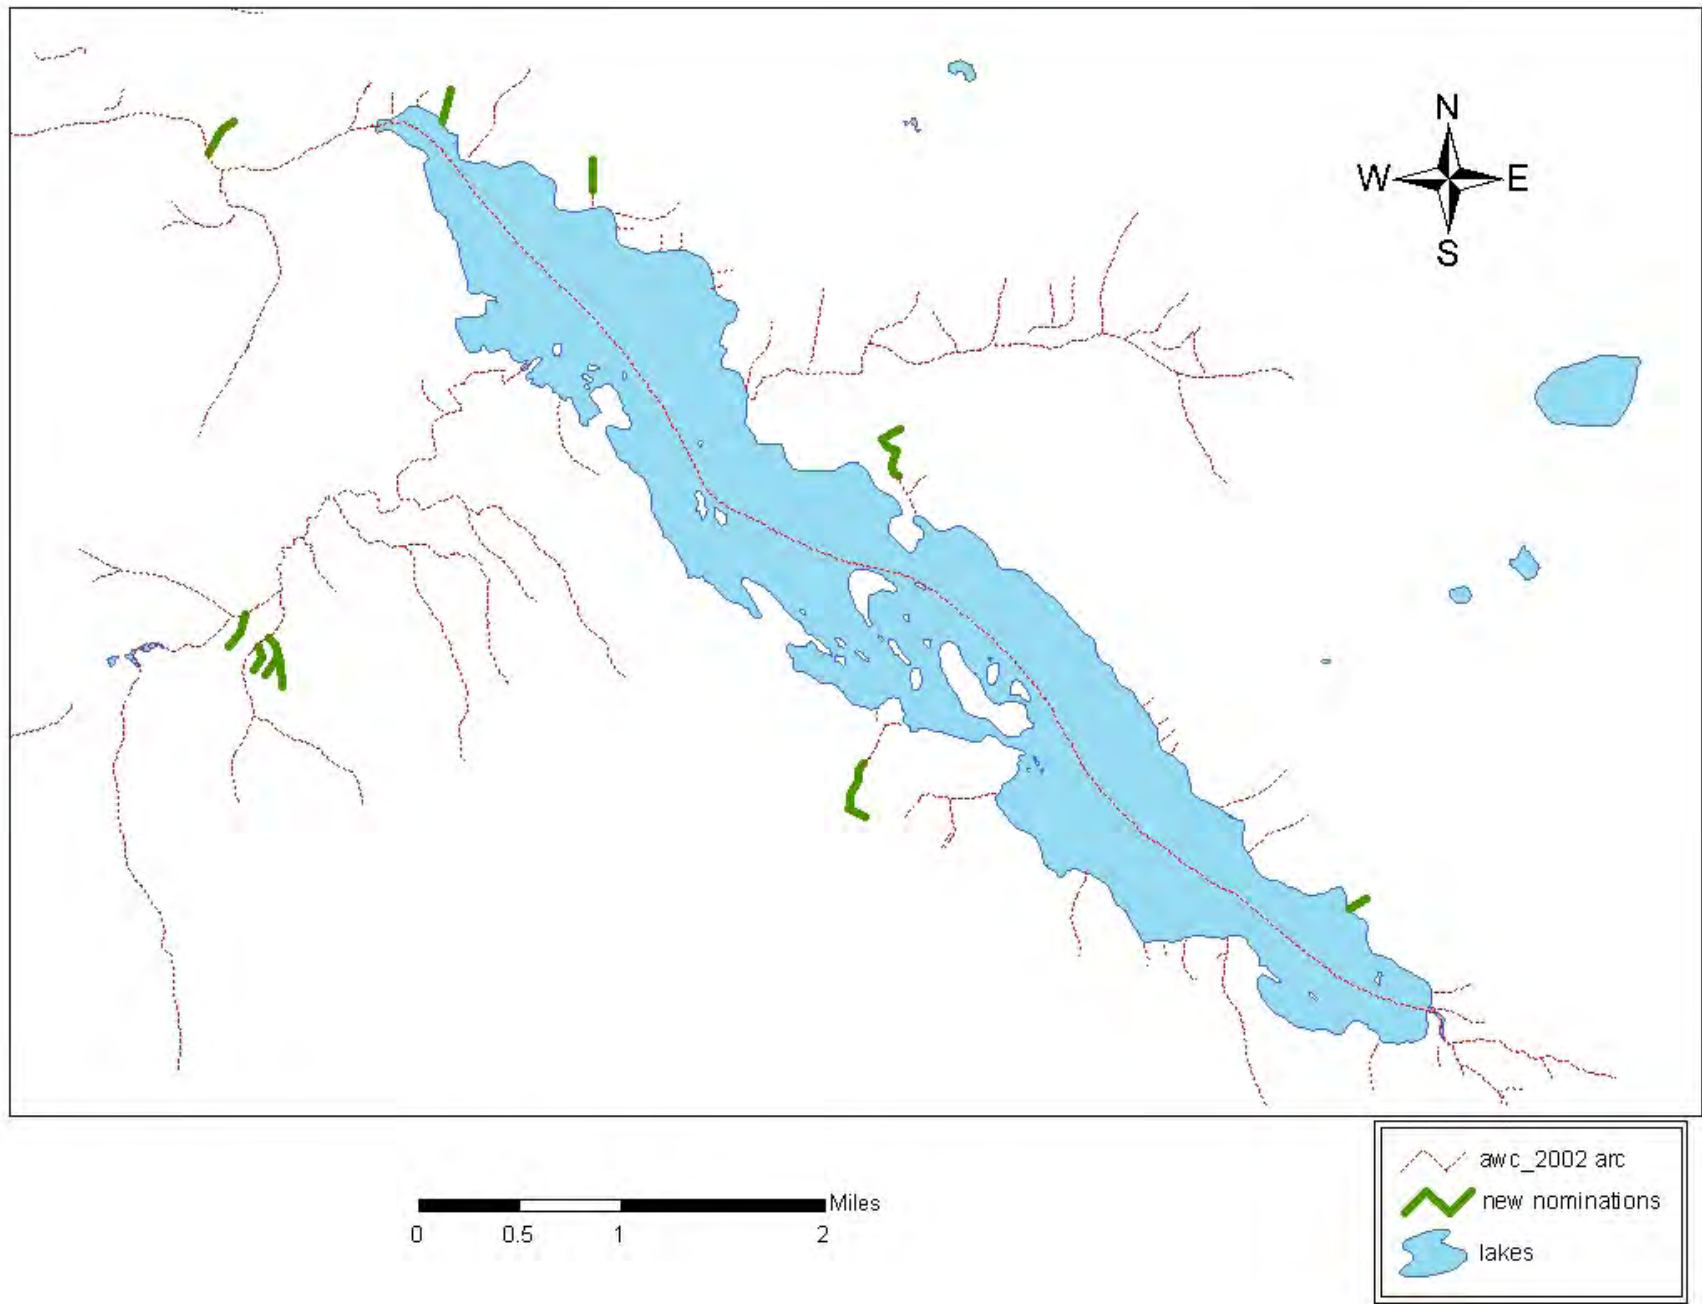
H&R trapping efforts during the course of the RCS work have led to the addition (or extension) of at least eight stream arcs in the Anadromous Waters Catalog. These will be nominated for update in the next cycle of nominations in 2004. The current distribution of known anadromous streams is depicted in Figure 11 and includes the draft updates mentioned.

Figure 11. Current known hydrography of anadromous waters within the Klawock Watershed, Prince of Wales Island, based on digital AWC (draft 2002) and fish trapping efforts during Road Condition Surveys, 2002.
