Klawock Lake Watershed Sockeye Spawning Habitat Assessment

Prince of Wales Island, Alaska

January 2018

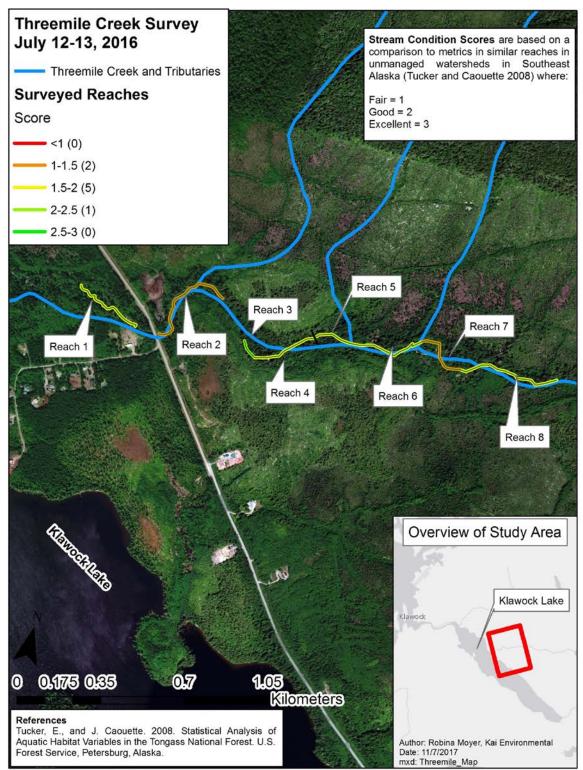
Figure 7: Threemile Creek Survey Area in Klawock Lake Watershed, Klawock, Alaska. Map shows surveyed reaches and habitat condition scores based on an analysis of survey data and a comparison to known metrics for Southeast Alaska streams.

Data collected showed that Reach 1 was classified as a floodplain, a professional call made by the field crew to how field conditions at the time were observed; however others have indicated

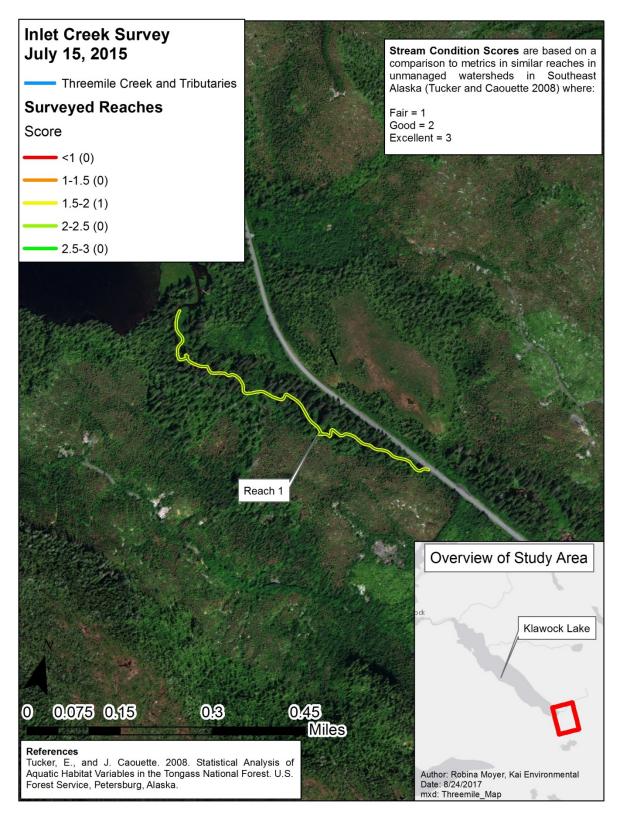
Figure 10. Inlet Creek Survey Area in Klawock Lake Watershed, Klawock, Alaska. Map shows surveyed reach and habitat condition scores based on an analysis of the survey data and a comparison to known metrics for Southeast Alaska streams.

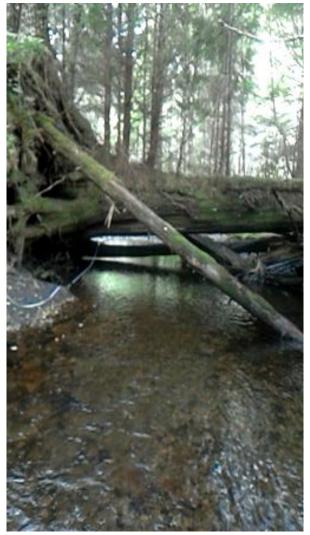
Photo 1. Starting point of stream survey on Hatchery Creek, in the Klawock Lake

Watershed, Klawock, Alaska. Photo taken from bridge, looking downstream.

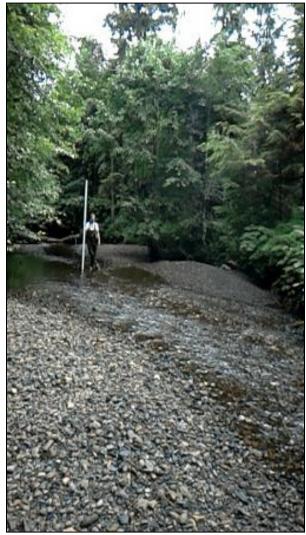
Photo 3: Photo of Reach 1 in Hatchery Creek, of the Klawock Lake Watershed, Klawock, Alaska. The photo is

taken looking upstream from the channel type verification point.

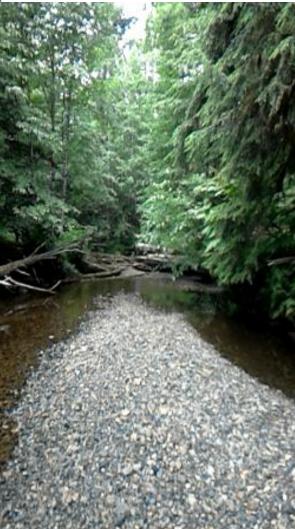
Photo 4. Photo of Reach 1 in Hatchery Creek, of the Klawock Lake Watershed, Klawock, Alaska. The photo is taken looking downstream from the channel type

verification point.

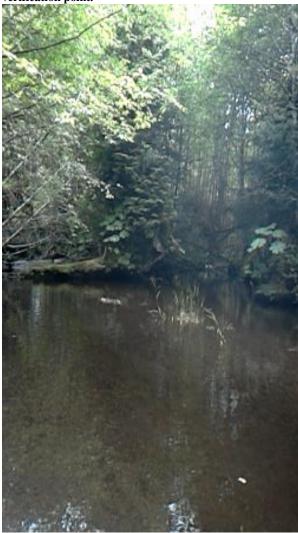
Photo 5. Photo of Reach 2 in Hatchery Creek, of the Klawock Lake Watershed, Klawock, Alaska. The photo is

taken looking upstream from the channel type verification point.

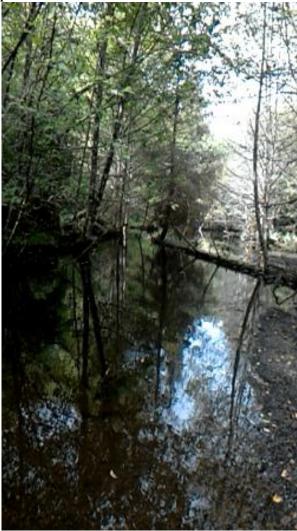
Photo 6. Photo of Reach 2 in Hatchery Creek, of the Klawock Lake Watershed, Klawock, Alaska. The photo is

taken looking downstream from the channel type verification point.

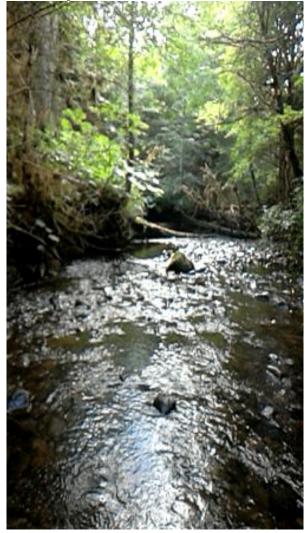
Photo 7. Photo of Reach 3 in Hatchery Creek, of the Klawock Lake Watershed, Klawock, Alaska. The photo is

taken looking upstream from the channel type verification point.

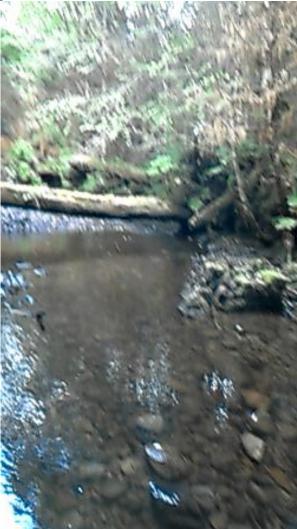
Photo 8. Photo of Reach 3 in Hatchery Creek, of the Klawock Lake Watershed, Klawock, Alaska. The photo is taken looking downstream from the channel type verification point

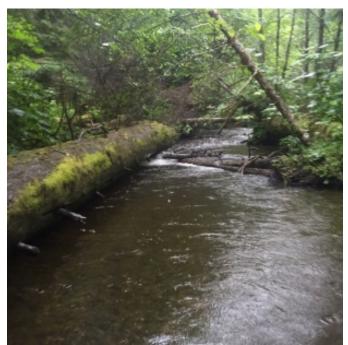
Photo 10: Photo of Reach 1 in Threemile Creek, of the Klawock Lake Watershed, Klawock, Alaska. The photo is taken looking downstream from the channel type verification point.

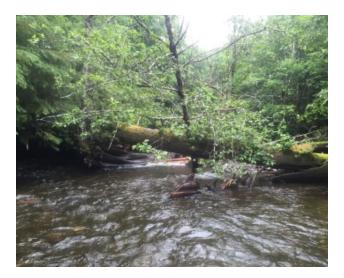
Photo 91: Photo of Reach 1 in Threemile Creek, of the Klawock Lake Watershed, Klawock, Alaska. The photo is taken looking upstream from the channel type verification point.

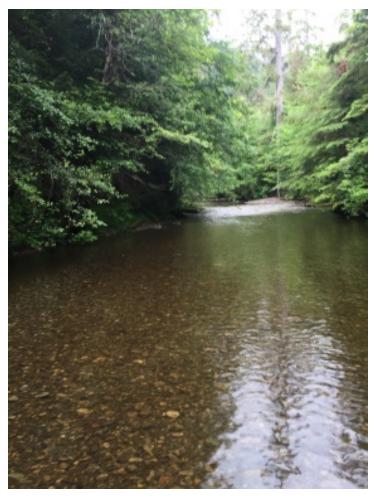
Photo 12: Photo of Reach 2 in Threemile Creek, of the Klawock Lake Watershed, Klawock, Alaska. The photo is taken looking downstream from the channel type verification point

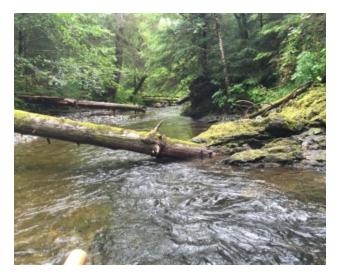
Photo 13: Photo of Reach 2 in Threemile Creek, of the Klawock Lake Watershed, Klawock, Alaska. The photo is taken looking upstream from the channel type verification point

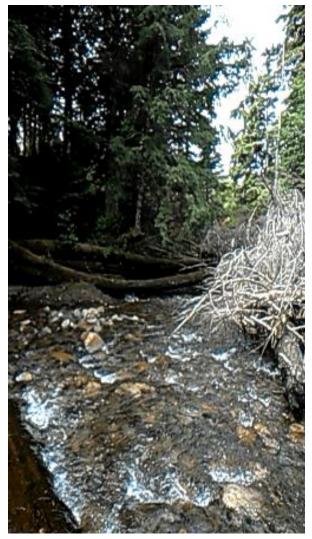
Photo 14: Photo of Reach 3 in Threemile Creek, of the Klawock Lake Watershed, Klawock, Alaska. The photo is taken looking downstream

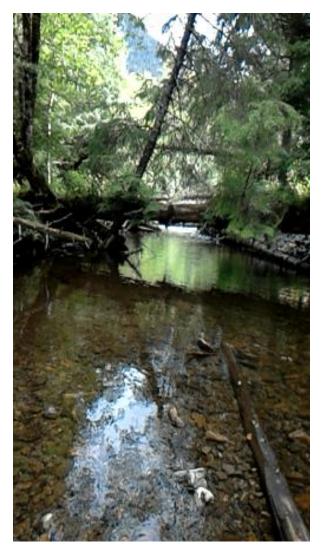
Photo 15: Photo of Reach 4 in Threemile Creek, of the Klawock Lake Watershed, Klawock, Alaska. The photo is taken looking downstream from the channel type verification point

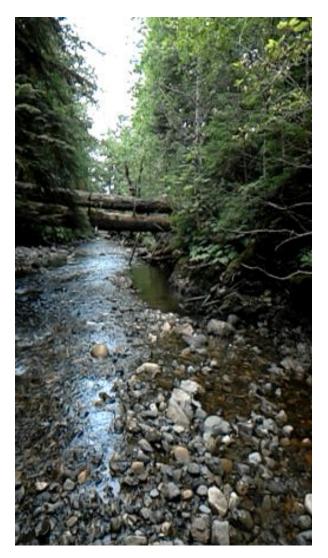
Photo 16: Photo of Reach 4 in Threemile Creek, of the Klawock Lake Watershed, Klawock, Alaska. The photo is taken looking upstream from the channel type verification point

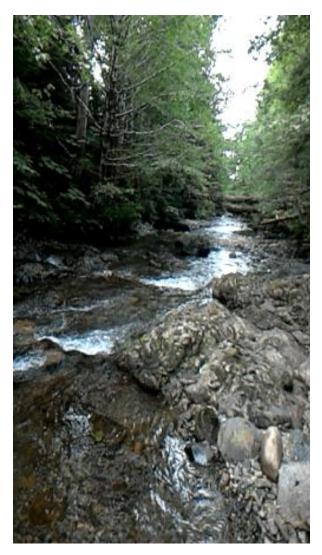
Photo 17: Photo of Reach 5 in Threemile Creek, of the Klawock Lake Watershed, Klawock, Alaska. The photo is taken looking downstream from the channel type verification point

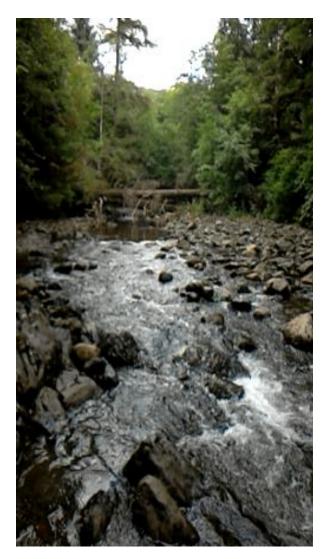
Photo 18: Photo of Reach 5 in Threemile Creek, of the Klawock Lake Watershed, Klawock, Alaska. The photo is taken looking upstream from the channel type verification point

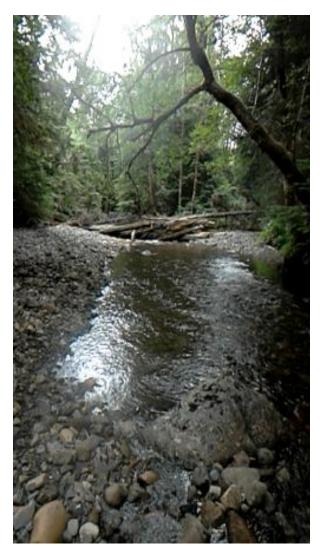
Photo 19: Photo of Reach in Threemile Creek, of the Klawock Lake Watershed, Klawock, Alaska. The photo is taken looking downstream from the channel type verification point

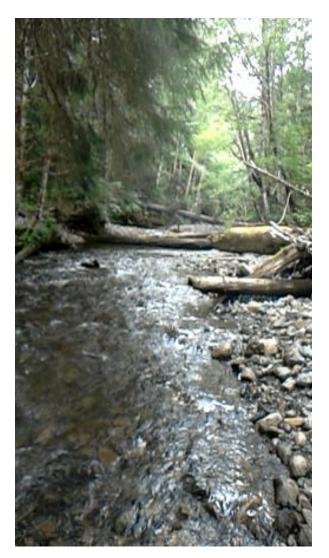
Photo 100: Photo of Reach 6 in Threemile Creek, of the Klawock Lake Watershed, Klawock, Alaska. The photo is taken looking upstream from the channel type verification point

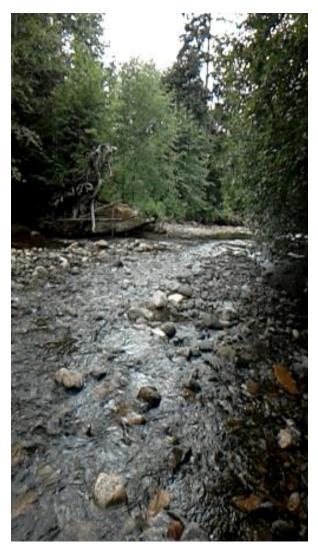
Photo 21: Photo of Reach 7 in Threemile Creek, of the Klawock Lake Watershed, Klawock, Alaska. The photo is taken looking downstream from the channel type verification point

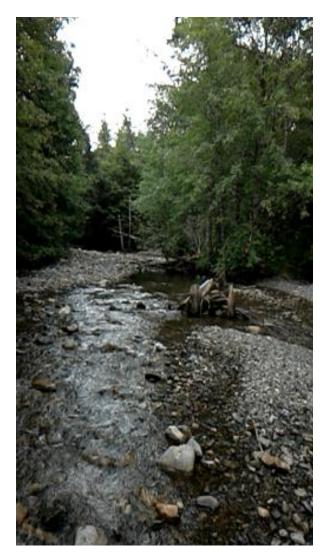
Photo 22: Photo of Reach 7 in Threemile Creek, of the Klawock Lake Watershed, Klawock, Alaska. The photo is taken looking upstream from the channel type verification point

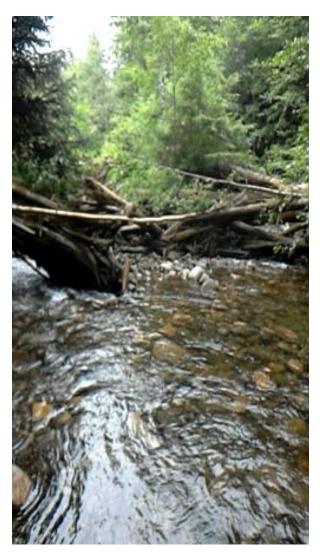
Photo 23: Photo of Reach 8 in Threemile Creek, of the Klawock Lake Watershed, Klawock, Alaska. The photo is taken looking downstream from the channel type verification point

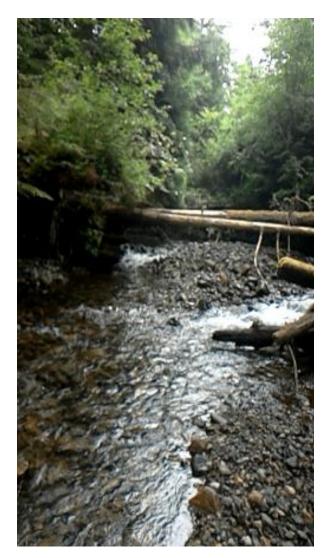
Photo 24: Photo of Reach 8 in Threemile Creek, of the Klawock Lake Watershed, Klawock, Alaska. The photo is taken looking upstream from the channel type verification point

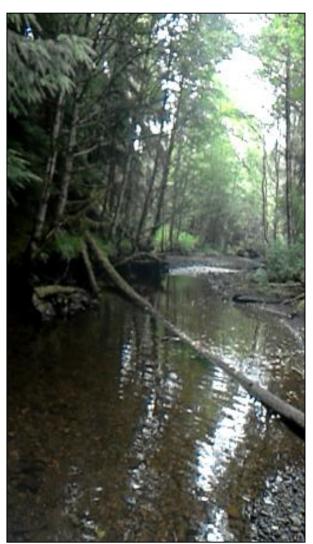
Photo 31: Photo of Inlet Creek, of the Klawock Lake Watershed, Klawock, Alaska. The photo is taken looking upstream from the lower portion of Reach 1

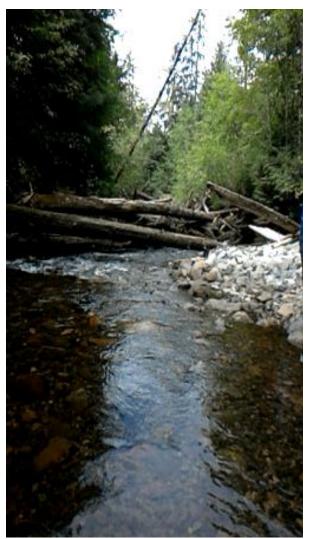
Photo 33. Photo of Inlet Creek, of the Klawock Lake Watershed, Klawock, Alaska. The photo is taken looking downstream from the upper portion of Reach 1.
