Coffman Creek Habitat Assessment
Prince of Wales Island, Alaska

January 2019

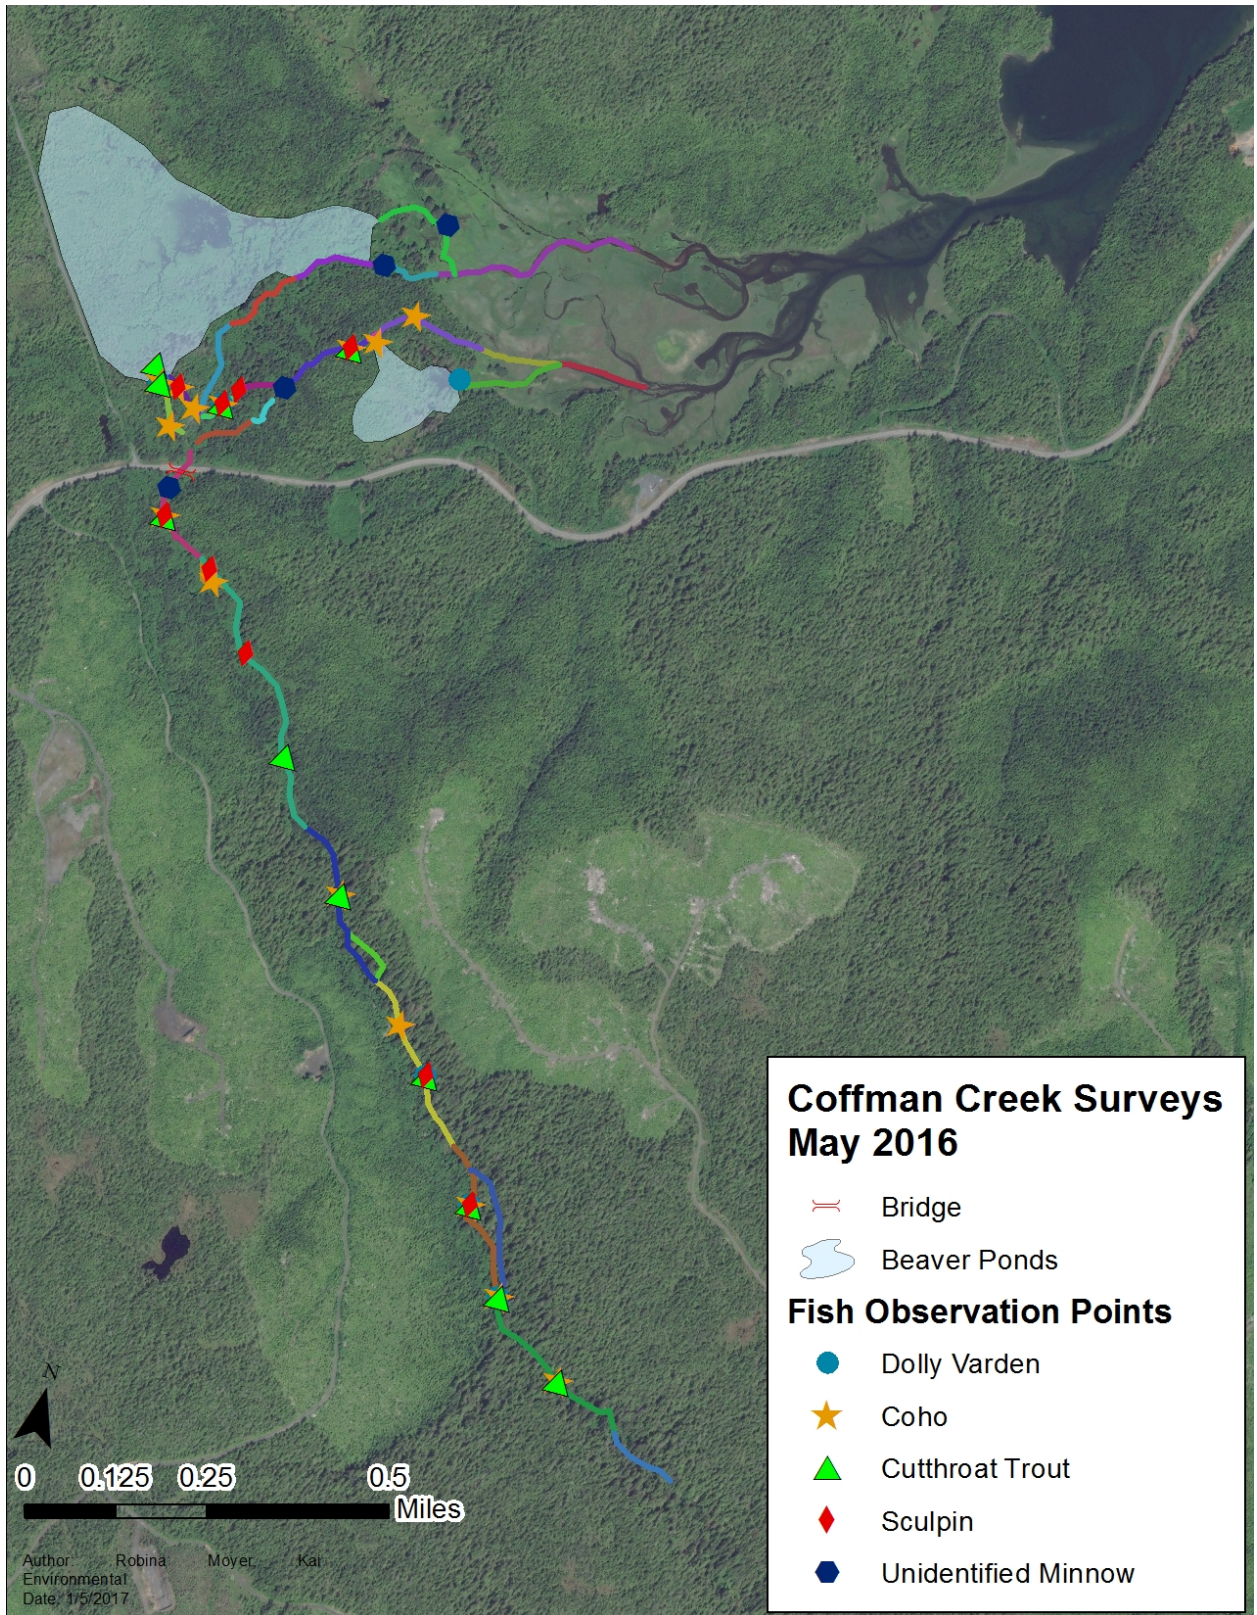
Figure 4: Fish observation points for juvenile fish for the surveyed reaches in Coffman Creek, near Coffman Cove, Alaska.

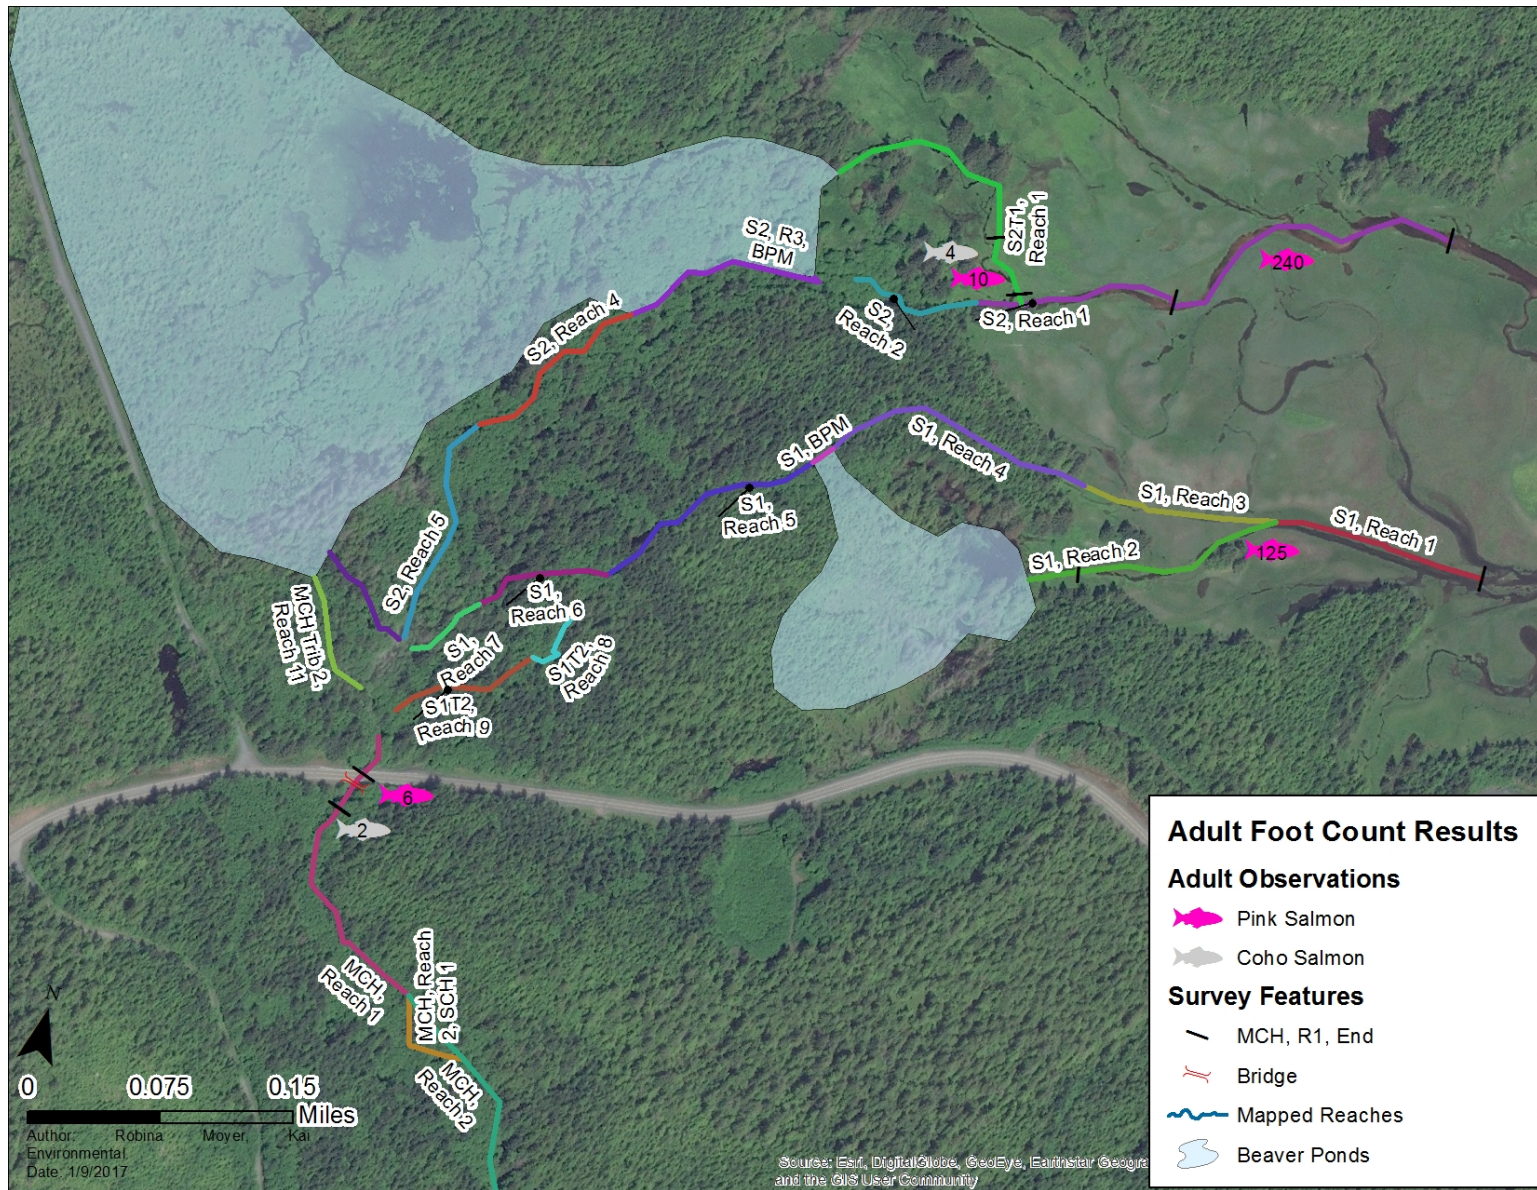
Figure 5: Fish observation points for adult fish for the surveyed reaches in Coffman Creek, near Coffman Cove, Alaska.

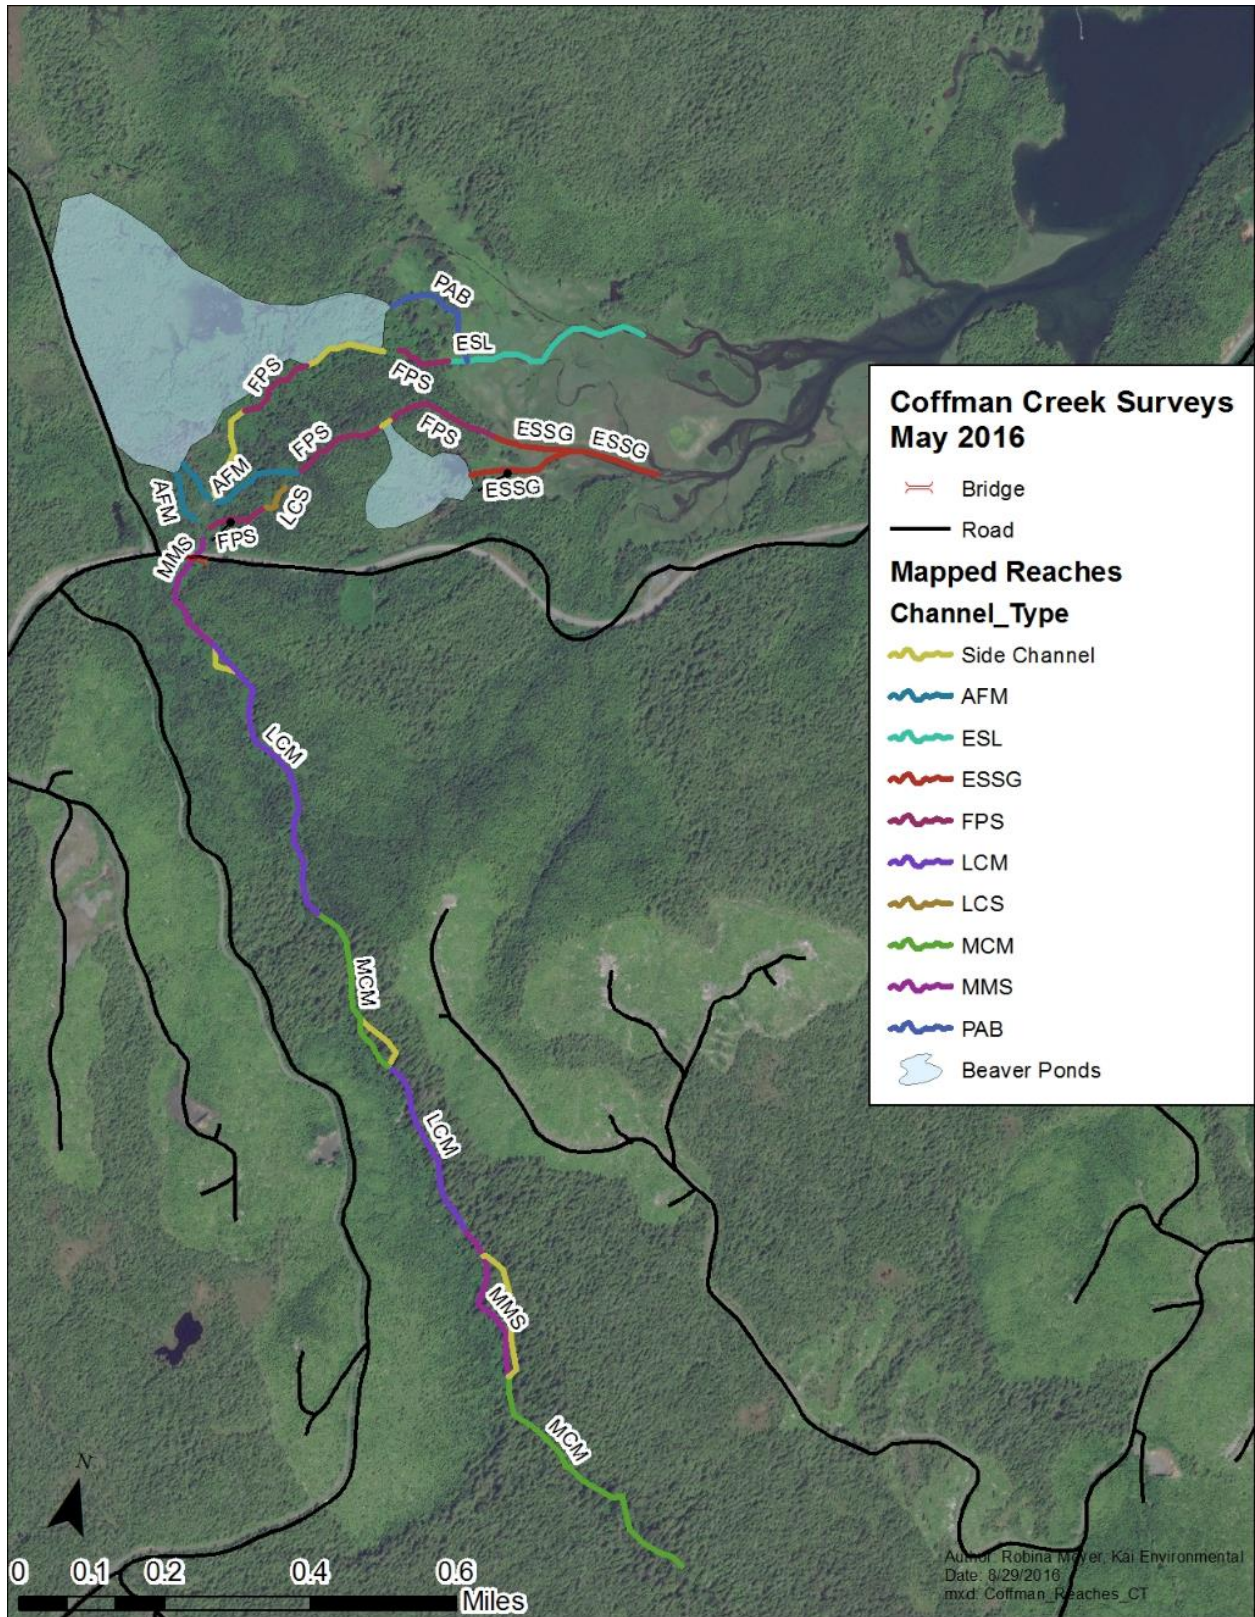
Figure 6: Map showing channel types of surveyed reaches along Coffman Creek near Coffman Cove, Alaska.

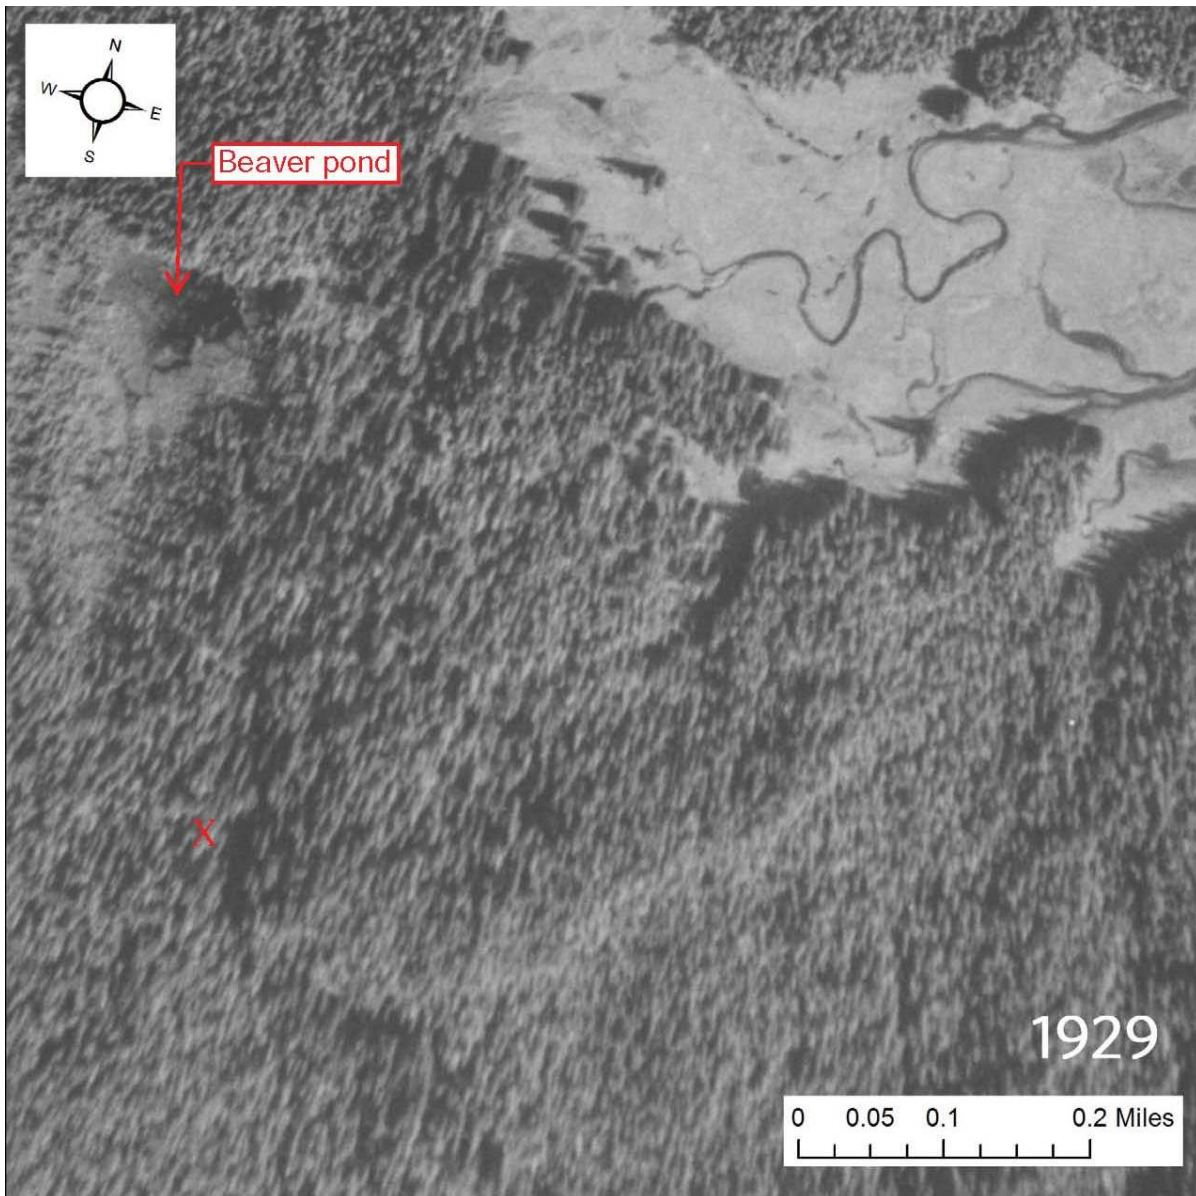
Figure 8: Aerial imagery from 1929 of the Coffman Creek estuary and Coffman Creek, near Coffman Cove, Alaska. The red X on the image refers to where a future road crossing occurs over the mainstem of Coffman Creek. Annotations on the image refer to changes in imagery when compared to other figures in the Coffman Creek Habitat Assessment report (2018).

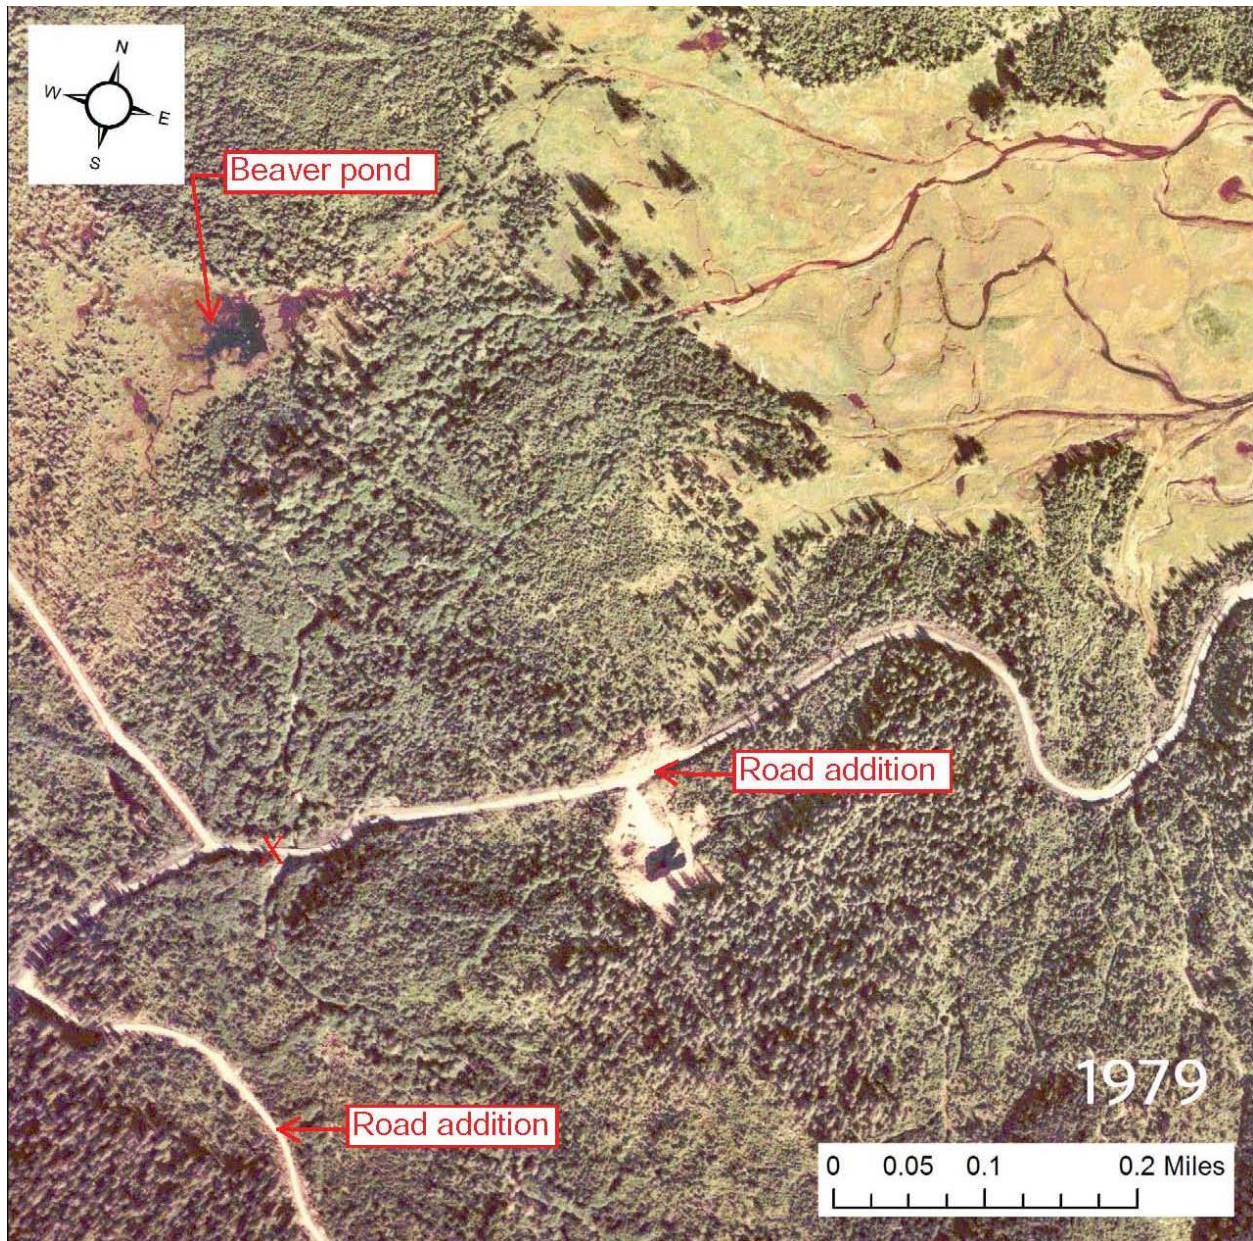
By 1979 (Figure 10), the Coffman Cove road had been built and the straightened estuary channel from the 1971 image remained. Based on USFS harvest records, there was approximately 175 acres of timber harvest in the watershed between 1971 and 1979, all east of the imagery analysis area, implying that changes seen between Figures 9 and 10 may be the results of road

Figure 10: Aerial imagery from 1979 of the Coffman Creek estuary and Coffman Creek, near Coffman Cove, Alaska. The red X on the image is a reference point to earlier imagery before the construction of the road crossing over the mainstem of Coffman Creek. Annotations on the image refer to changes in imagery when compared to other figures in the Coffman Creek Habitat Assessment report (2018).
