# Forest Road Condition Surveys – SE AK and Kenai Peninsula Borough

AK Fish Passage Meeting, October 13, 2015

Joel Nudelman, Forest Practices/Resource Forester

Alaska Department of Natural Resources Division of Forestry

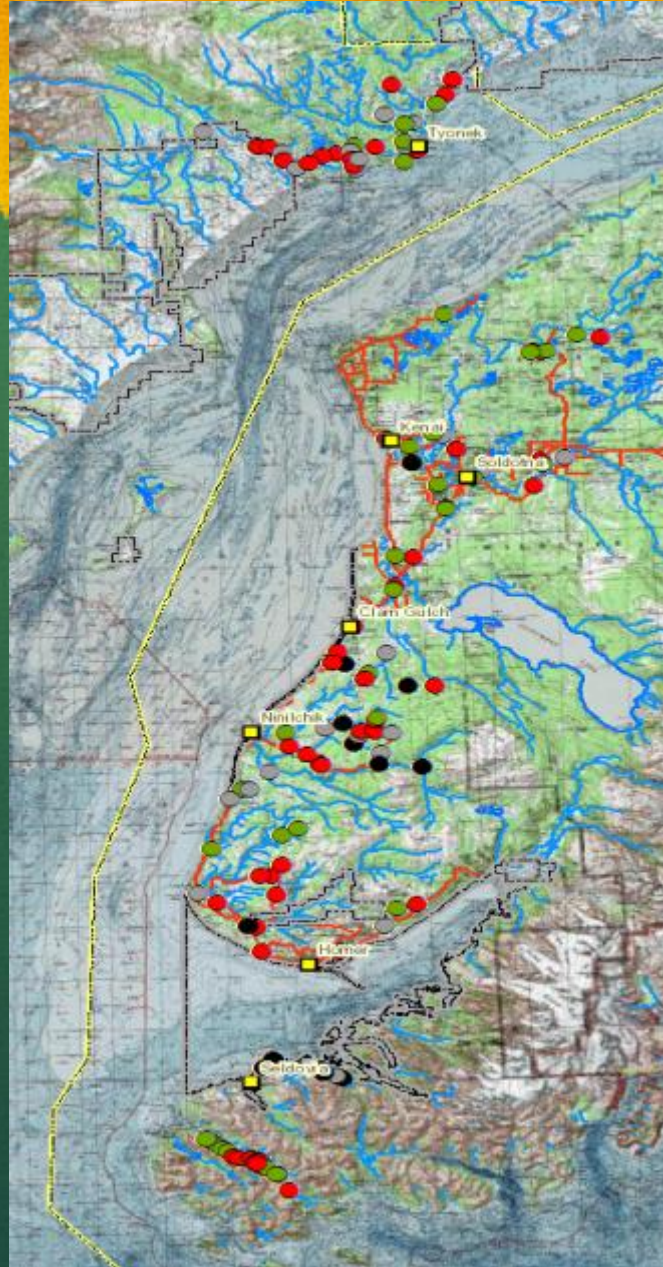
# ADFG – Fish Resource Monitor Website

# Crossing Structure Interface from ADFG Fish Resource Monitor Internal Site
