ADF&G Fish Passage Inventory and Assessment Program

Gillian O'Doherty
Alaska Department of Fish & Game

Assess structures on fish bearing streams for impacts to fish passage

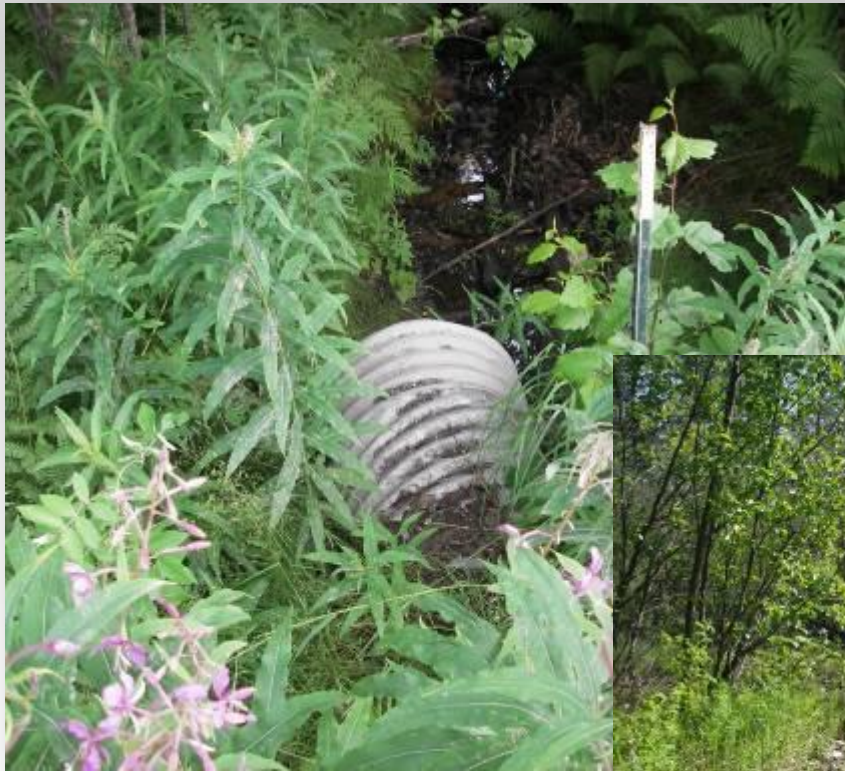
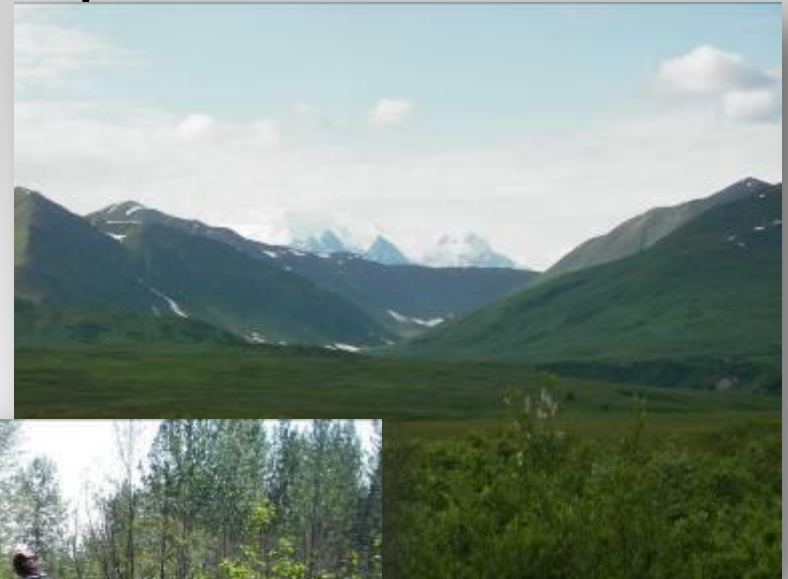
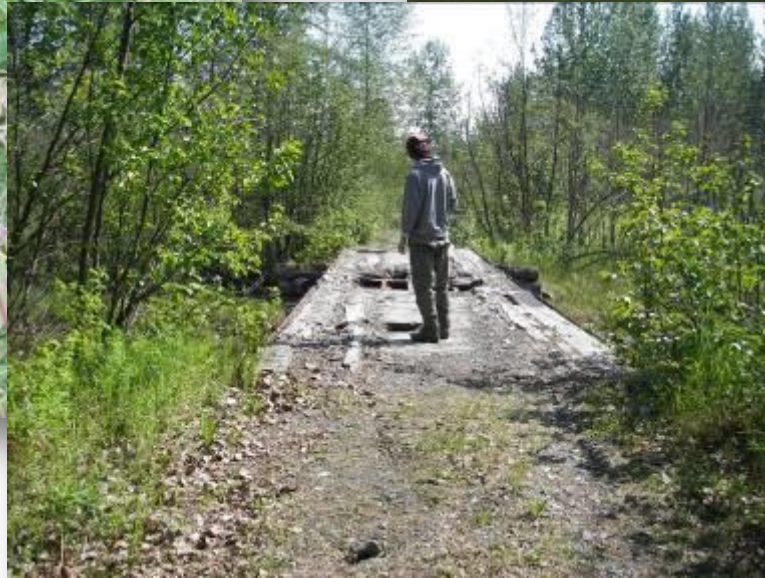
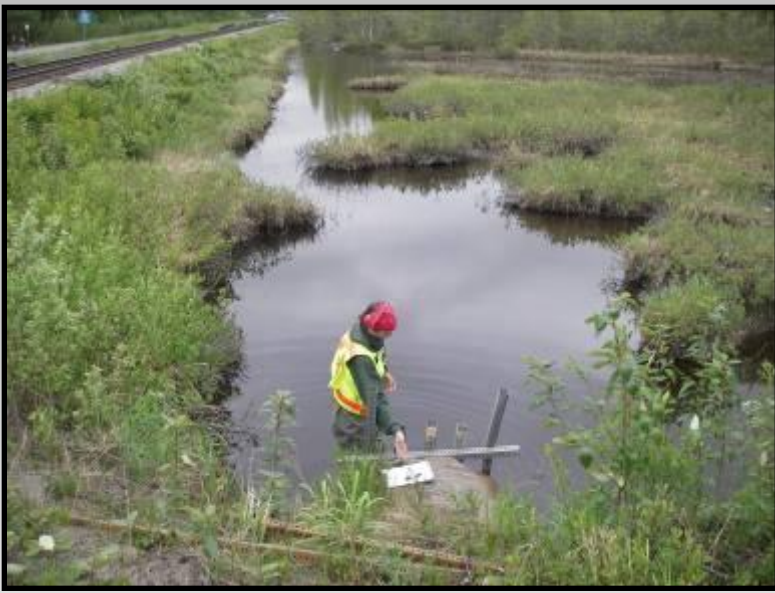
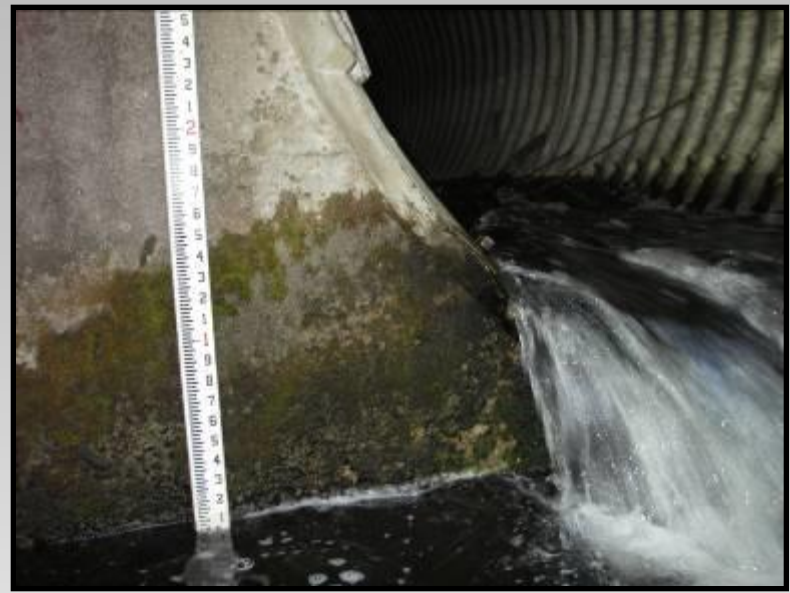
Step two: Inventory

Bridges, fords, non standard culverted crossings, non fish-bearing channels, ephemeral channels

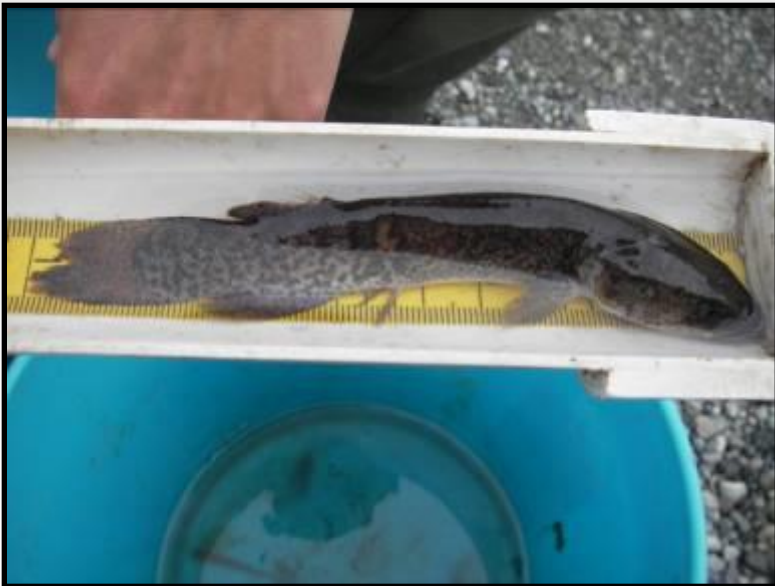
Step Three: Assessment

- Site Description
- Photographs
- Site sketch
- Culvert & channel dimensions
- Long Profile
- Fish trapping

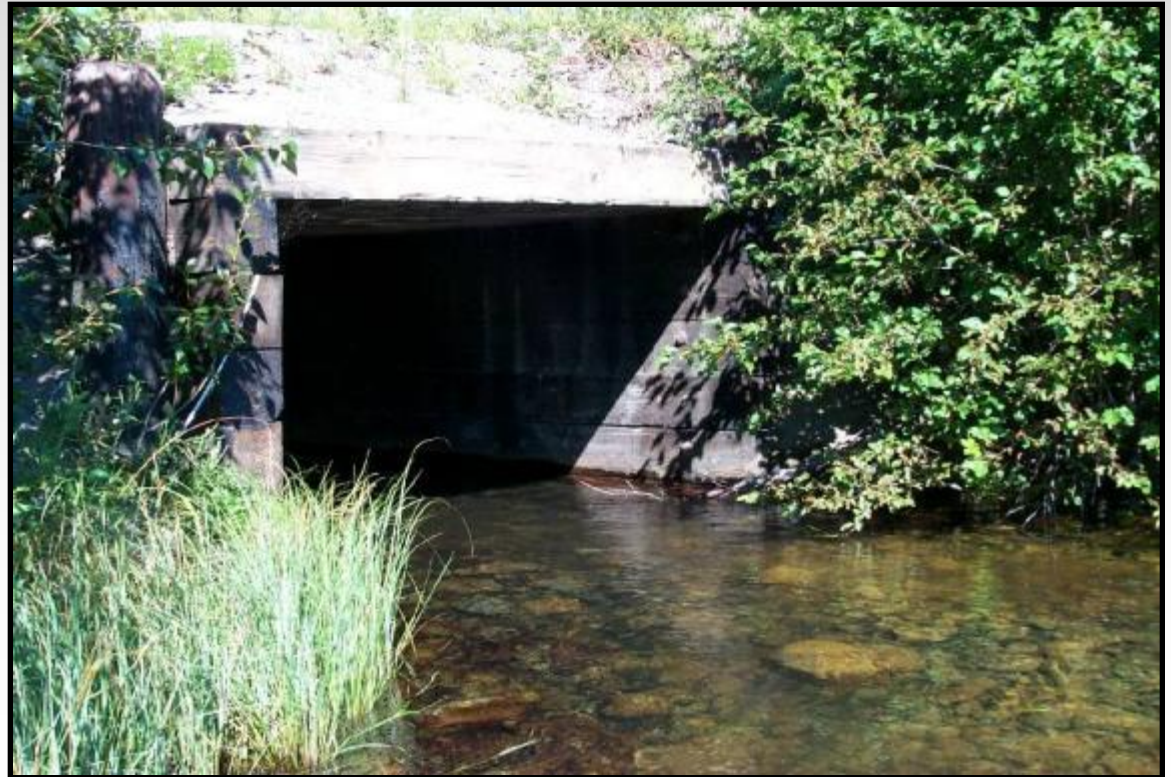
The **Red, Gray, Green** Classification is based on:

- 1. a 55mm Coho**
- 2. Culvert Type**
- 3. Measured Critical Values**
 - Slope
 - Perch Height
 - Constriction Ratio

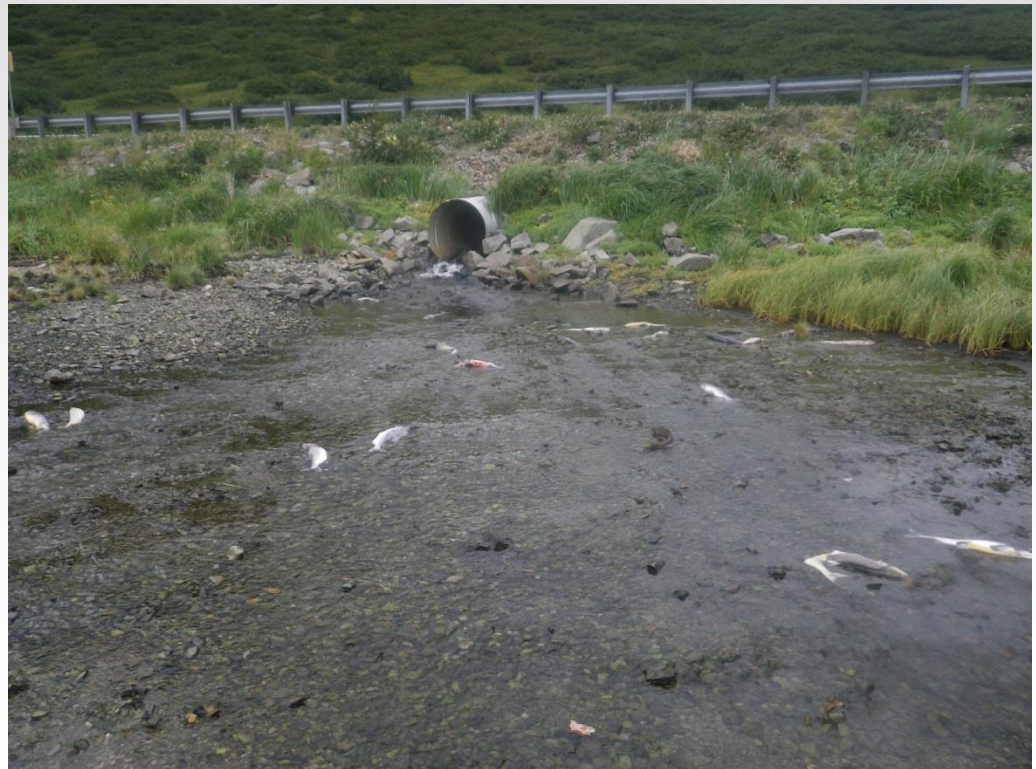
Standardize- ex: damage

- (1) *Defective*, culvert is in dire need of prompt repair or replacement, flaws threaten to disrupt or are hindering traffic;
 - (2) *Poor*, culvert is in need of repair and shows potential for further deterioration;
 - (3) *Fair*, culvert is operational but may need maintenance to restore function to full potential, distinct rust line and/or abraded bottom present, adverse conditions could lead to major problems;
 - (4) *Good*, culvert shows minor deficiencies, beginning of rust line formation may be visible; with continued maintenance should be trouble free;
 - (5) *Excellent*, culvert shows no signs of problems or rust, could allow flow at full capacity without disrupting traffic.
- (Baker et al unpublished)
