# **Duck Creek Restoration Assessment Report**

## **Mendenhall River Watershed in Juneau, Alaska**

Prepared for: Juneau Watershed Partnership  
June 2007

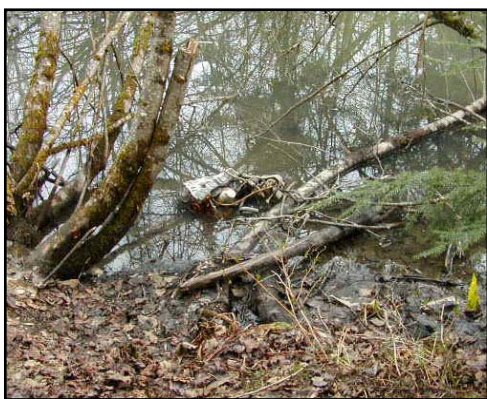
Figure 4. An engine that has been dumped into Duck Creek next to Super Bear, May 2007.

The primary sources of debris in Duck Creek are littering and inadequate storage of garbage at residential and commercial properties, but occasional deliberate “dumping” is also a concern (Figure 3). Ongoing education and outreach to teach residents to secure their garbage from ravens and bears can help reduce debris accumulation, but regular community clean ups are necessary. The Juneau Watershed Partnership’s (JWP) Adopt-a-Stream program encourages groups to adopt a section of Duck Creek to regularly clean up. JWP coordinates with Litter Free, Inc.’s annual spring community clean up to pick up the winter’s accumulation of trash, and then hosts another stream clean up in the fall to specifically target local streams.

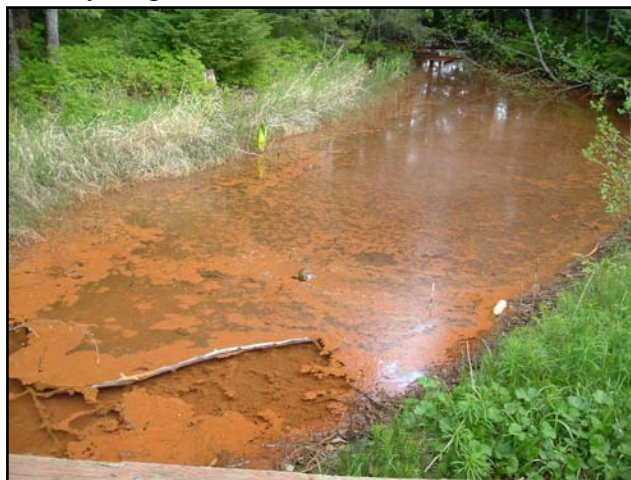
Figure 5. Iron floc in a ditch near Short Court that flows into Duck Creek.

Land disturbances such as excavation during development increase groundwater exposure to surface oxidation and further disrupt surface and groundwater flow paths to Duck Creek, which subsequently increases the likelihood of groundwater becoming exposed to D.O. and forming a floc that accumulates on the substrate. Overall development and increased urban runoff also contribute to lower D.O. from the accumulation of more nutrients and deicing chemicals, as they require large amounts of oxygen for their breakdown (Koski and Lorenz, 1999).

very quickly once the groundwater discharges into the stream and large amounts of oxygen are consumed (Hood et al., 2005). This oxidation produces the ubiquitous iron floc which covers much of the bottom of Duck Creek and clogs the interstitial spaces between gravels, drastically reducing productive habitat for fish and aquatic insects. D.O. levels in these conditions are typically less than 2.0 mg/L and have been found to be as low as 0.61 mg/L (E.P.A. 2005; Koski and Lorenz, 1999). State water quality criteria requires D.O. levels greater than 7 mg/L for water used by anadromous and resident fish while D.O. levels within spawning gravels must be at least 5.0 mg/L (E.P.A., 2001). Iron floc provides an energy source for iron-fixing bacteria. This combination of dissolved iron and the action of the bacteria results in a chemical reduction that lowers the concentrations of D.O. (U.S. Corps, 2001) resulting in a nearly sterile stream in many reaches.
